CK-2452

NORRISH CREEK 7.1km

2018 Inspection

| Crossing Name | Rose Creek |

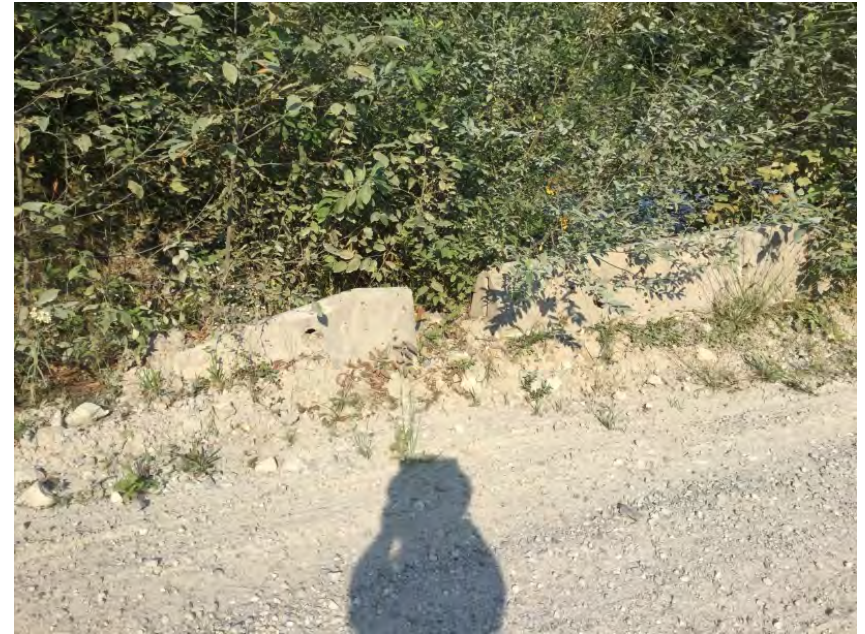
Upstream right approach bullnose not connected

Bullnose not connected at upstream right approach

Reconnect concrete bullnose at upstream right approach and brush approaches. Current load rating of L165 or 150 tonnes to continue.

| 1 | Low | Reconnect upstream right approach bullnose |

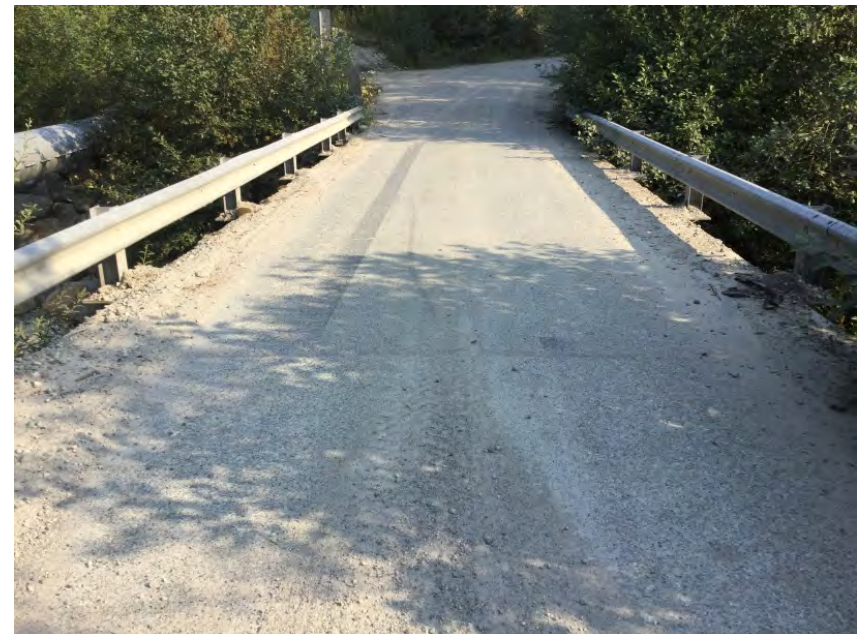
Concrete Deck      **Fair**      Some wear noted on wheel path

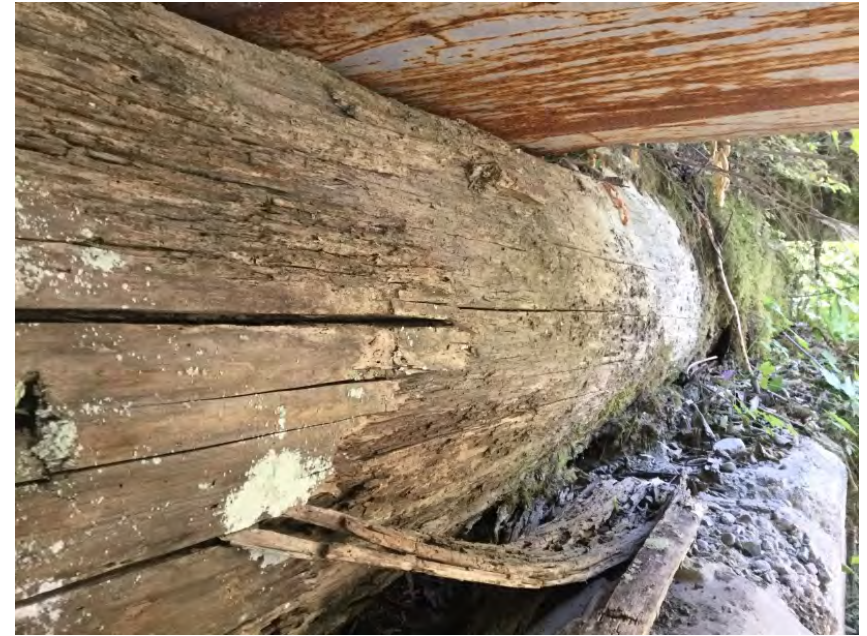
Log sill right bank with 60mm sap rot

Right bank log sill condition

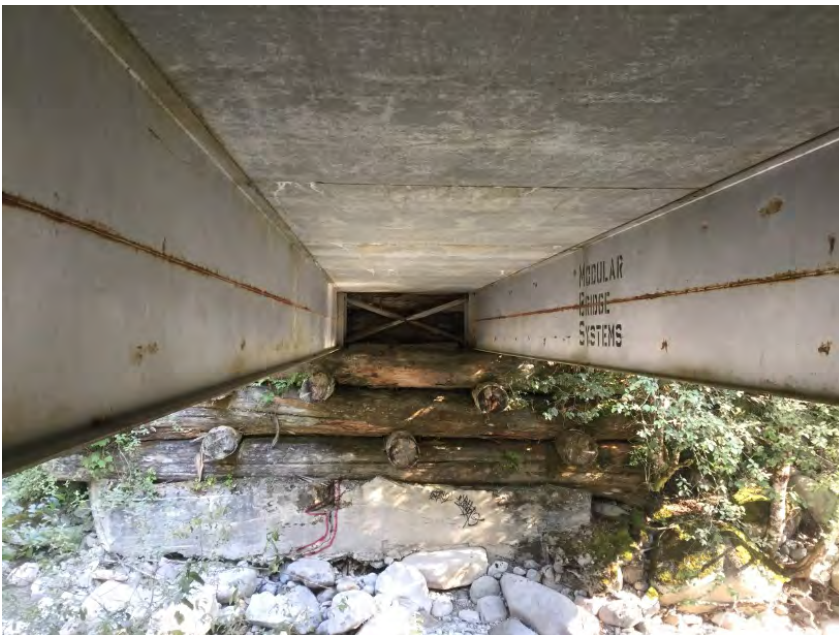
Superstructure

Painted steel box girders

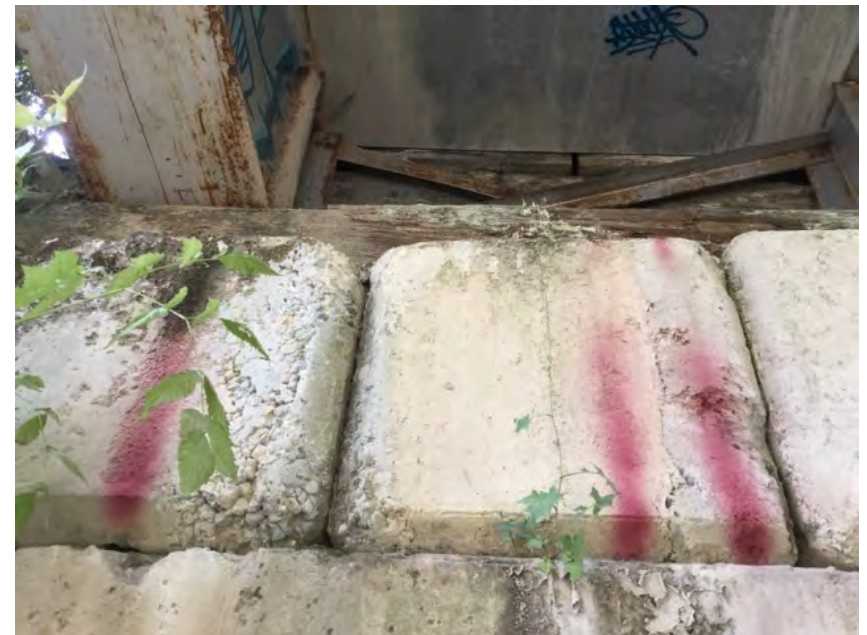
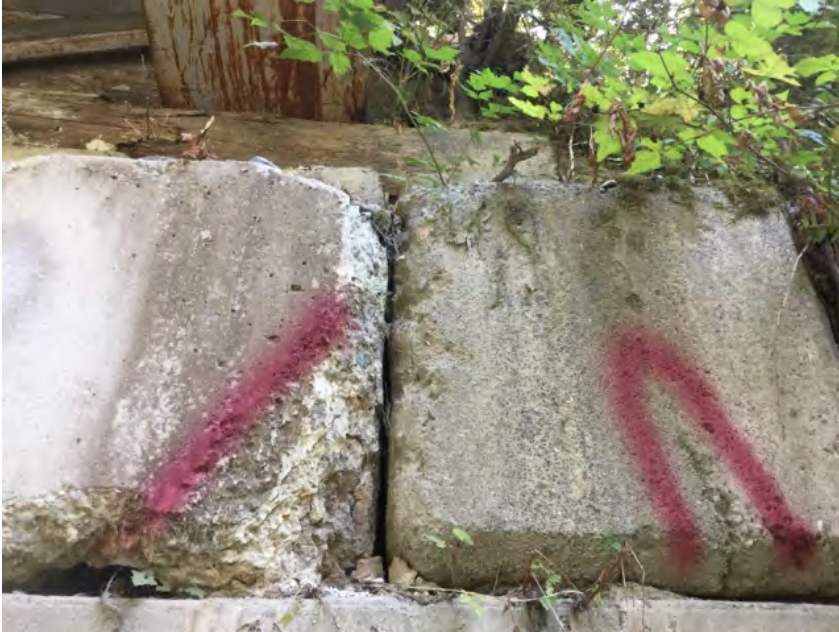
CIP left bank with vertical crack under upstream girder, no apparent change. Precast and lock blocks right bank. Blocks are spalling throughout and some have visible cold joints

Lock block condition

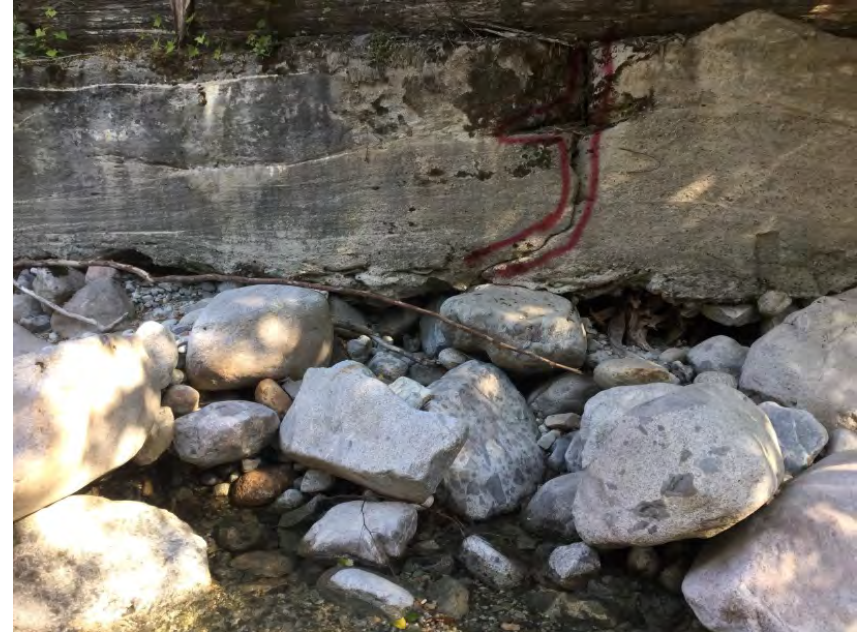
Scour under CIP extends 600mm in places

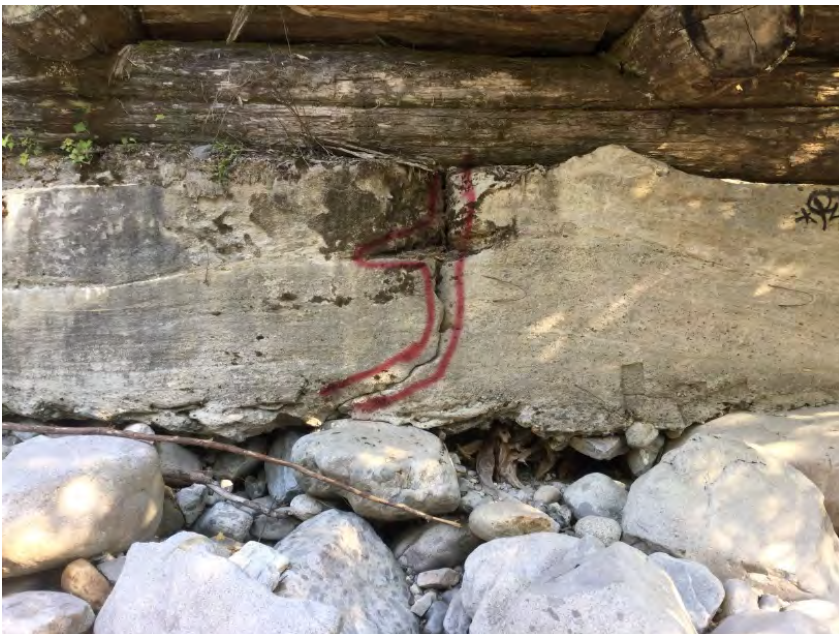
Vertical crack in CIP

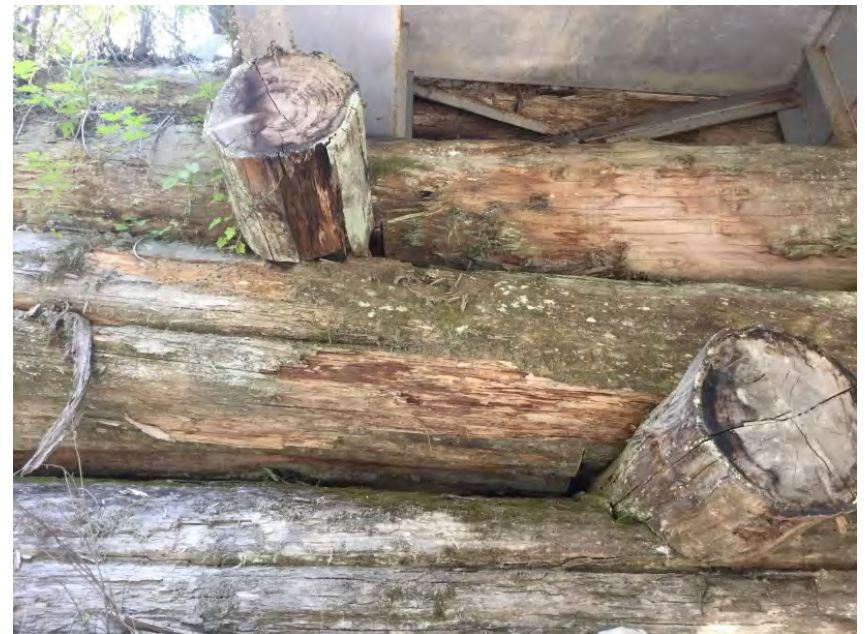
Left bank large dia. Cw 3x closed face with up to 50mm sap rot

3 on bottom log and 4 under girders, all with end splits and rot

Log crib condition
