CK-2453

NORRISH CREEK 7.4km

2018 Inspection

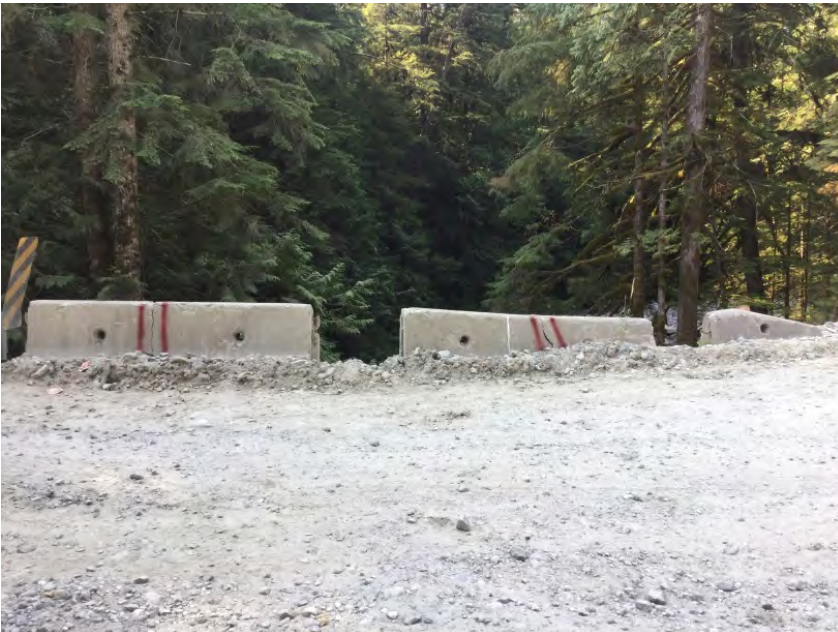
Downstream right approaches concrete barriers unconnected and cracked throughout

Downstream right bank concrete barriers in poor condition

Replace the downstream right approach concrete no post barriers. Consider replacing with a 12m length. Monitor the fill condition at the left bank. Current load rating of L100 or 91 tonnes to continue.

| Repair Item | Priority | Repair Description |
|---|---|---|
| 1 | Medium | Replace the downstream right approach concrete no post barriers |

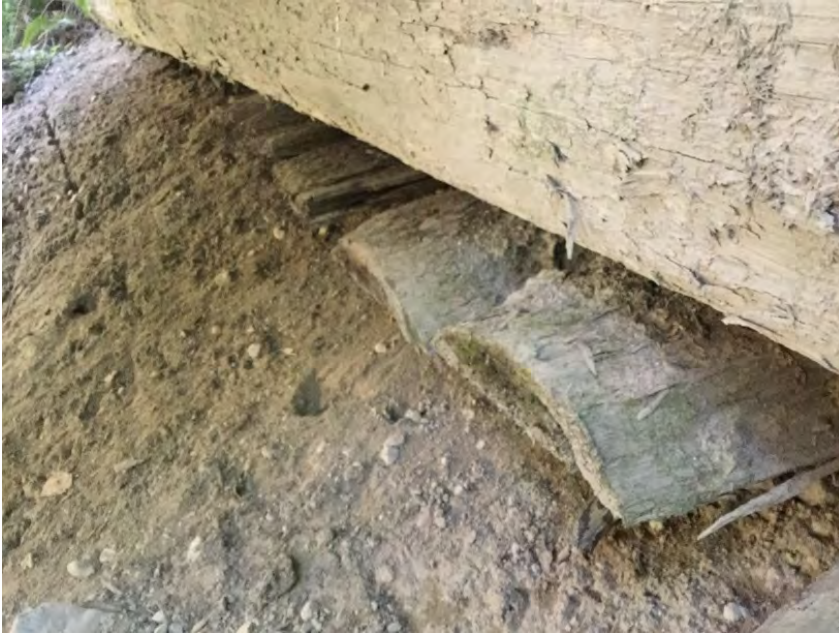
No change since last inspection on the fill retaining log at left abutment. Continue to monitor

Eroding on left bank - monitor

Left bank fill retaining log

| Item | Monitor Description | Frequency |
|---|---|---|
| 1 | left bank fill erosion | Routine Inspection |
