CK-2457

NORRISH CREEK 13.6km

2018 Inspection

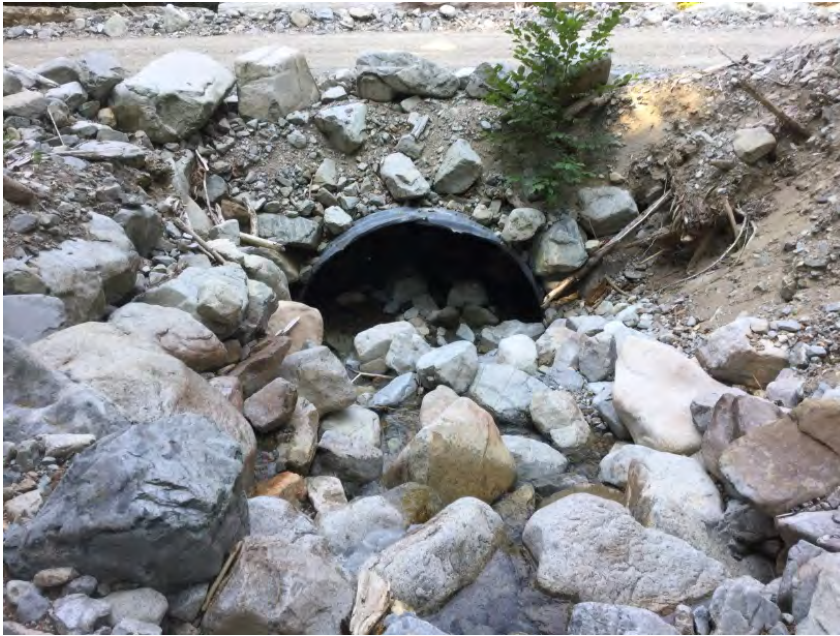
Inlet

Aggrading and 50% blocked

Comments Stream aggrades annually. This structure should be replaced

Clean the inlet and monitor future aggradation, especially following heavy precipitation or rain on snow events. Consider replacing the structure. Current load rating of BCL-625 or 63 tonnes to continue.

| Item | Priority | Repair Description |
|---|---|---|
| 1 | High | Clean the inlet |

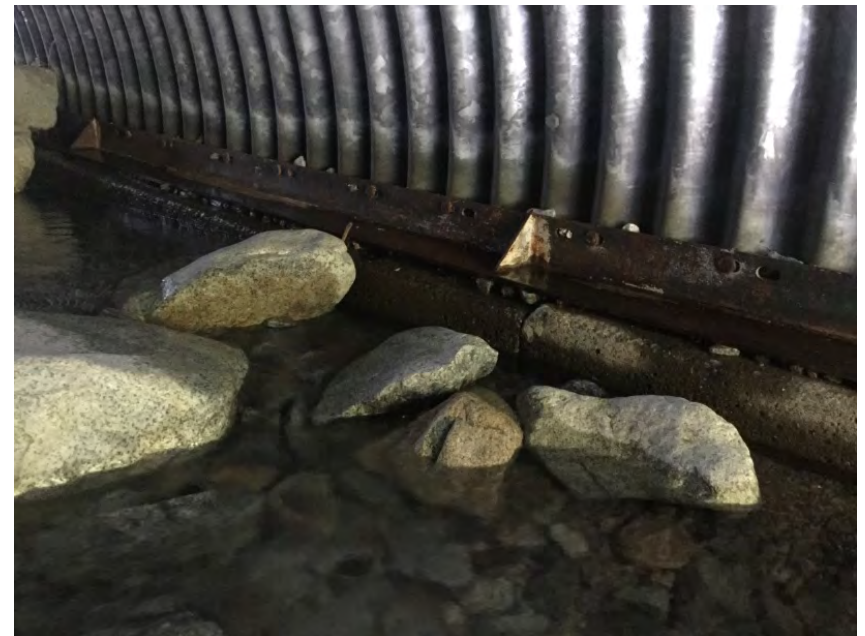
Settling on left bank side

Consistent bearing on both footings, right bank settlement of left footing noted

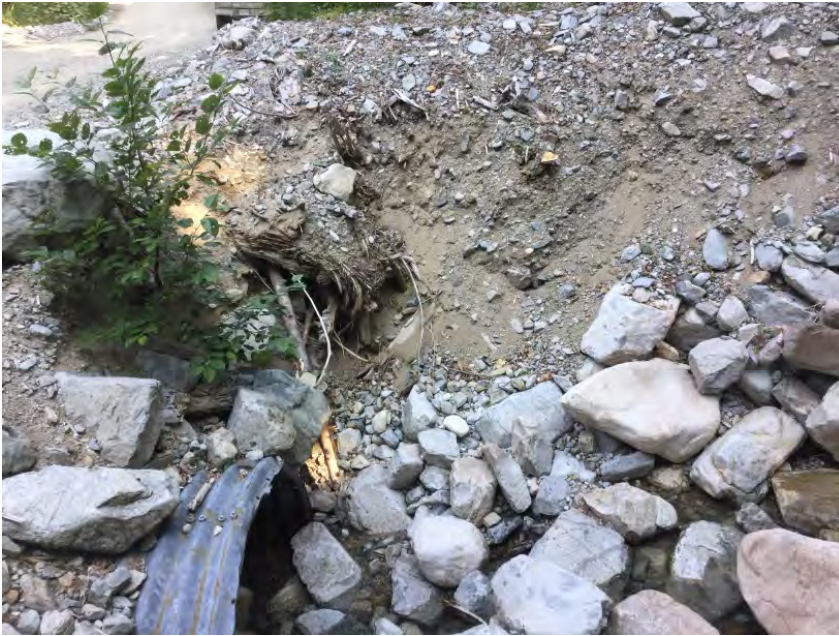
Organics and lack of riprap at inlet
