CK-2461

Hornet FSR 2.0km

2018 Inspection

| Structure Class | Woodbox/Log Culvert |

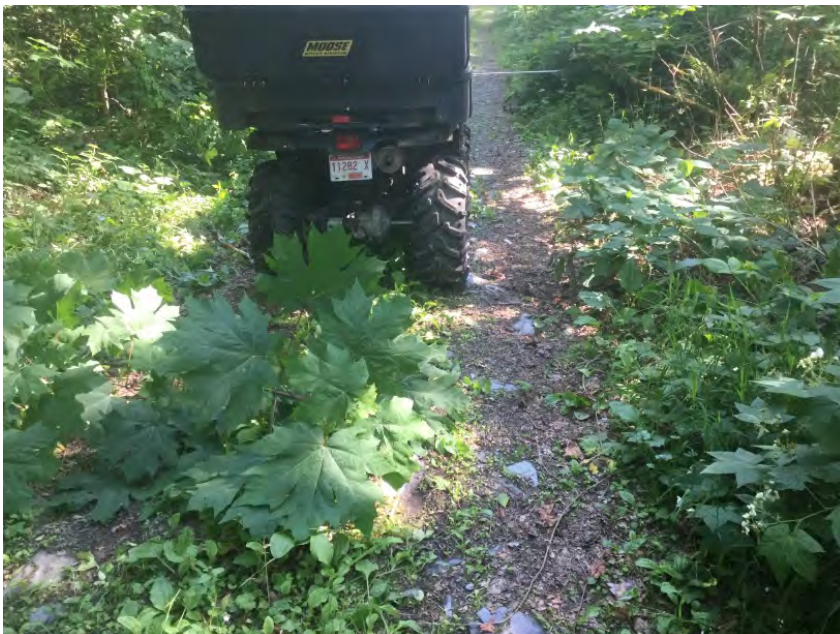
Curb Rail/Blocks/Posts Poor Too low

Overall Deck Condition Poor Due to rail

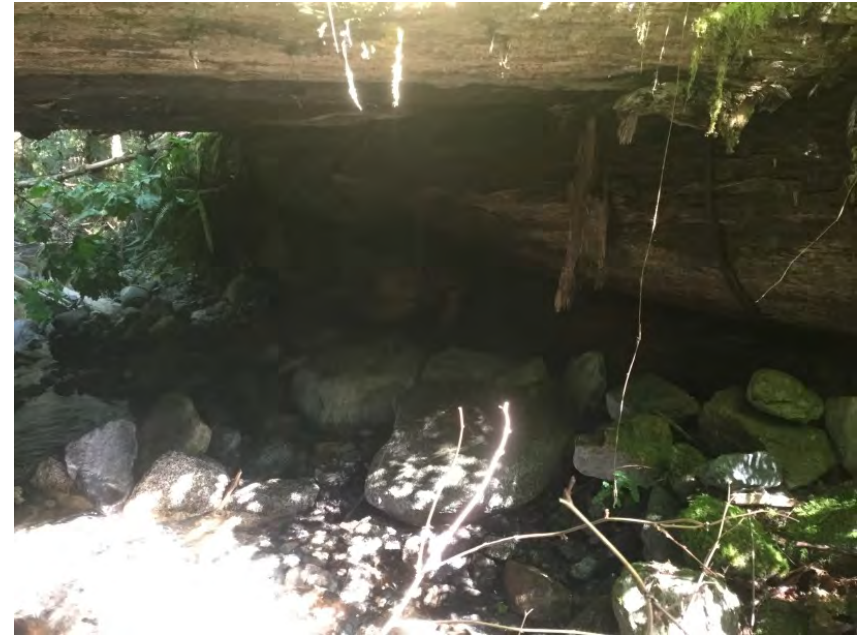
Right Bank Abutment when facing downstream

Log/Timber Cribs Fair 2x with up to 50mm sap rot

Hardware Poor loose lashing

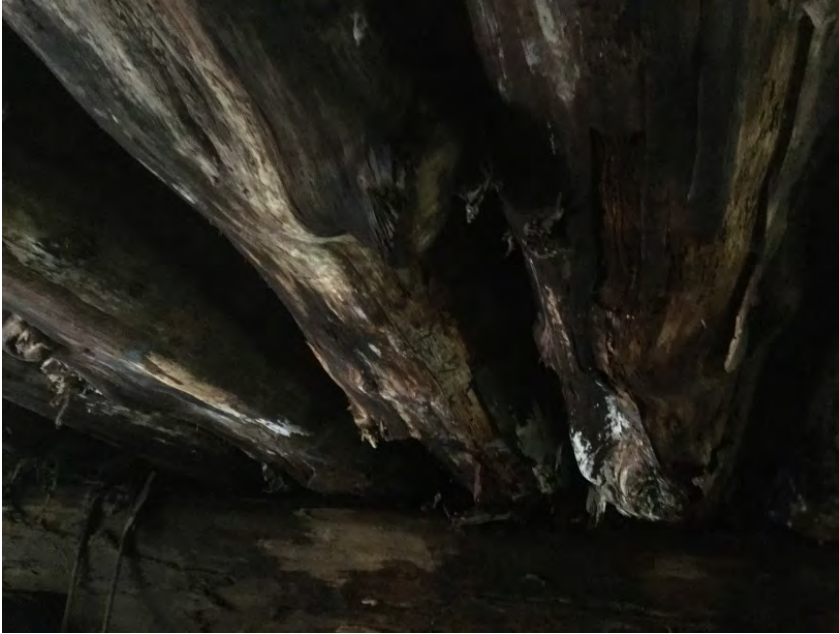
Stringers

All stringers knotty with horizontal cracking of sap wood and in general poor condition

| Stringer<br>Number | Species | Peeled | Diameter<br>(mm) | Rot Depth<br>(mm) | Condition | Comment |
|---|---|---|---|---|---|---|
| 1 | Cw | Y | 610 | 100 | Poor | Large knots and horizontal cracks in sap |
| 3 | Cw | Y | 600 | 80 | Poor | Large knots |
| 4 | Cw | Y | 580 | 60 | Poor | Cracking and delamination in sap wood |
| 5 | Cw | Y | 660 | 120 | Poor | Large knots |

The structure is considered a Wood Box Culvert due to span; however the structure is in poor condition. 5 tonnes load rating. Post load rating sign and plan to replace the entire structure prior to industrial activity.
