CK-2462

HORNET 2.8km

2018 Inspection

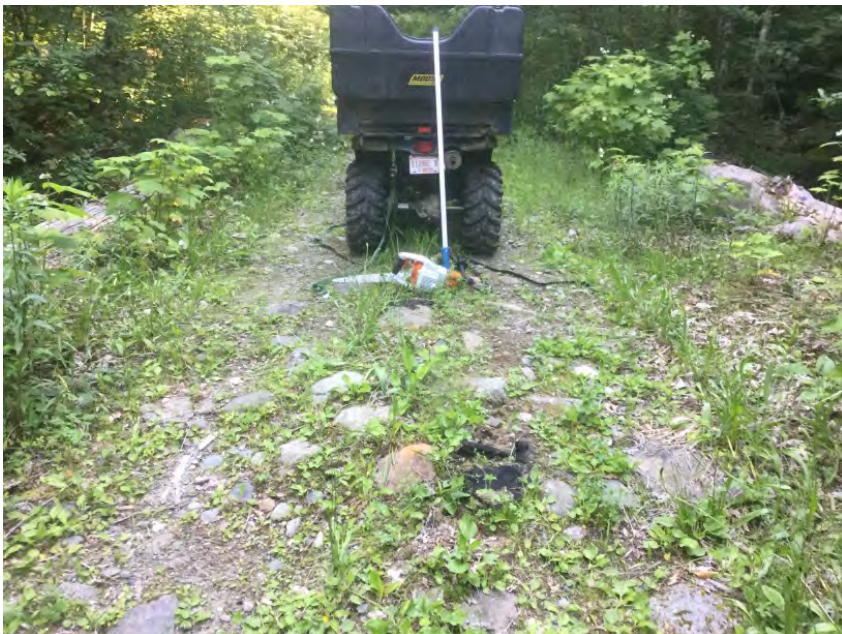
Deck

Poor

Random material from 300mm cobbles to gravel

Due to rail and gravel

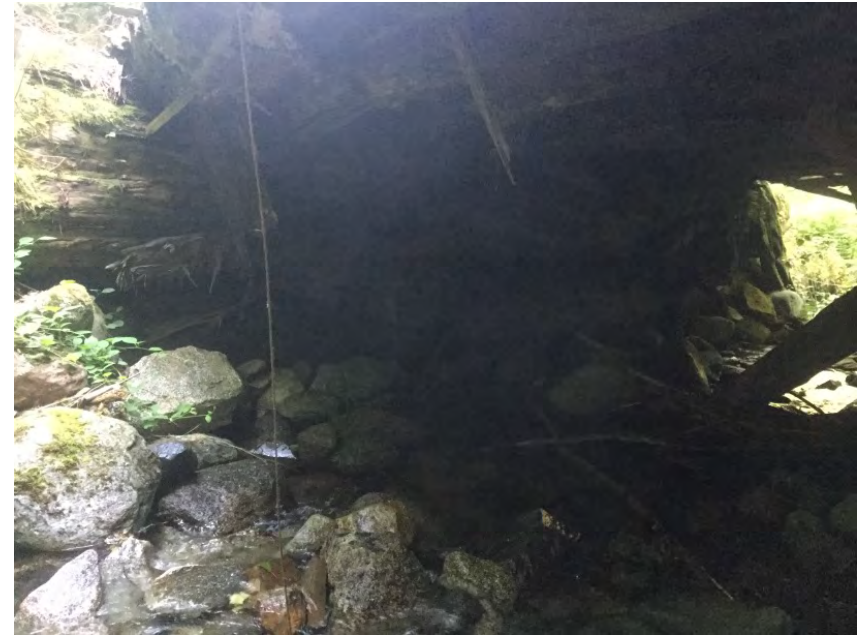
Left Bank Abutment when facing downstream

Riprap Poor None in front

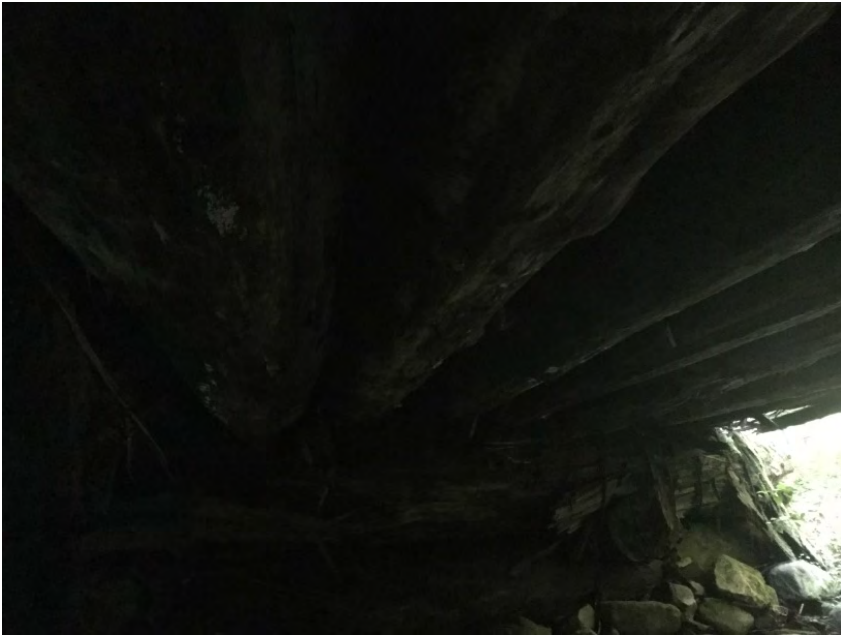
Stringers are generally in poor condition due to the amount of large knots and cracks throughout

Structure is in poor condition, replace with activity. Present load rating of 10 tonnes to continue. Post load rating sign.

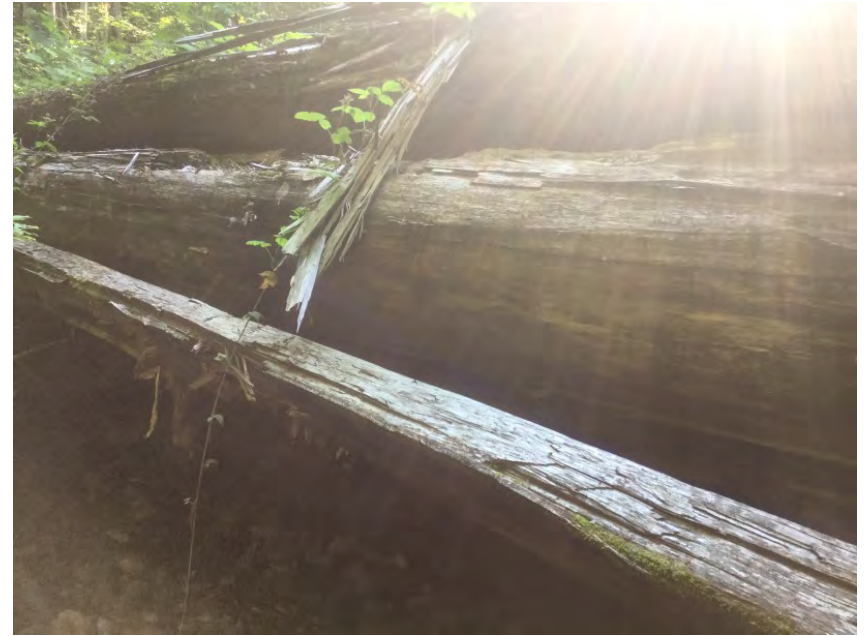
Stringer 10

| Stringer<br>Number | Species | Peeled | Diameter<br>(mm) | Rot Depth<br>(mm) | Condition | Comment |
|---|---|---|---|---|---|---|
| 10 | Cy | Y | 600 | 200 | Poor | Cat face and cracked throughout |
