CK-2468

HARRISON EAST 18.4km

2018 Inspection

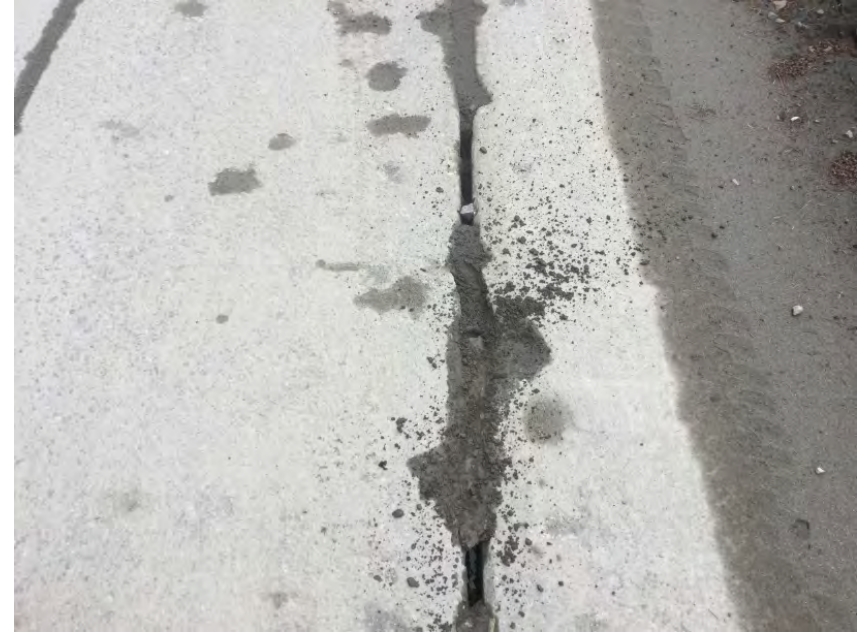
Deck Joints      Poor      Paraseal missing/failing throughout

Paraseal missing and rocks edged in between slabs are causing damage

Replace all the parseal joints and brush the approaches. Present load rating of L75 or 68 tonnes to continue.

| 1 | High | Replace all paraseal |

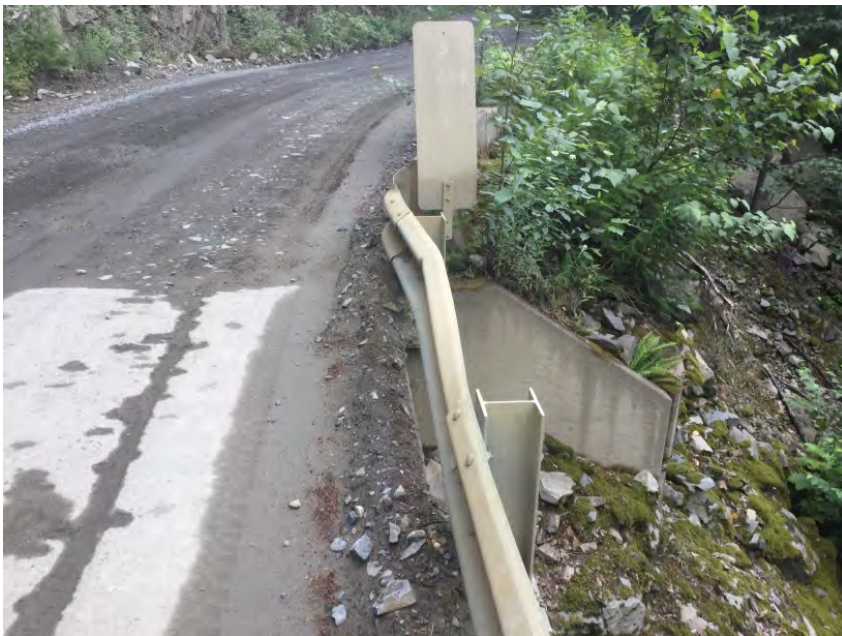
Minor damage to downstream guardrail
