CK-2469

HARRISON EAST 31.3km

2018 Inspection

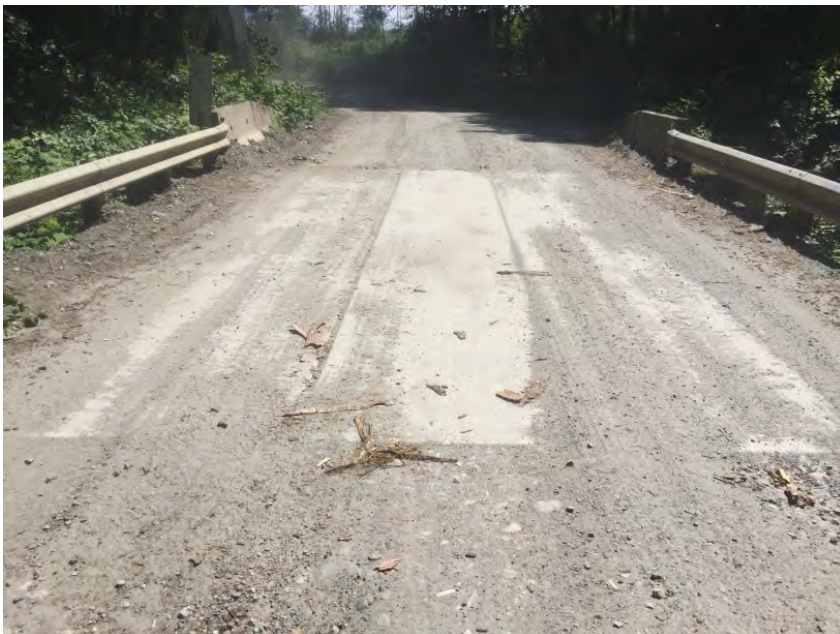
Deck Joints      **Poor**

| 3 | Medium | Clean deck joints and replace the paraseal |

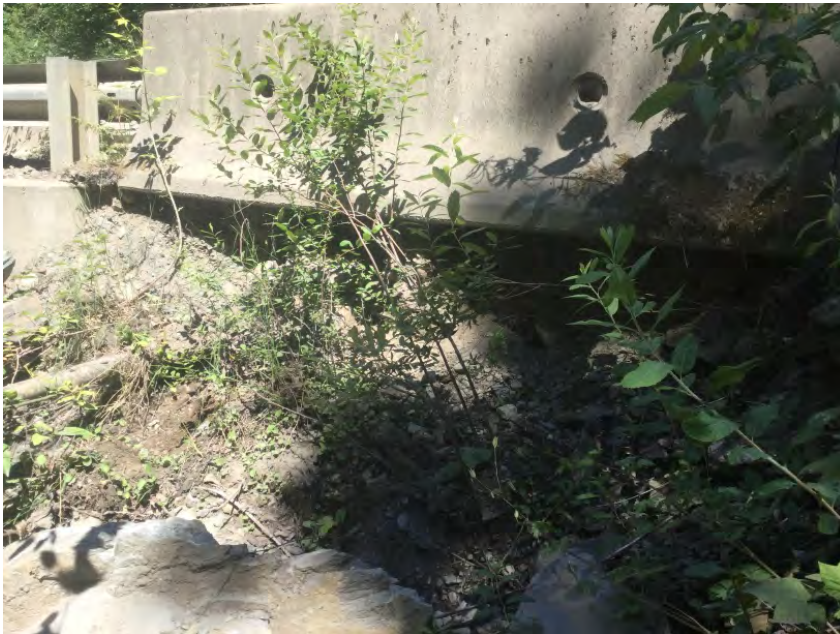
Fill Poor Failing downstream left approach

Fill under no post barriers on down stream left bank failing

Replace the failing fill at the downstream left approach. Clean the deck joints and and replace the paraseal. Brush the approaches and replace the delineators. Present load rating of L150 or 136 tonnes to continue.

| 2 | Medium | Repair failing fill |
