CK-2470

HARRISON EAST 22.5km

2018 Inspection

| Structure Class | Major Culvert |

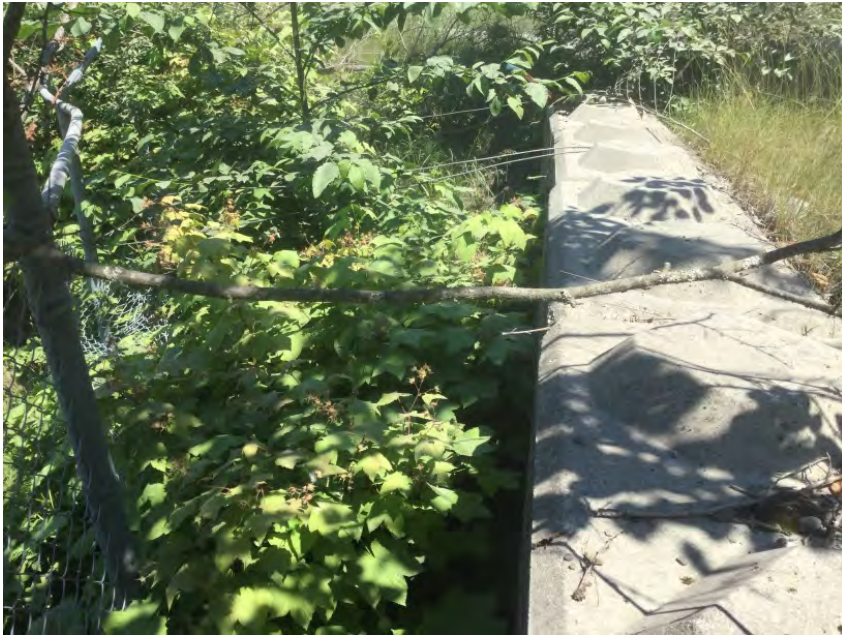
Downstream wall retaining fill

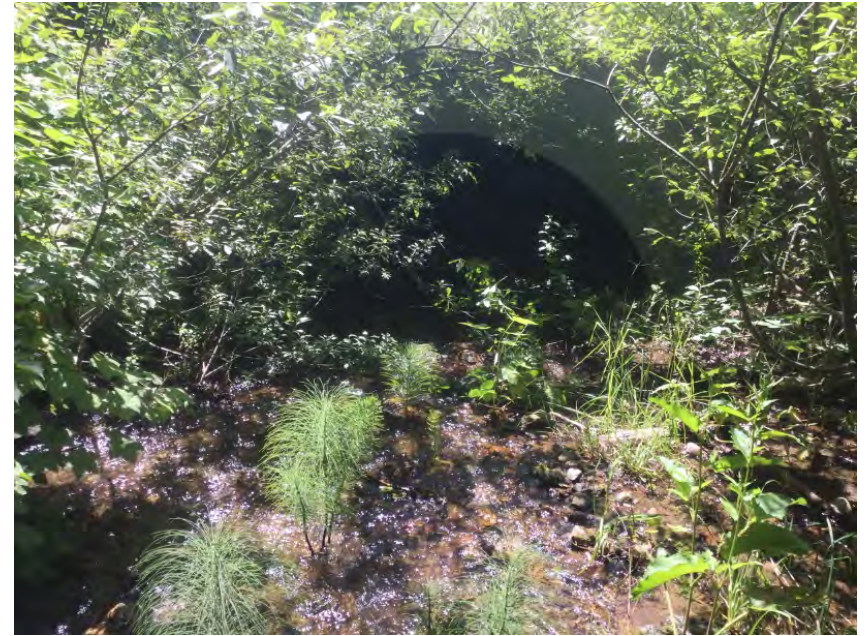
Inlet      Good

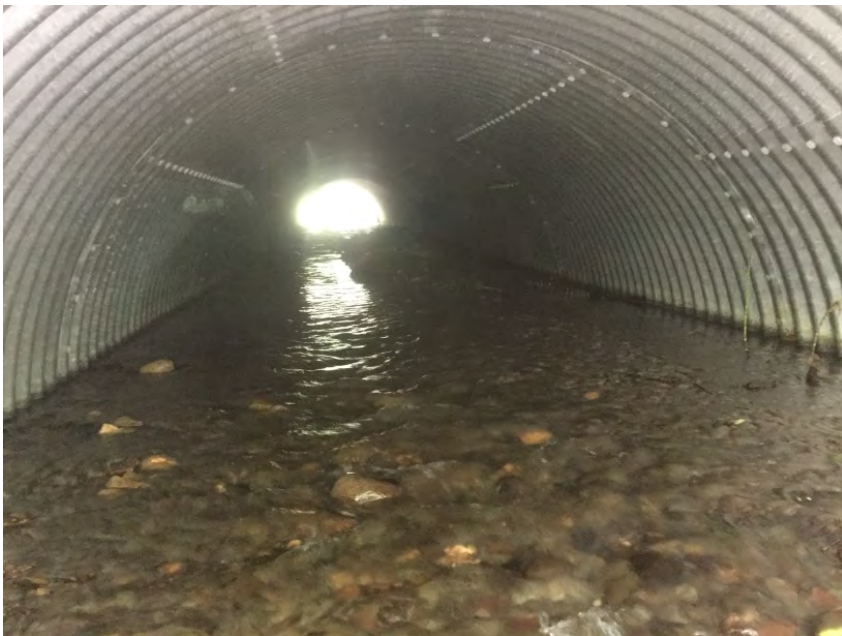
Looking from the outlet

Outlet      Good
