CK-2472

MAISAL 6km

2018 Inspection

Crossing Name Upper Maisal

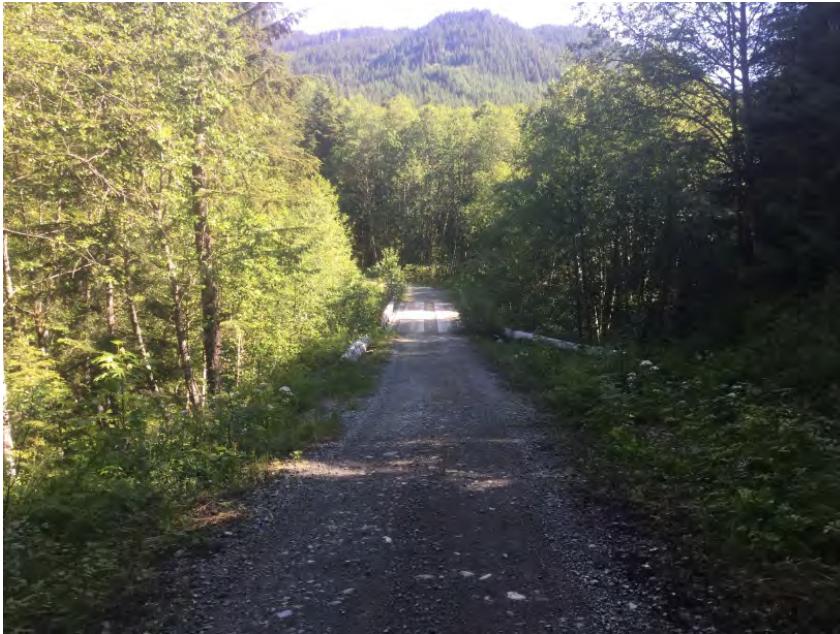
Approach from Left Bank when facing downstream

Loosing fill at left approach

| Item | Priority | Repair Description |
|---|---|---|
| 1 | Medium | Brush and grade approaches when active |

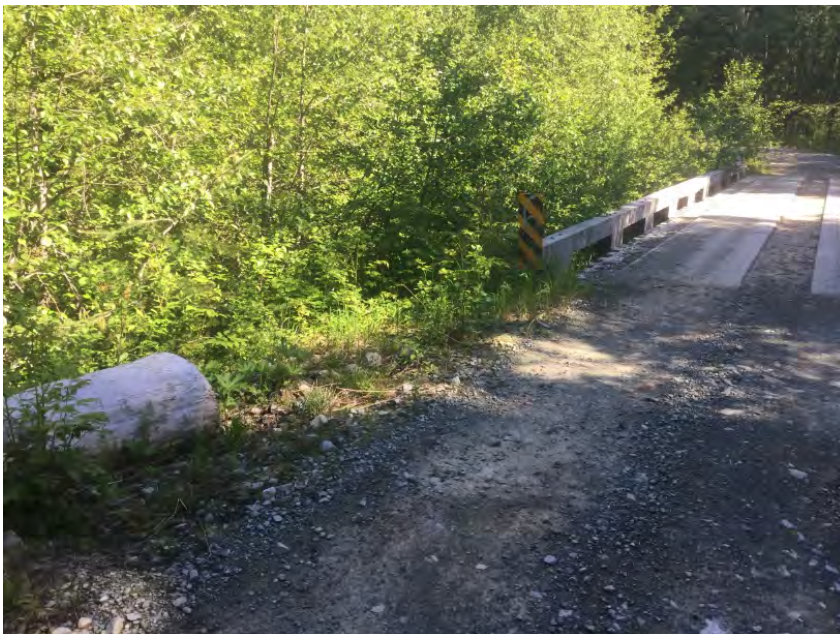
Fender log can be realigned closer to bridge

| 2 | Medium | Realign downstream left fender closer to bridge |

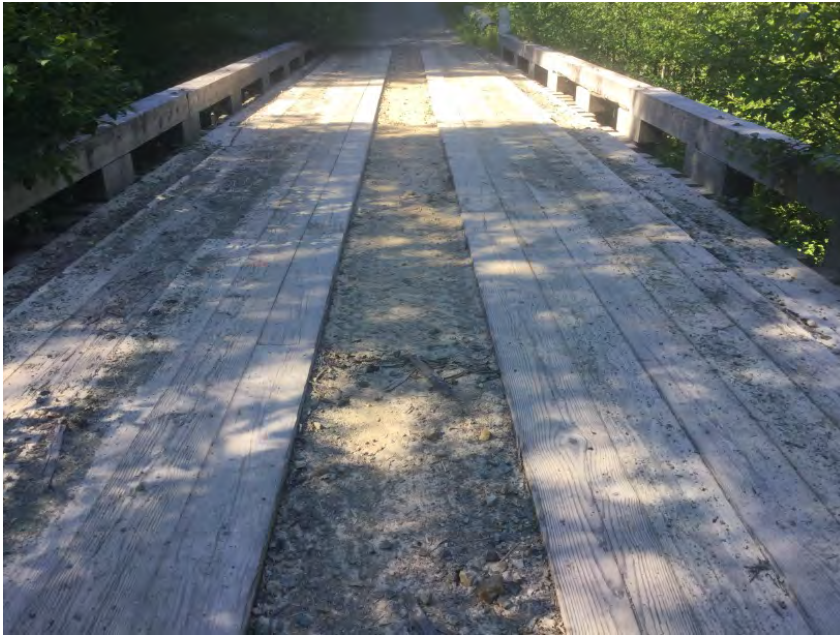
Overall Deck Condition Fair

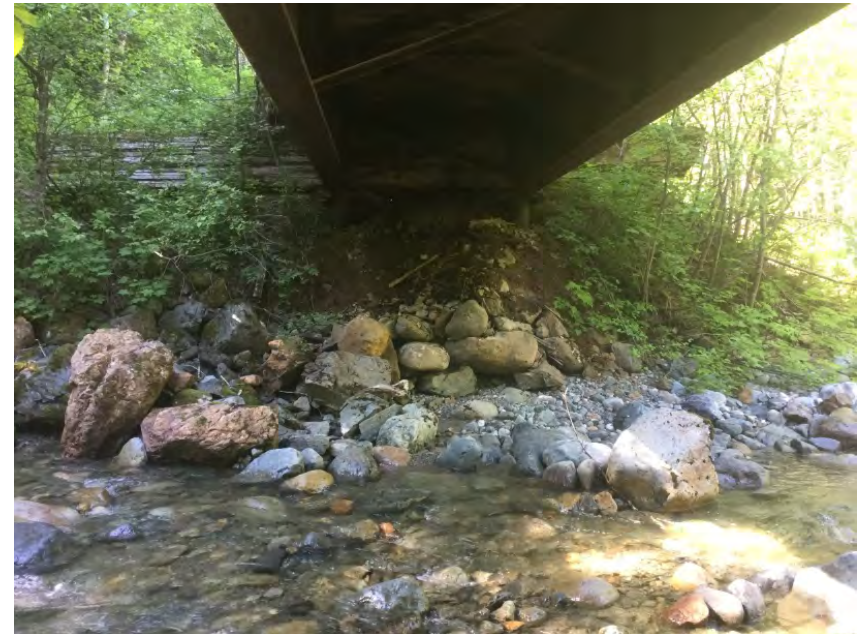
Left Bank Abutment when facing downstream

Very little riprap protecting the abutments and the riprap is rounded

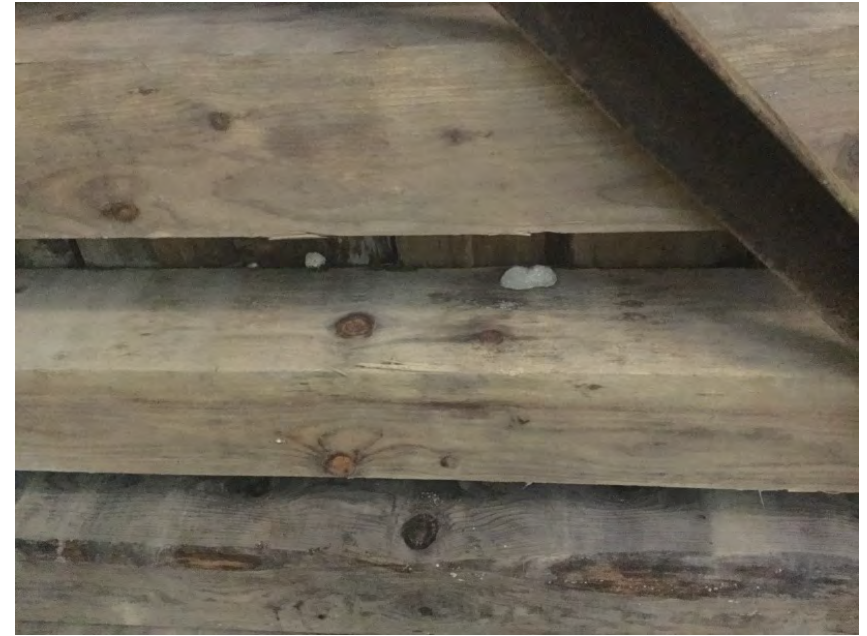
Very little riprap but no indication of heavy flow and scour  
Timber deck just starting to show rot indicators (conk) but very localized

Conk starting to appear in random tie
