CK-2474

NAHATLATCH 46km

2018 Inspection

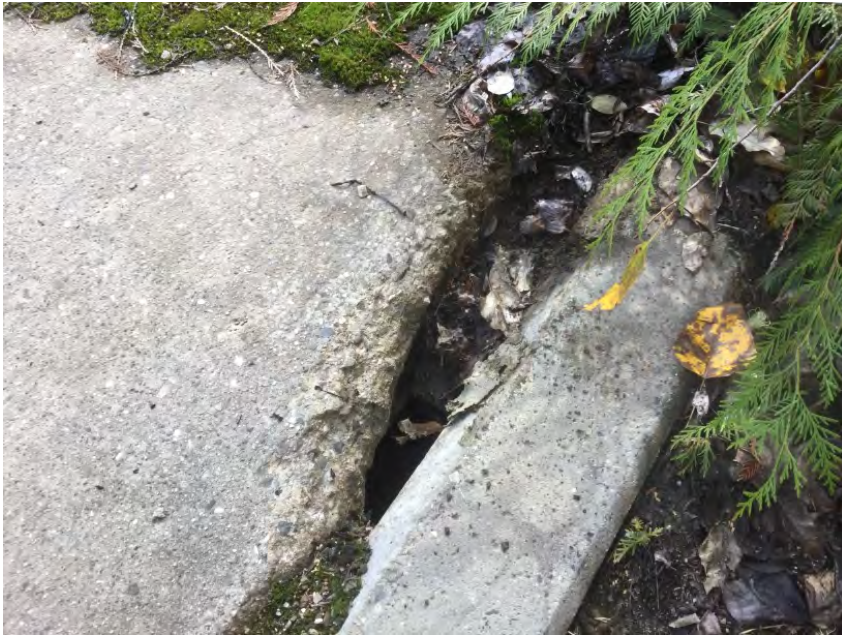
Concrete Deck Fair Damage noted to panel 1 at left bank; removable panels

Damage to panel 1 at left approach

Replace the guardrail, risers and blocks. Replace all the rubber deck seals and repair the damage to the concrete deck panels consistent the Concrete Repair Guide for Concrete Bridge Components (MFLNRO, 2017). Brush approaches. Present load rating of L75 or 68 tonnes to continue.

| Item | Priority | Repair Description |
|---|---|---|
| 4 | Medium | Repair damage noted to the deck panels |

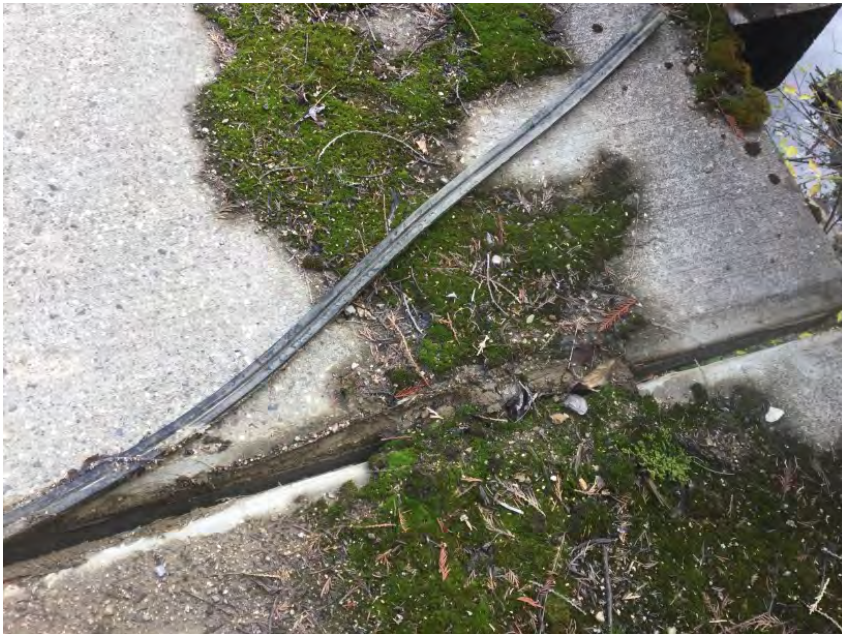
Deck Joints Poor Rubber seals failing throughout

Deck seals not functional

| Item | Priority | Repair Description |
|---|---|---|
| 2 | Medium | Reset all deck seals |

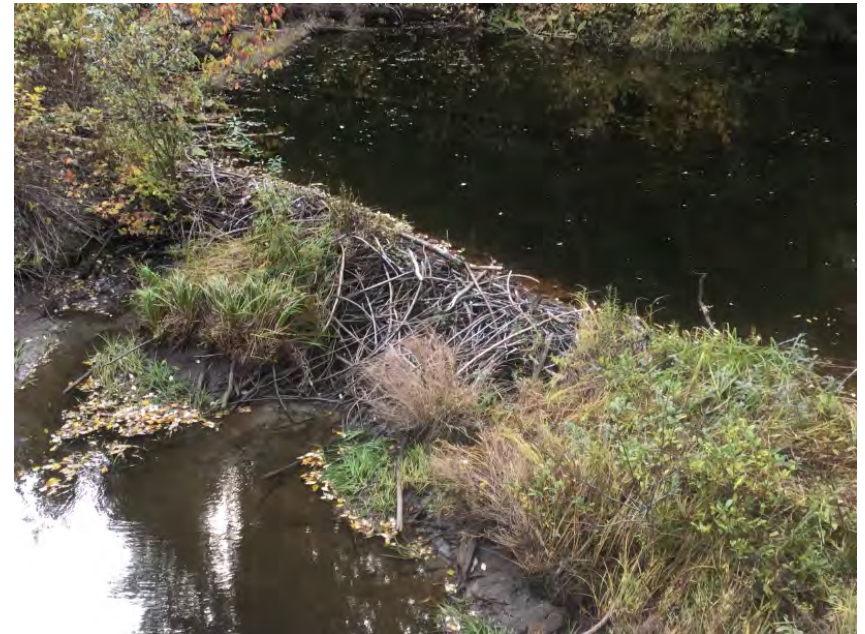
Comments Beaver activity upstream

Beaver activity

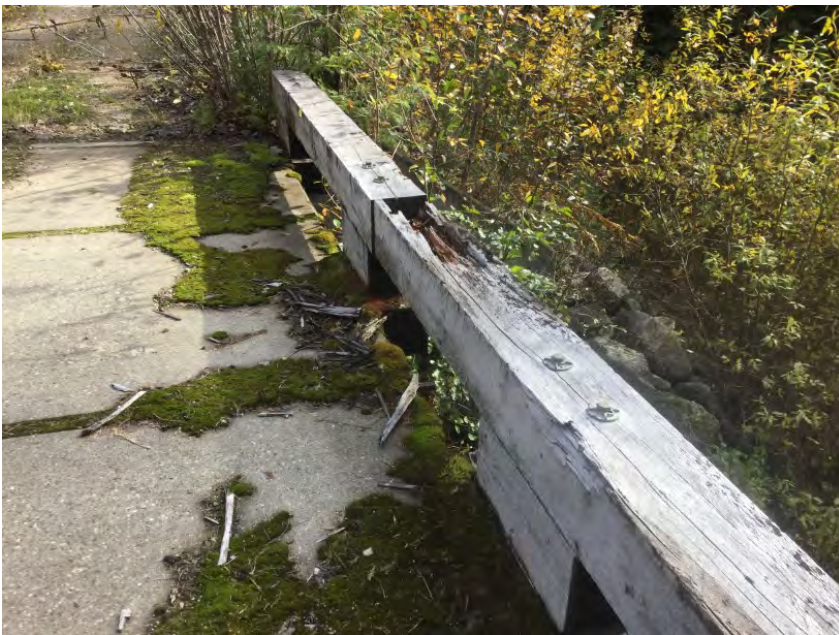
Guard Rail

Curb Rail/Blocks/Posts Poor Rotten

Hardware Poor Loose rail bolts

Overall Deck Condition Poor Due to rail condition and deck seals

| Item | Priority | Repair Description |
|---|---|---|
| 1 | Medium | Replace guardrail, risers and blocks |
