CK-2475

NAHATLATCH 46.5km

2018 Inspection

| Crossing Name | Nahatlatch River |

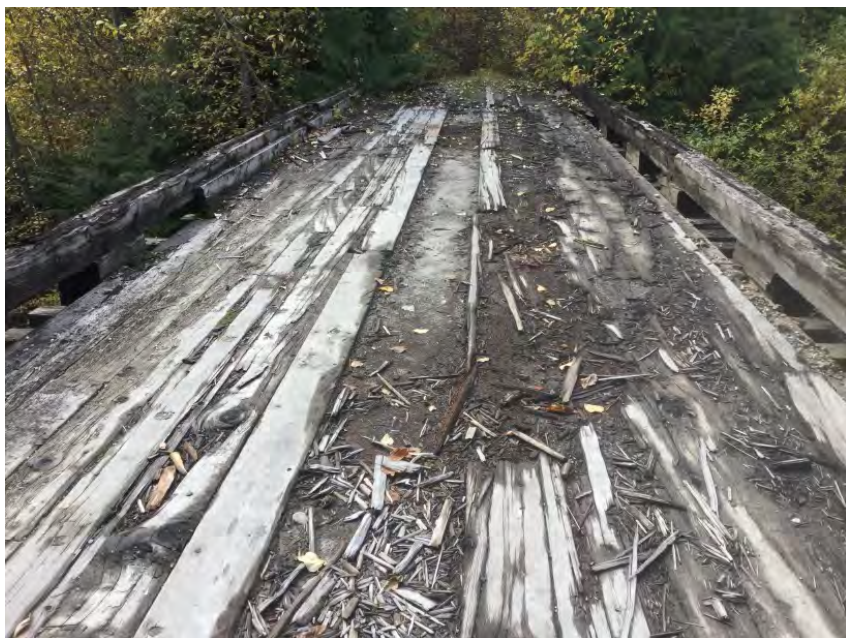
| Running Planks | Poor | Rotten and heavily worn |

| Nails | Poor | Protruding |

| Overall Deck Condition | Poor | Due to rail and plank condition |

| Item | Priority | Repair Description |
|---|---|---|
| 1 | High | Replace running planks, guardrail and risers |

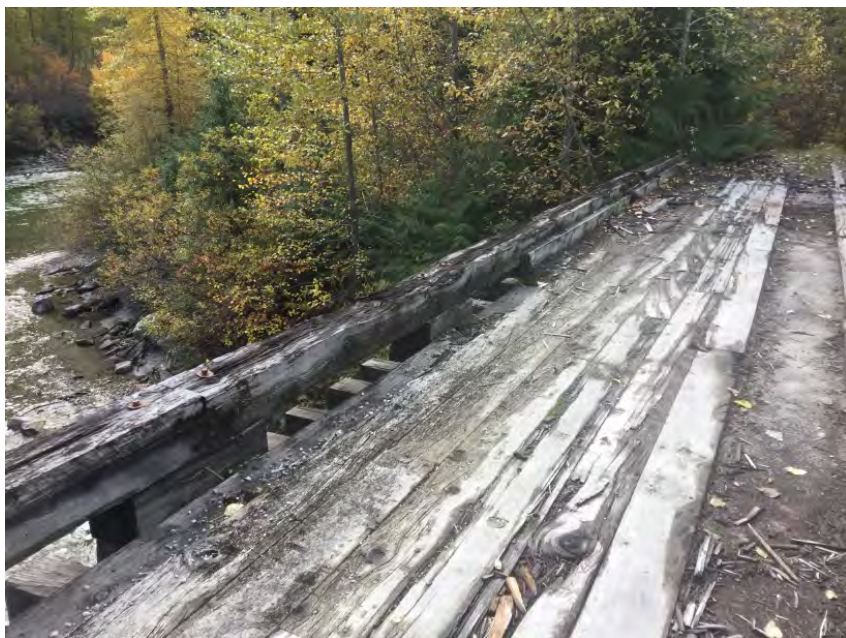
Guard Rail

| Curb Rail/Blocks/Posts | Poor | Rotten |

| Hardware | Poor | Loose rail bolts |

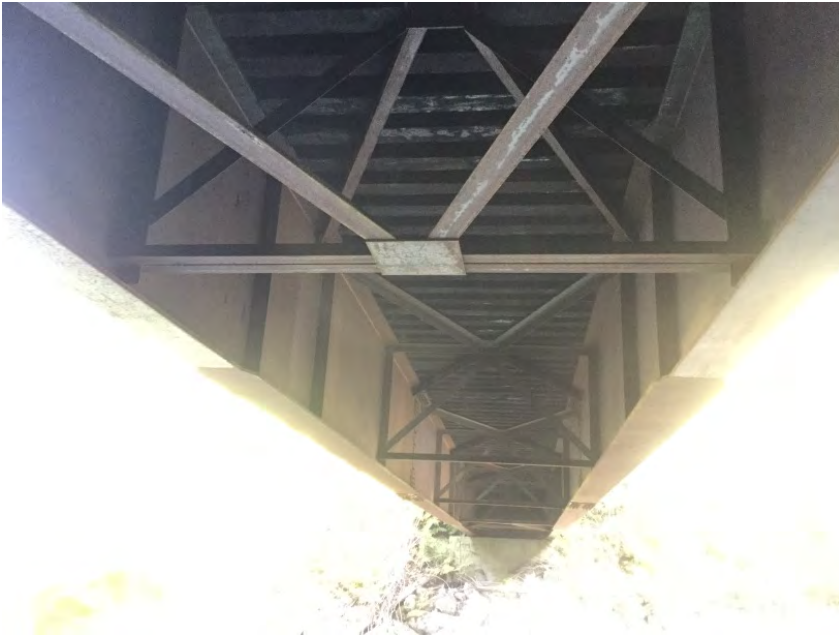
Superstructure

Girders Good

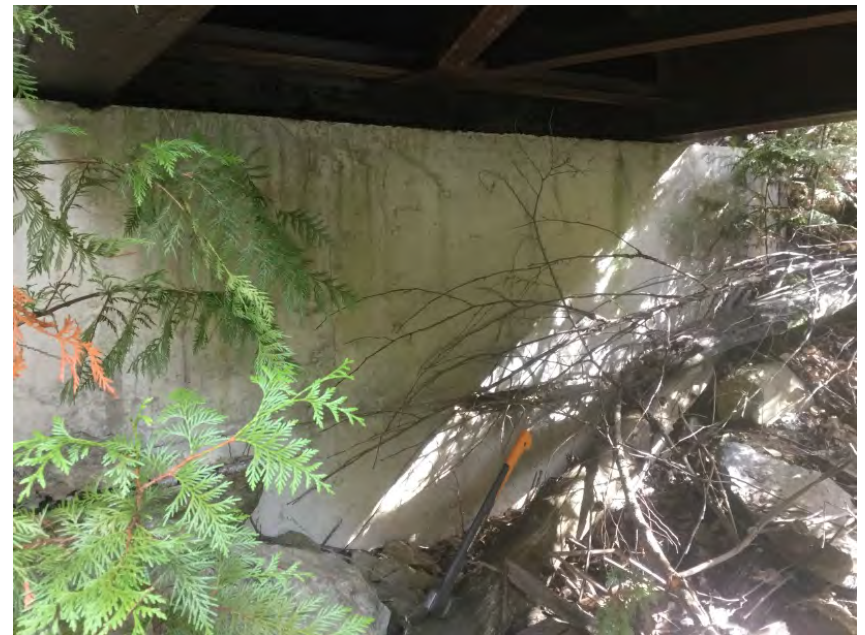
Right bank fill retainment structure

Right abutment fill retainment structure, spall with exposed rebar

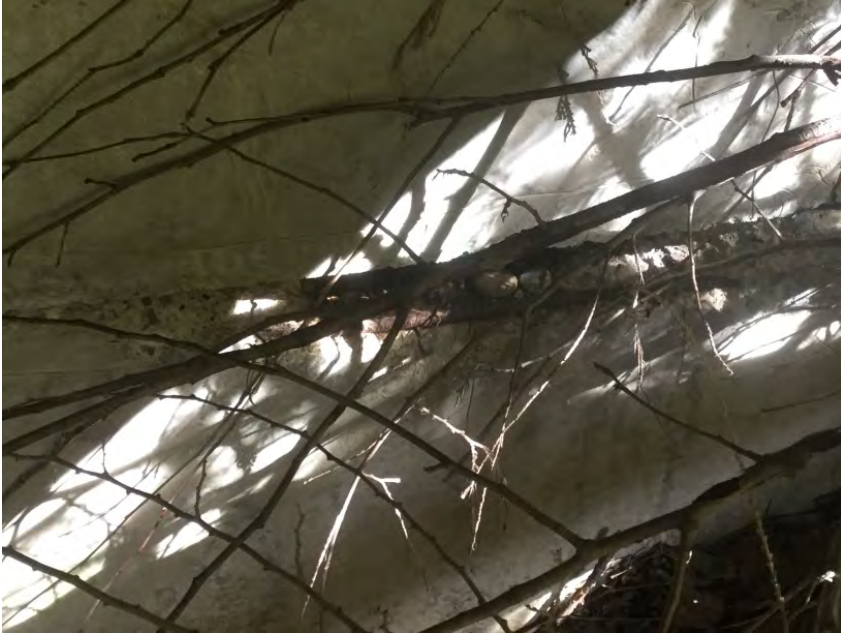
Right bank fill retainment structure damage
