CK-2477

NAHATLATCH 39.8km

2018 Inspection

| Crossing Name | Nahatlatch Creek |

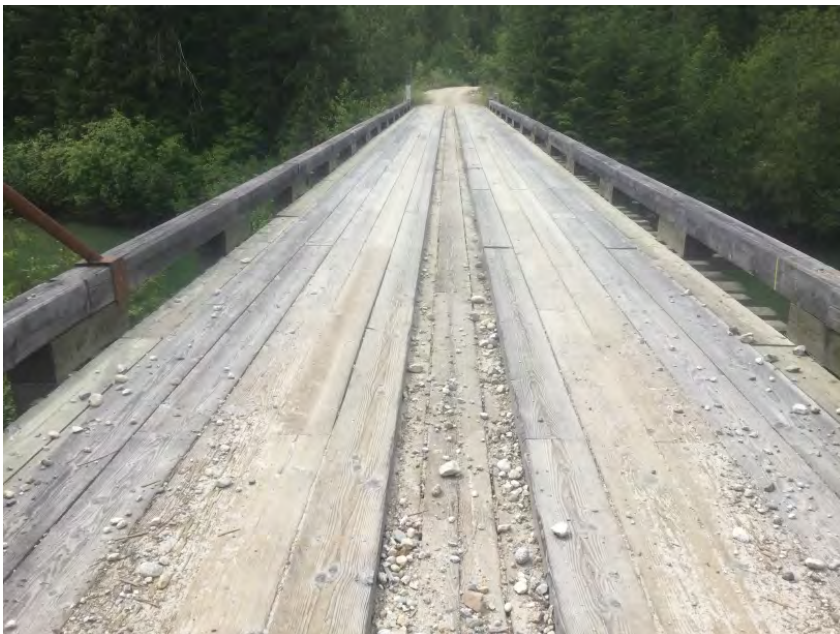
Overall Deck Condition      **Good**

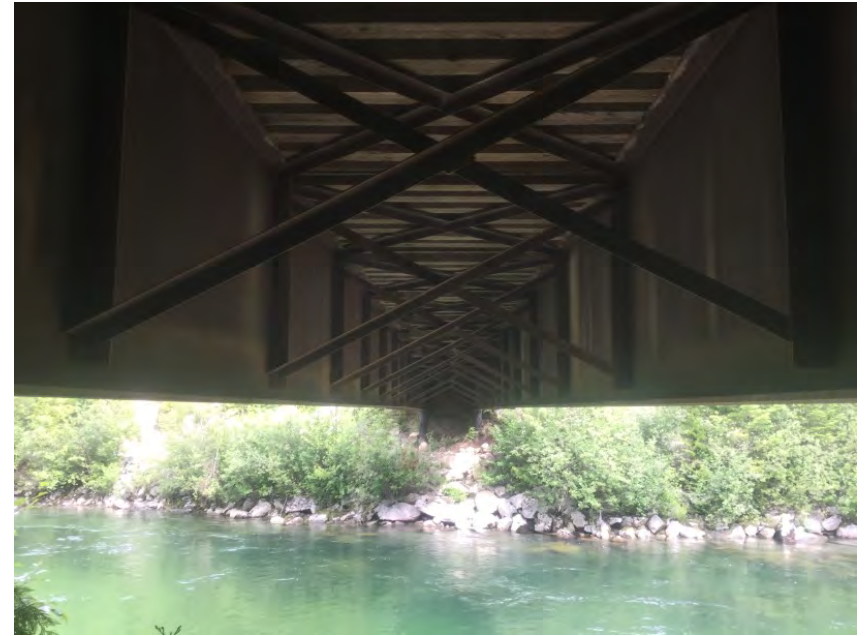
Superstructure

Girders Good

Cantilevered over posts

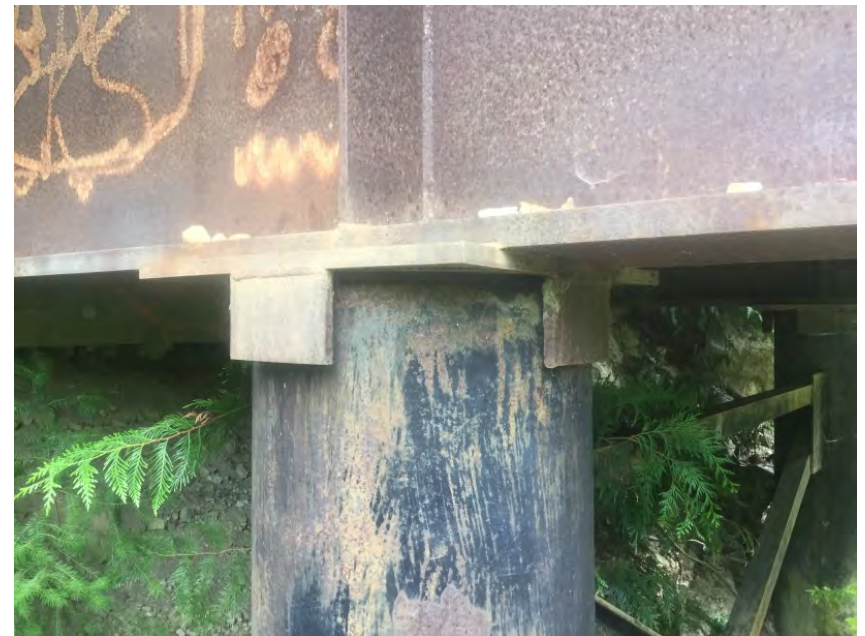
Typical bearing

Bearings Fair This rubber pads on top of posts

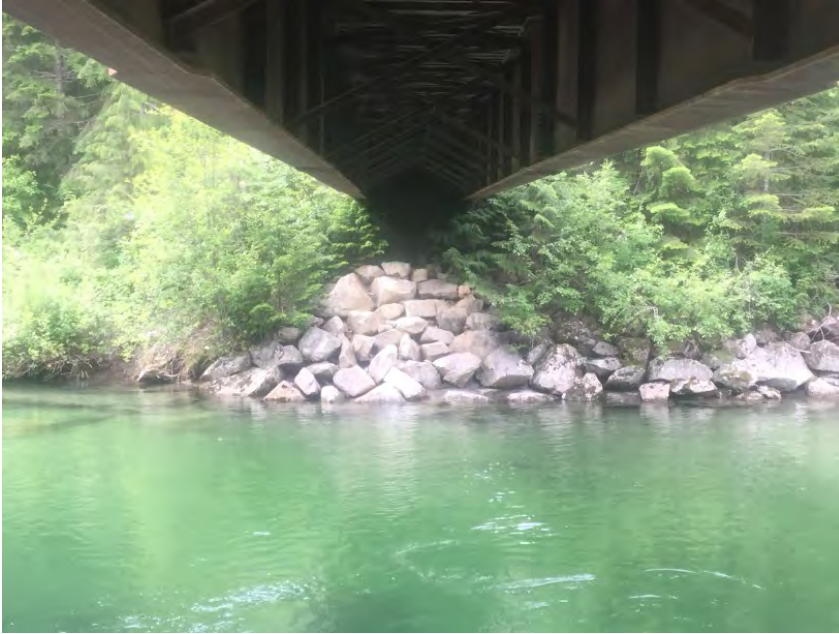
Right Bank Abutment when facing downstream

Ballast Wall Fair Treated timbers, bending downstream right bank due to fill
