CK2479

GRIZZLY 2.1km

2018 Inspection

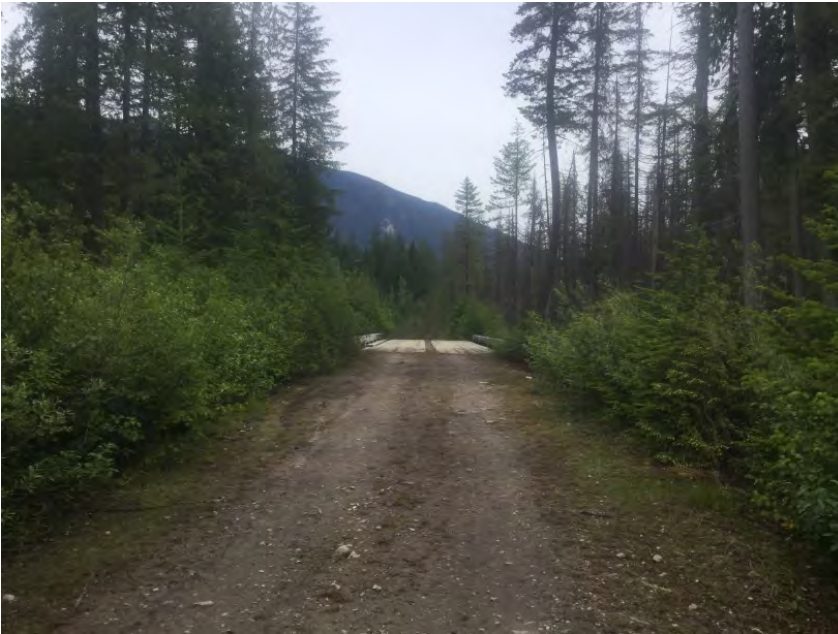
Approach from Left Bank when facing downstream

Alignment Fair

Horizontal curve and vertical curves

Fender Condition Poor

None in place

Road Surface Poor

Grade below bridge deck and potholes

| Repair | | Repair Description |
|---|---|---|
| 3 | Medium | Brush both approaches, add fenders to both approaches and post bridge ahead signs |

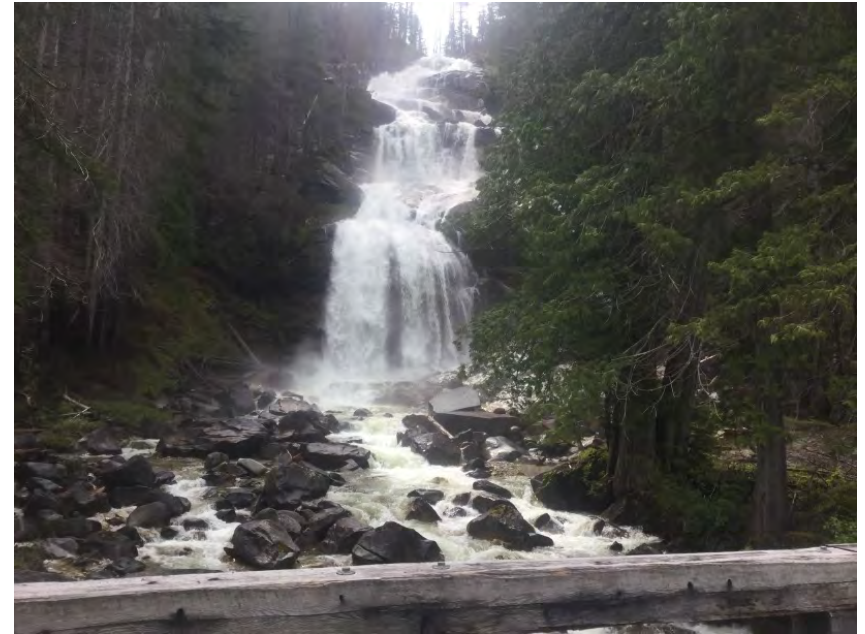
Upstream from Crossing

Signs of debris under bridge

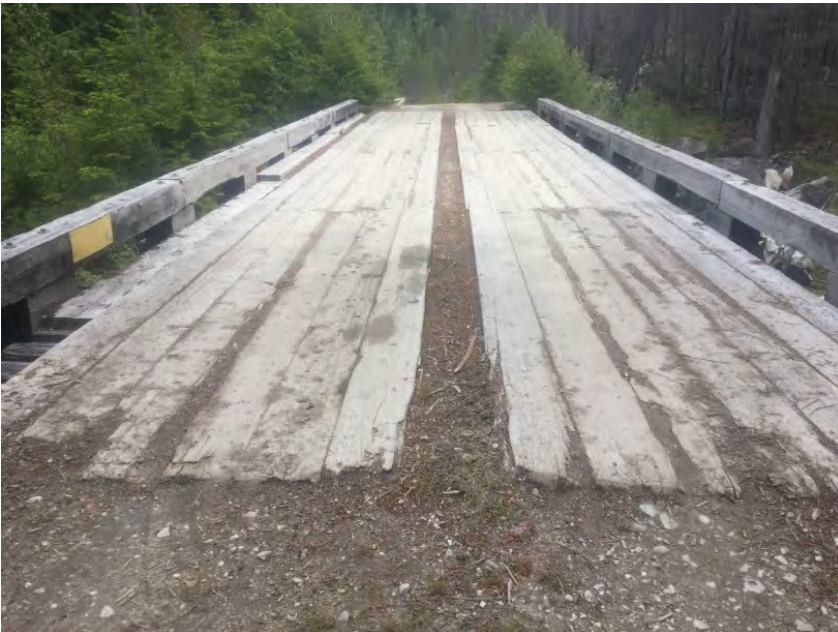
| Running Planks | Poor | Rotten sections throughout, especially at approaches |

| Nails | Poor | Protruding through planks |

| Curb Rail/Blocks/Posts | Poor | Rotten risers and pocket rot in guardrail |

| Overall Deck Condition | Poor | Due to timber plank and guardrail condition |

| Repair | | Repair Description |
|---|---|---|
| 1 | High | Replace guardrail, running planks, risers and delineators |

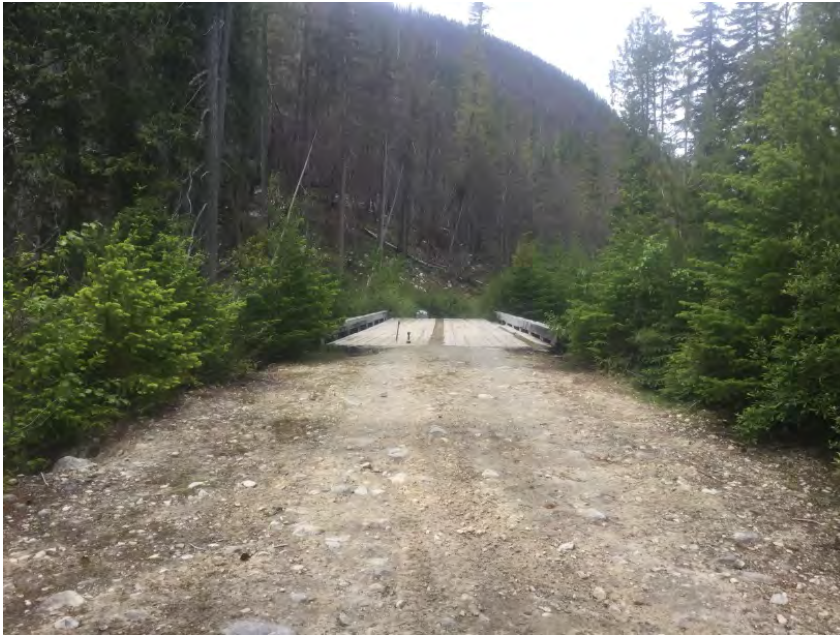
Approach from Right Bank when facing downstream

Eroding at right approach resulting in a reduced road width

| Repair | | Repair Description |
|---|---|---|
| 2 | High | Add additional slope protection and fill at right approach |

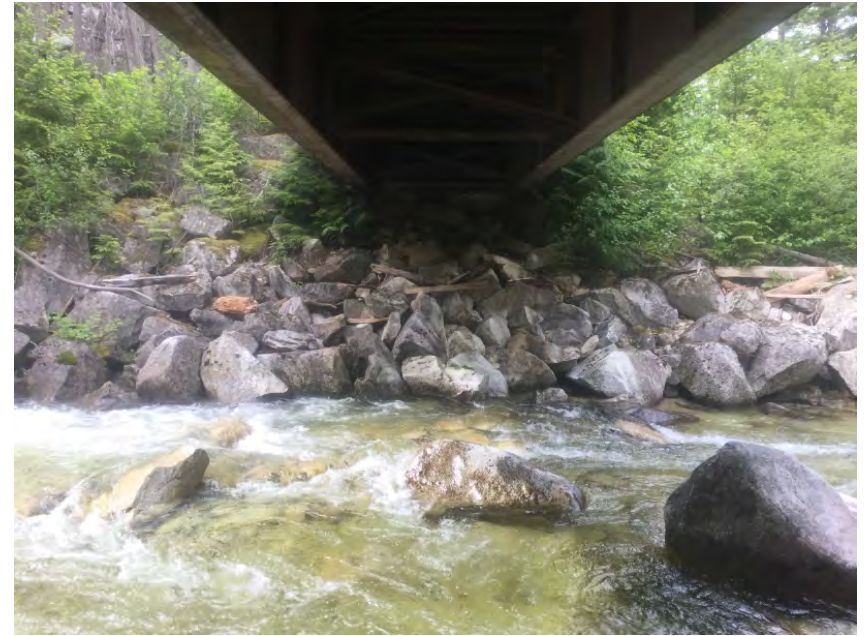
Left Bank Abutment when facing downstream

Piles or Posts Fair

Ballast Wall Fair

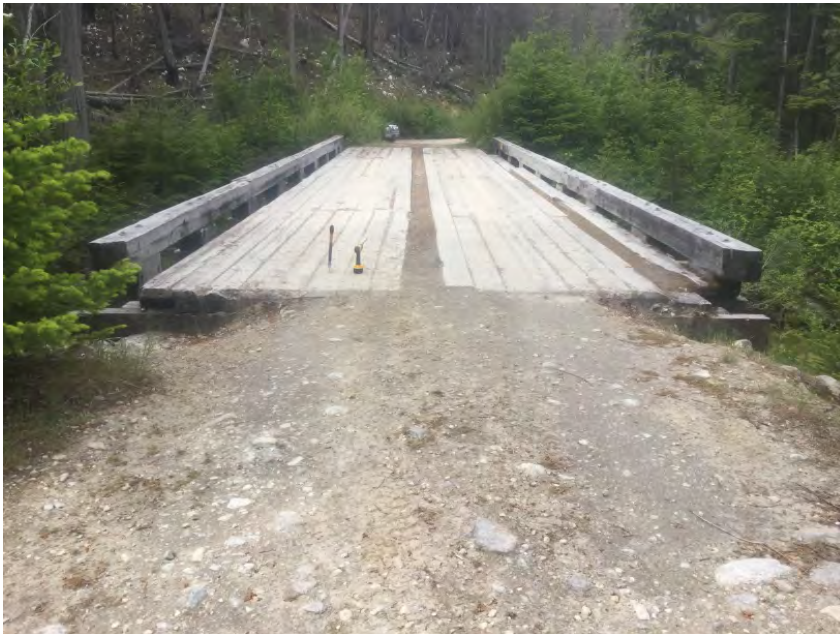
Fill Poor

Loosing fill on road approach to right abutment

Replace the running planks, guardrail and risers. Add slope protection and fill at right approach, and consider replacing the timber ballast wall on the right bank with longer timbers to help hold the additional fill requirement. Place fenders at both approaches; post missing bridge ahead signs, replace missing delineators and brush approaches. Limit loading to L45 or 41 tonnes until the work has been completed. Post updated load rating sign.

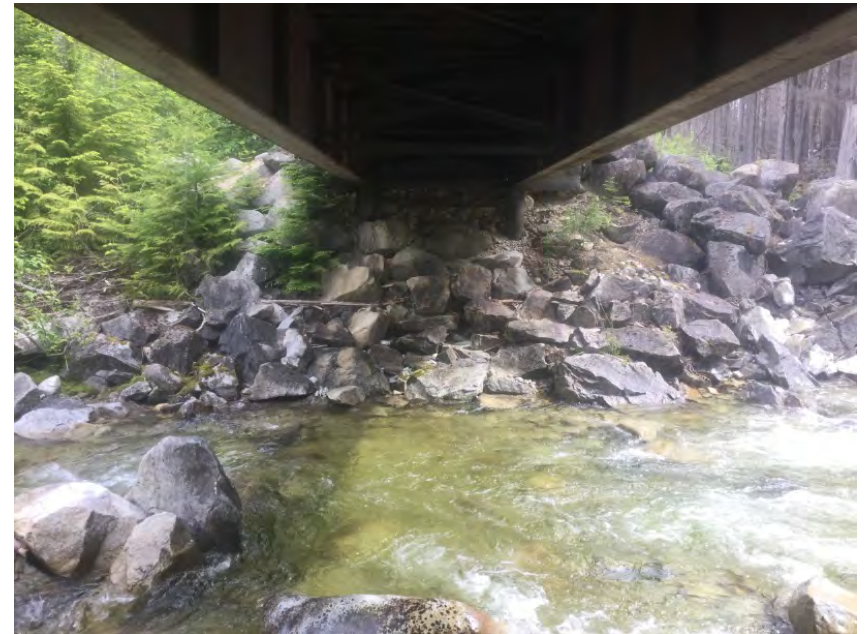
Right Bank Abutment when facing downstream

Creosote timbers. Consider replacing with longer pieces to hold fill material

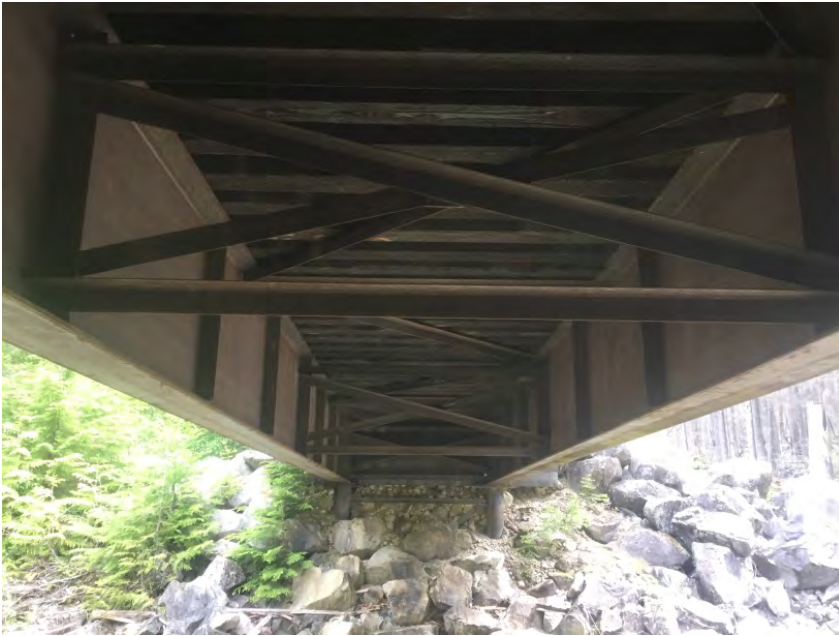
Superstructure

Girders Good

Diaphragms Good

Bracing Good
