CK-2494

NORRISH 17000 0.1km

2018 Inspection

| Crossing Name | Dickson Creek |

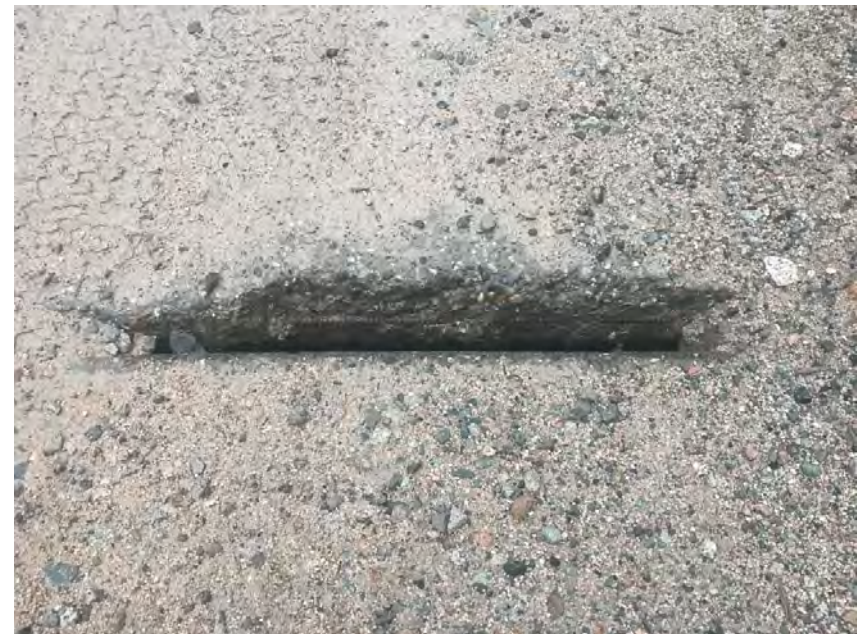
Damage at left approach

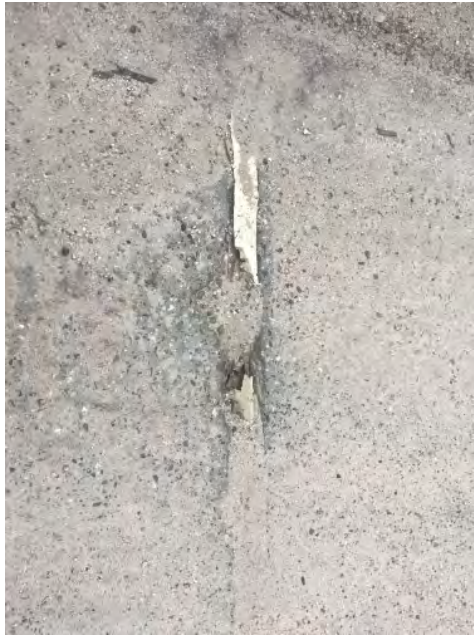
Deck Joints Poor All seals gone

All deck joint seals gone

| 2 | High | Replace all deck seals |

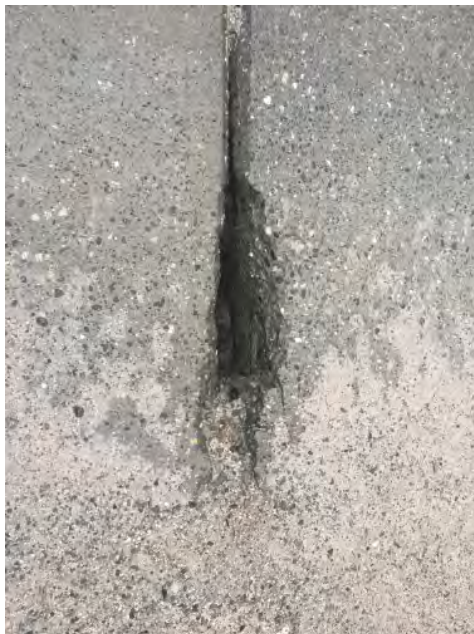
Concrete Deck Fair Damage noted to many of the panel ends

Damage to deck panels

| Repair Item | Priority | Repair Description |
|---|---|---|
| 1 | High | Repair all damage to deck panels and ballast walls |

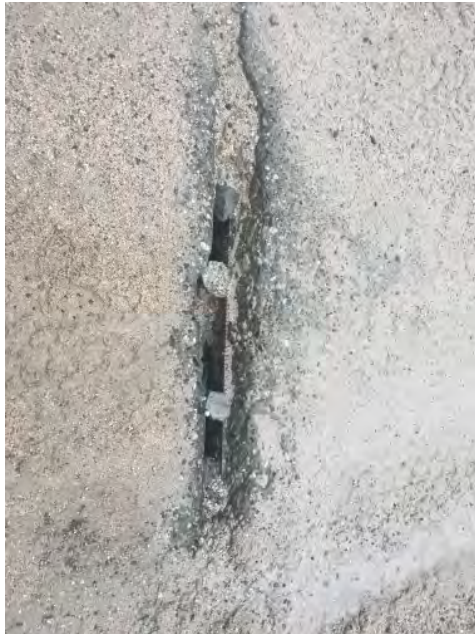
Damage to deck panels

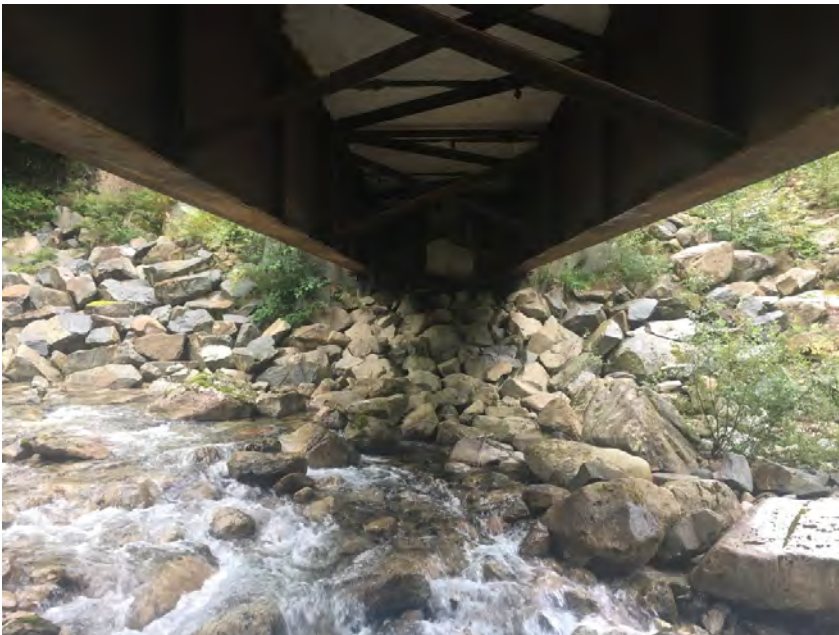
Left Bank Abutment when facing downstream

Ballast Wall Fair

Damage noted at surface
