CK-2495

STS'AILES (WEST) 1.2km

2018 Inspection

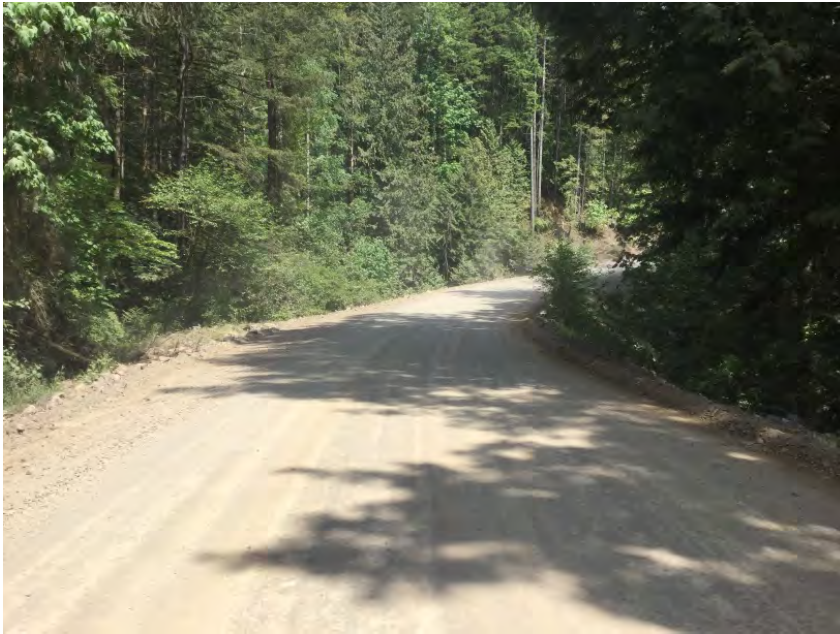
Approach from Right Bank when facing downstream

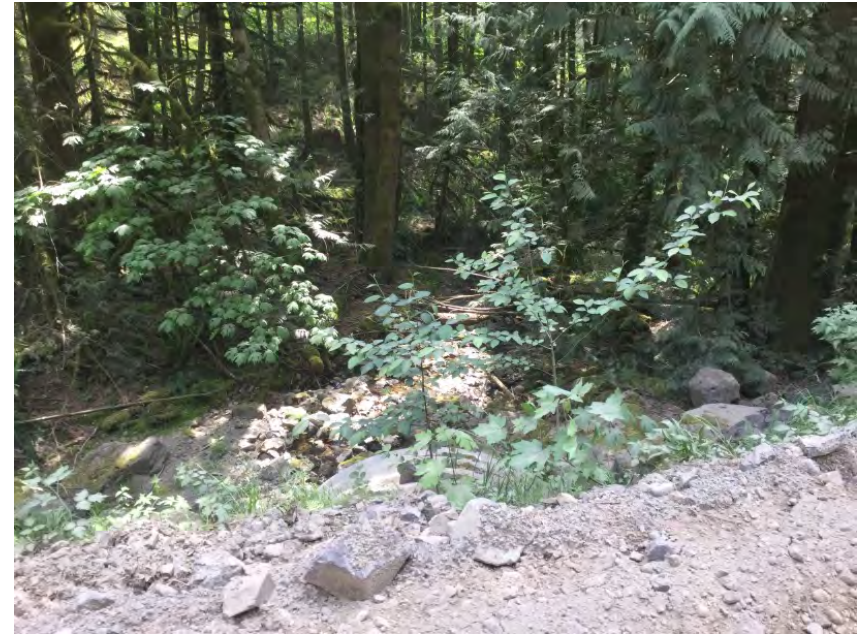
Downstream from Crossing

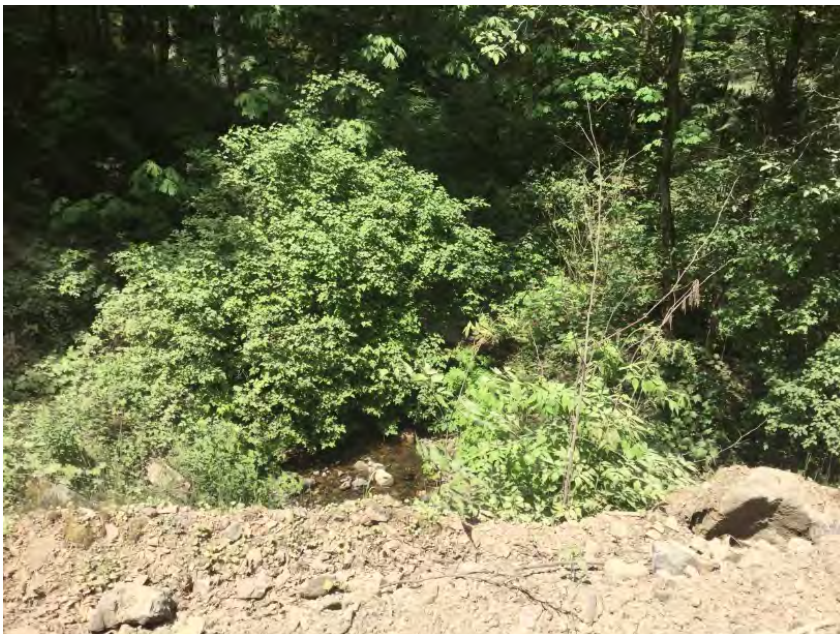
Upstream from Crossing

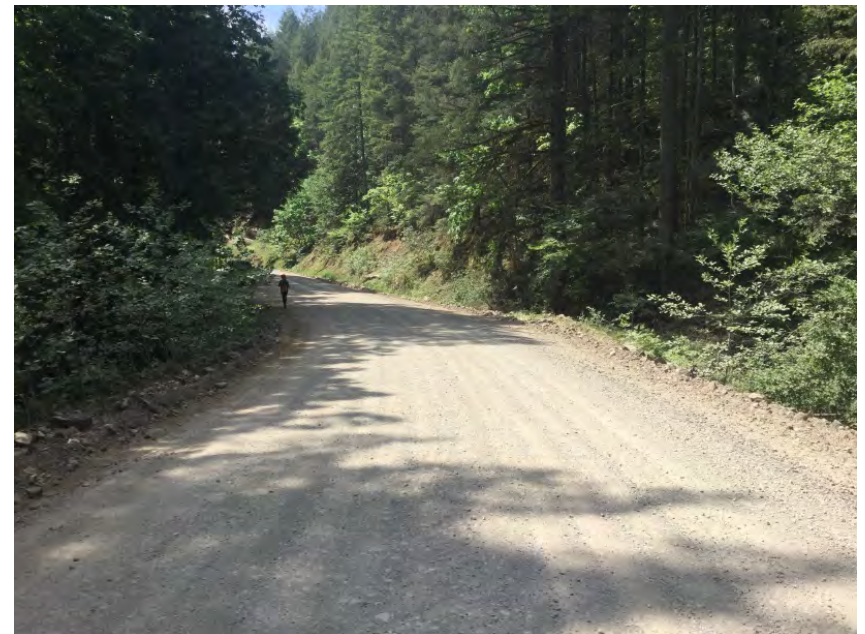
Approach from Left Bank when facing downstream

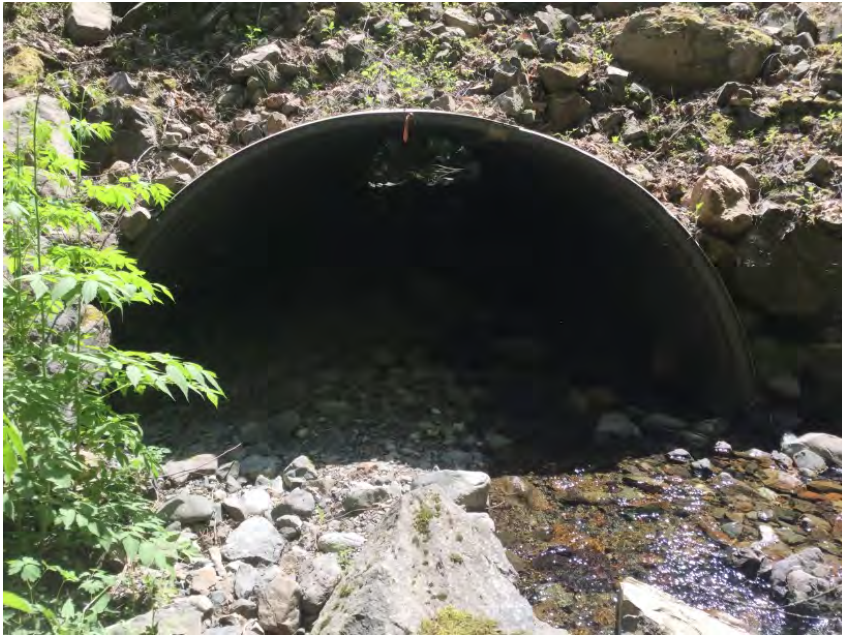
Inlet      Good

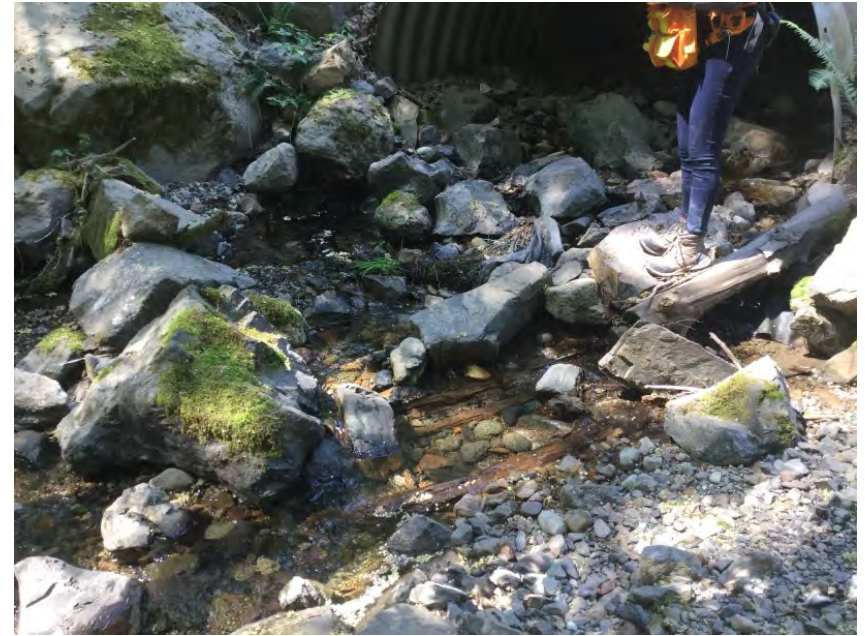
Outlet      Fair      Slightly perched outlet with fabric showing

Outlet scour

1 Outlet scour

Routine Inspection
