CK-2496

ENGLISH 2km

2018 Inspection

Crossing Name Side Creek

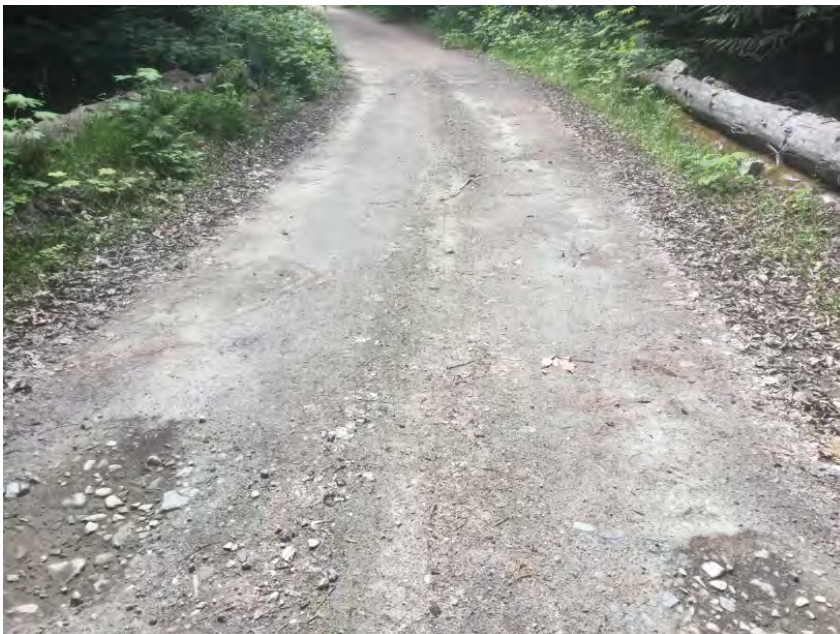
Overall Deck Condition      Fair

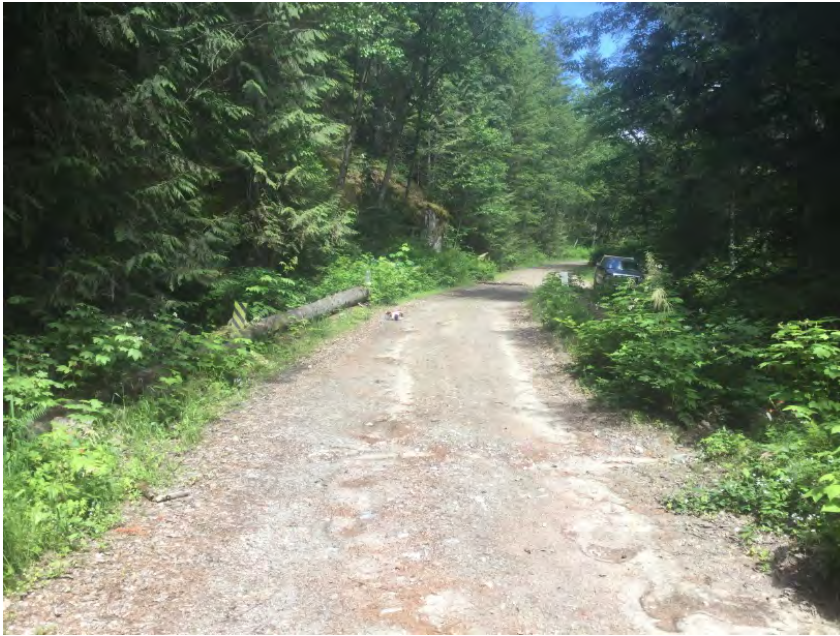
Approach from Right Bank when facing downstream

Missing downstream right approach

| 1 | Medium | Replace missing fender log |

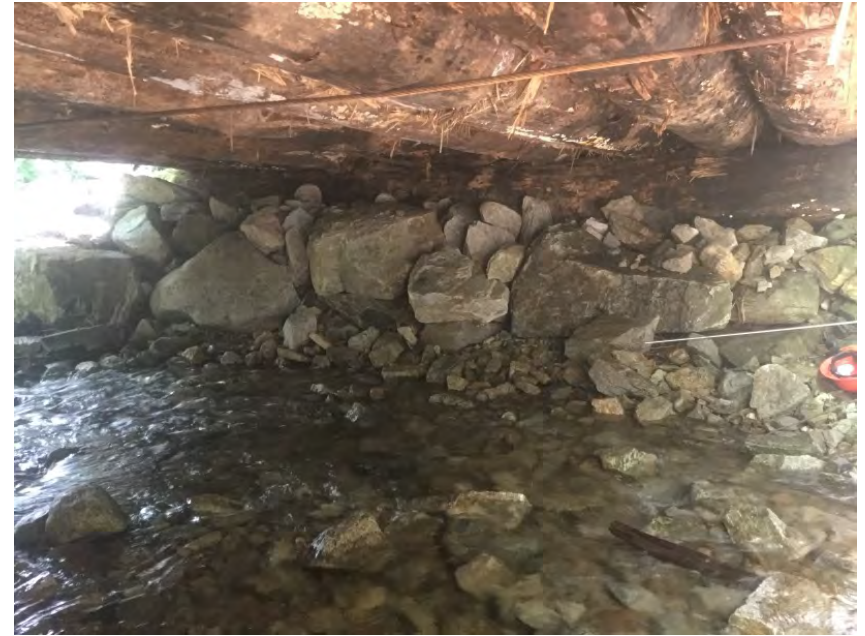
Right Bank Abutment when facing downstream

Single log sills
