CK-2497

ENGLISH 2.6km

2018 Inspection

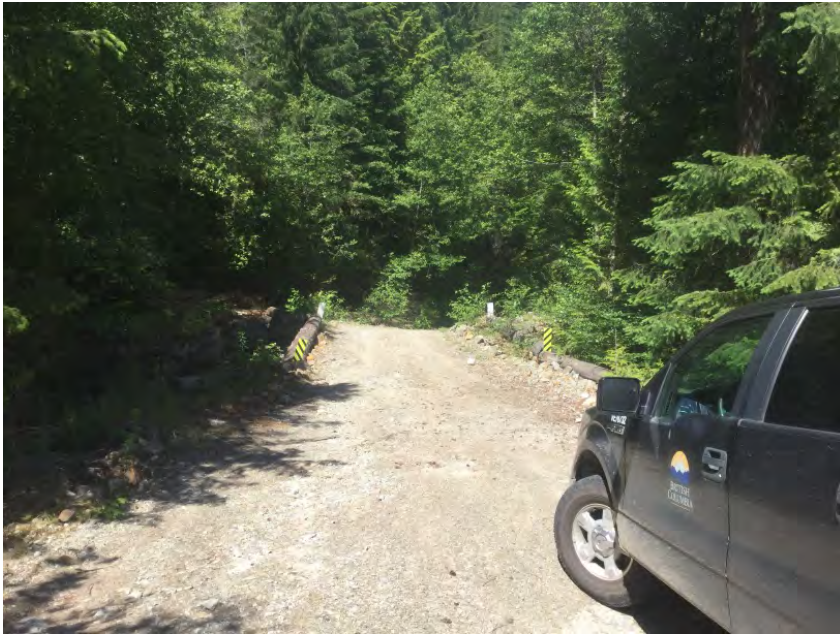
Approach from Right Bank when facing downstream

Alignment Poor

VC both approaches

Bridge Ahead Signs  
Missing☐ 0 ☐ 1 ☒ 2

Post bridge ahead signs and monitor the riprap stability. Present load rating of L100 or 91 tonnes to continue.

| Item | Priority | Repair Description |
|---|---|---|
| 1 | Low | Post bridge ahead signs |

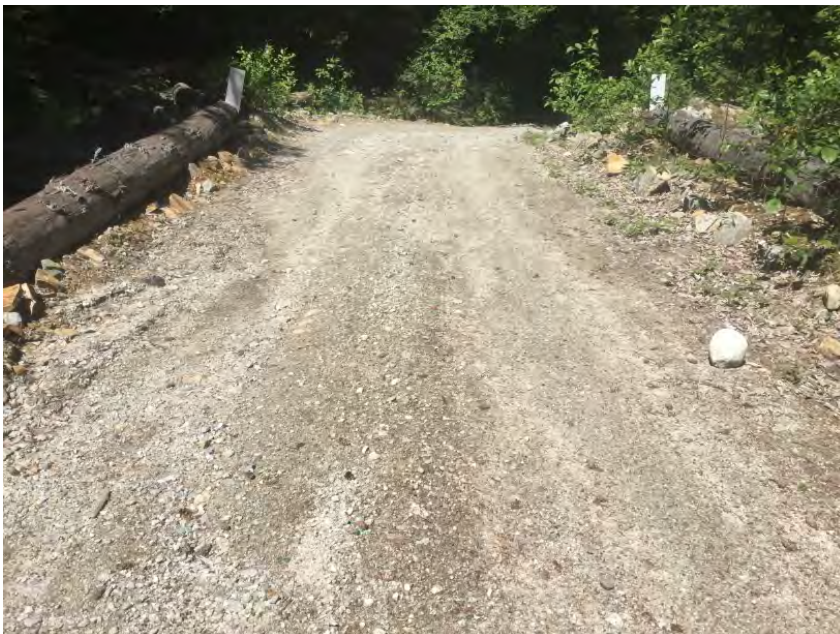
Gravel Surface Fair

Overall Deck Condition Fair

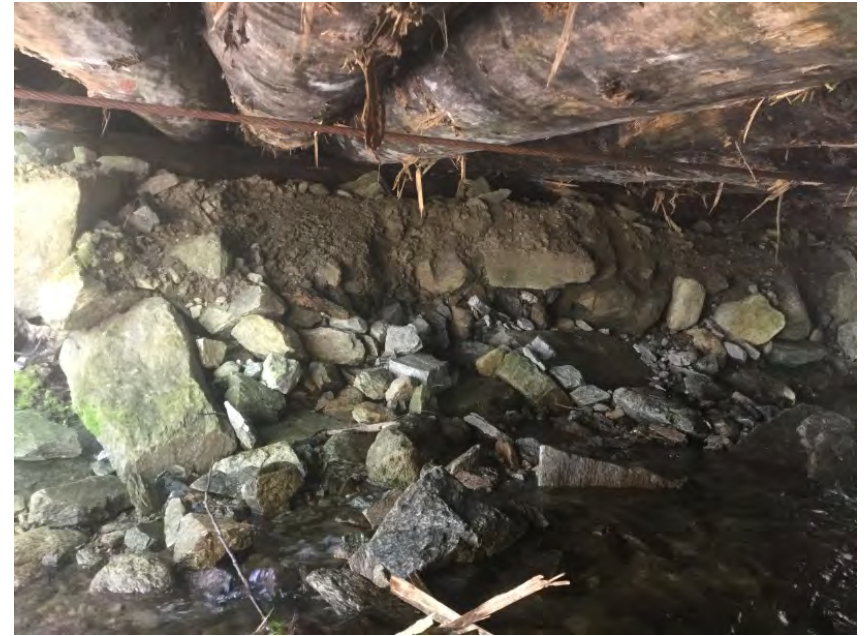
Right Bank Abutment when facing downstream

Caps or Sills Good

Single log sills

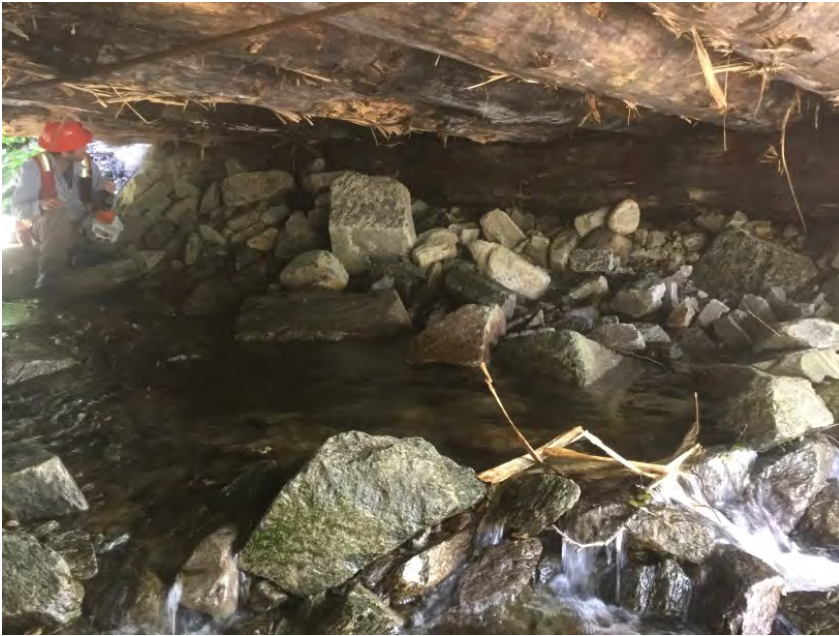
Left Bank Abutment when facing downstream

Riprap Fair

Missing downstream left bank

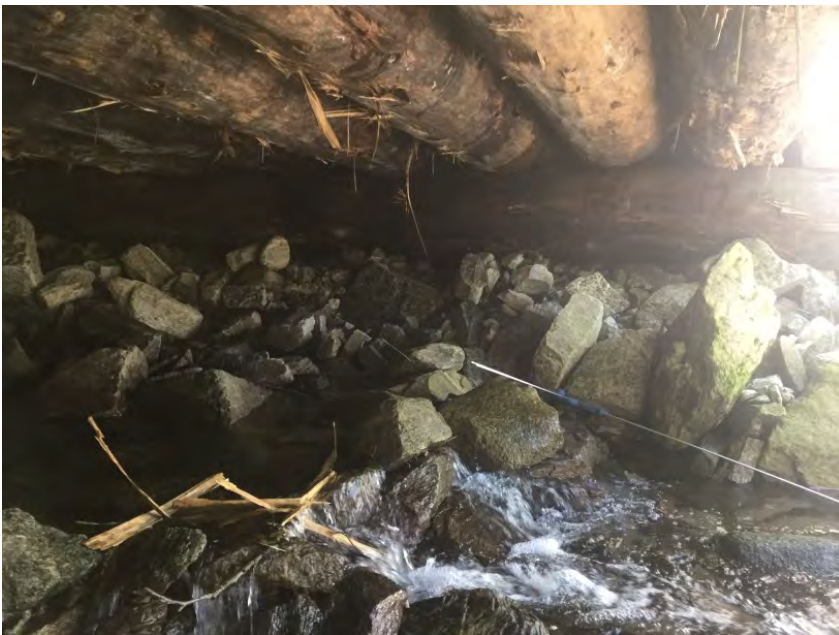
Eroded riprap downstream left bank

| Item | Monitor Description | Frequency |
|---|---|---|
| 1 | Riprap scour | Routine Inspection |
