CK-2501

FLEETWOOD 5km

2018 Inspection

| Structure Class | Major Culvert | | |

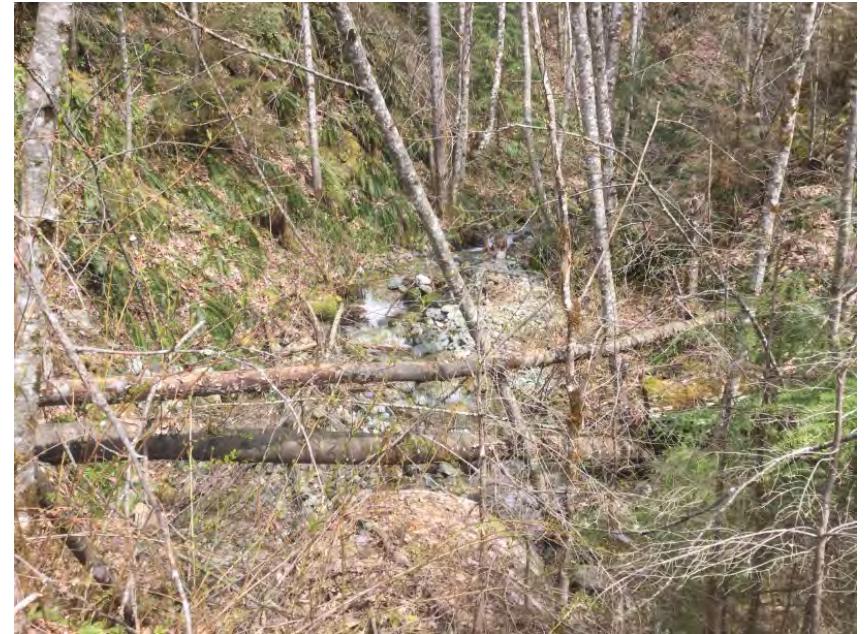
Looking upstream from road

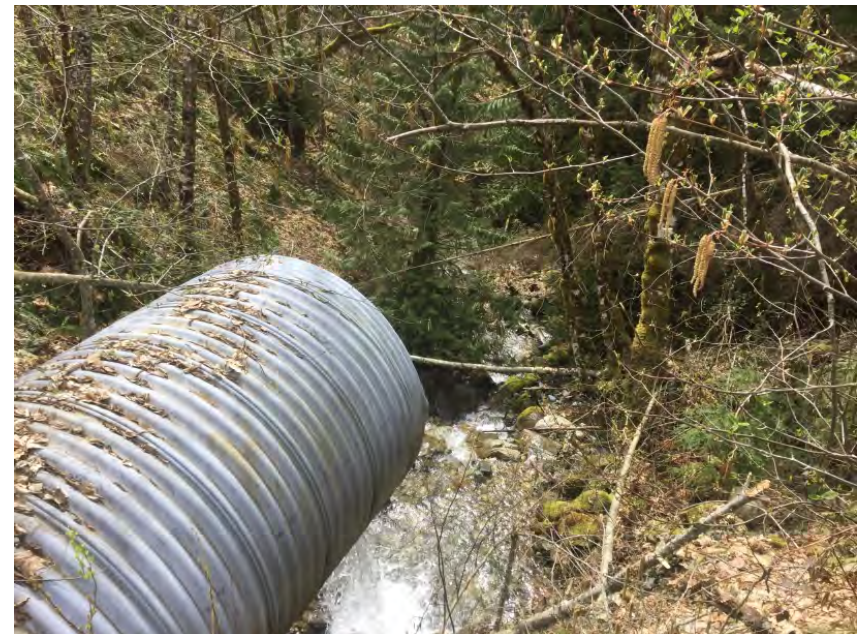
Looking downstream from road

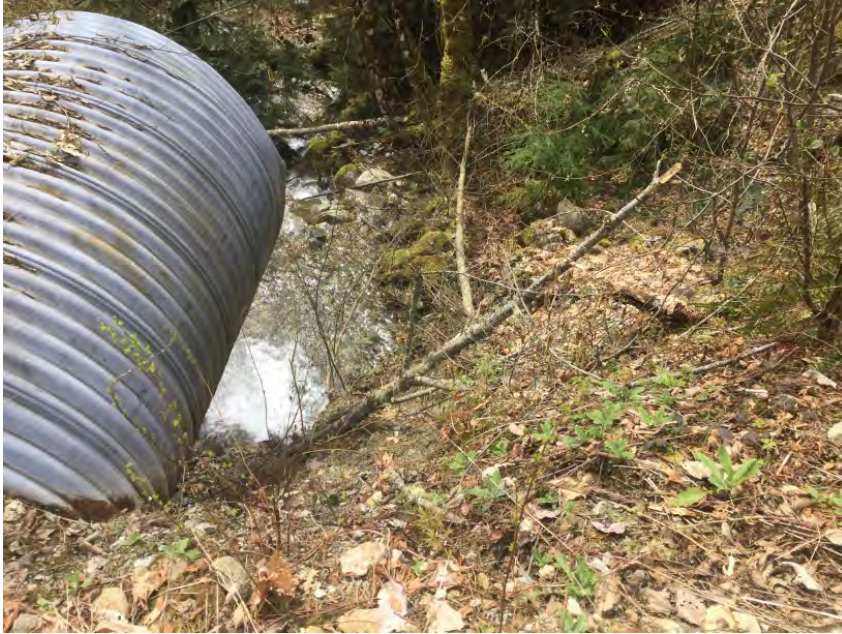
Fill      Poor      Outlet fill has eroded at both banks

Right bank outlet erosion

Add riprap to the outlet of the culvert

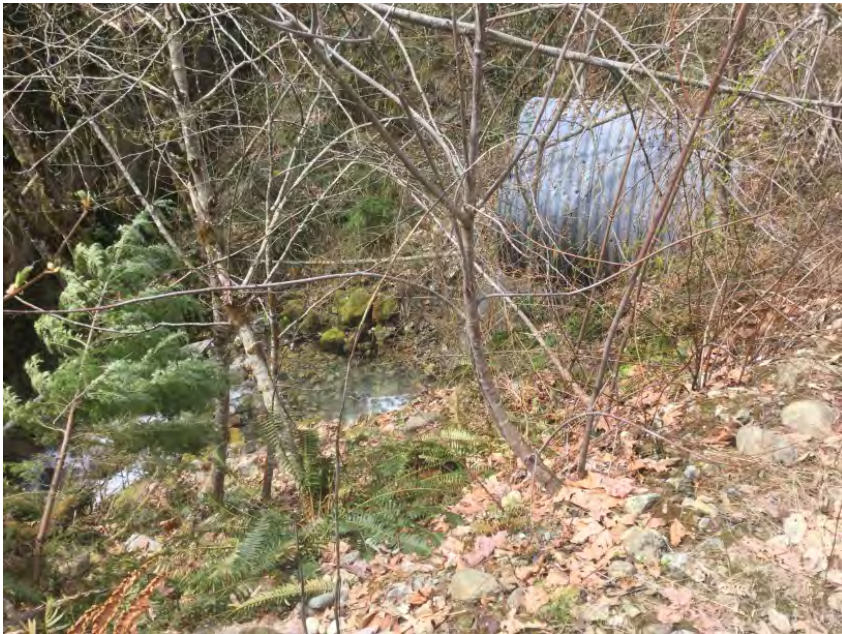
Left bank outlet erosion

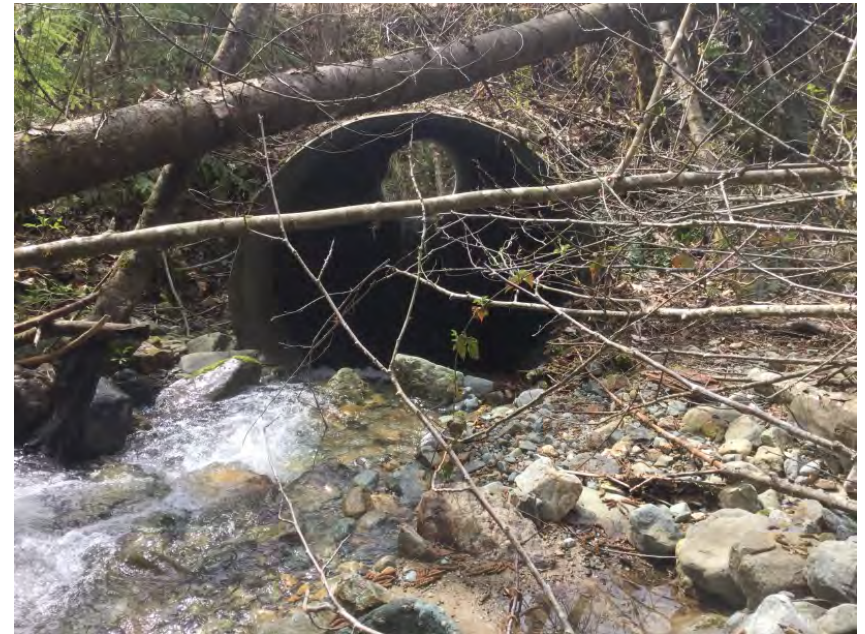
Inlet      Fair      Inlet has been partially blocked with debris

Inlet

2 Medium Clean inlet

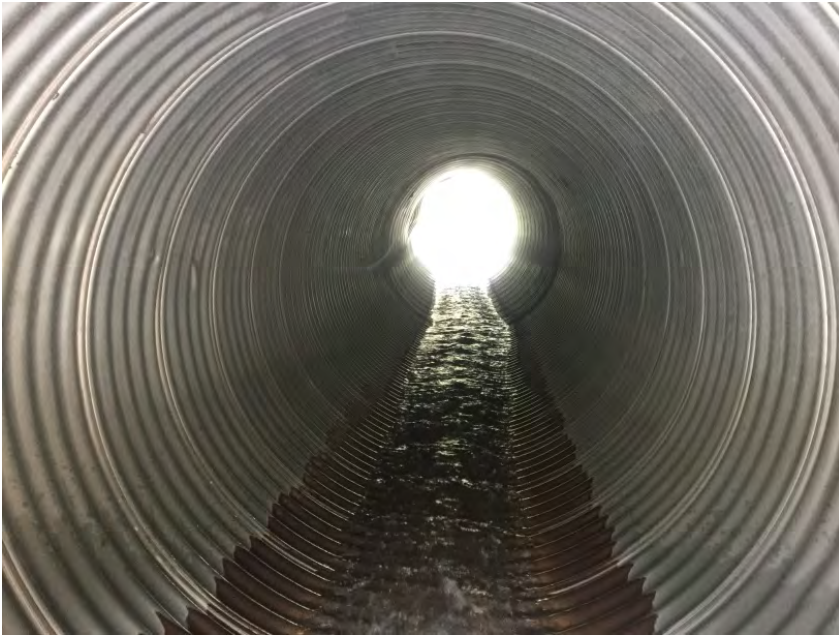
Looking through culvert from inlet
