CK-2502

FLEETWOOD 7km

2018 Inspection

| Structure Class | Temporary Bridge | | |

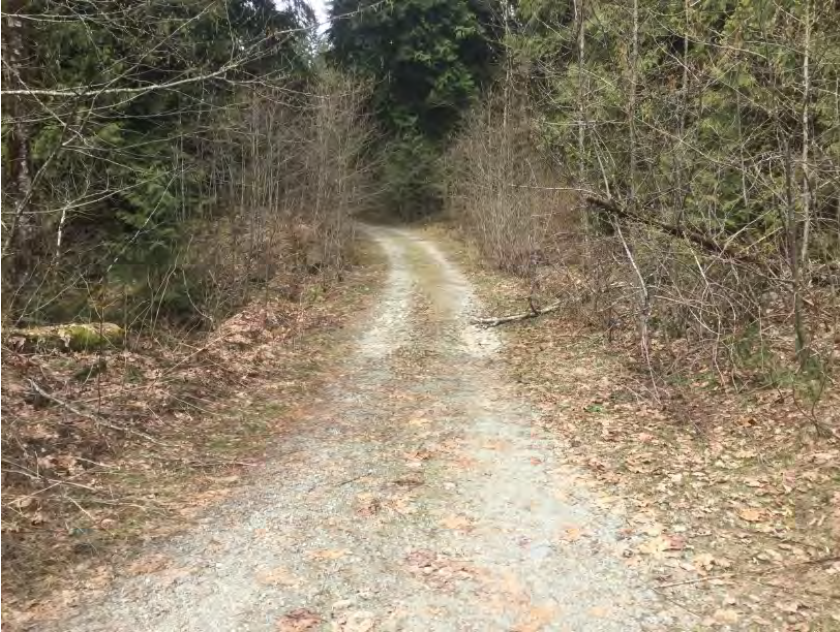
Slight HC left approach

Old rotten logs that are too low

Approach from Left Bank when facing downstream

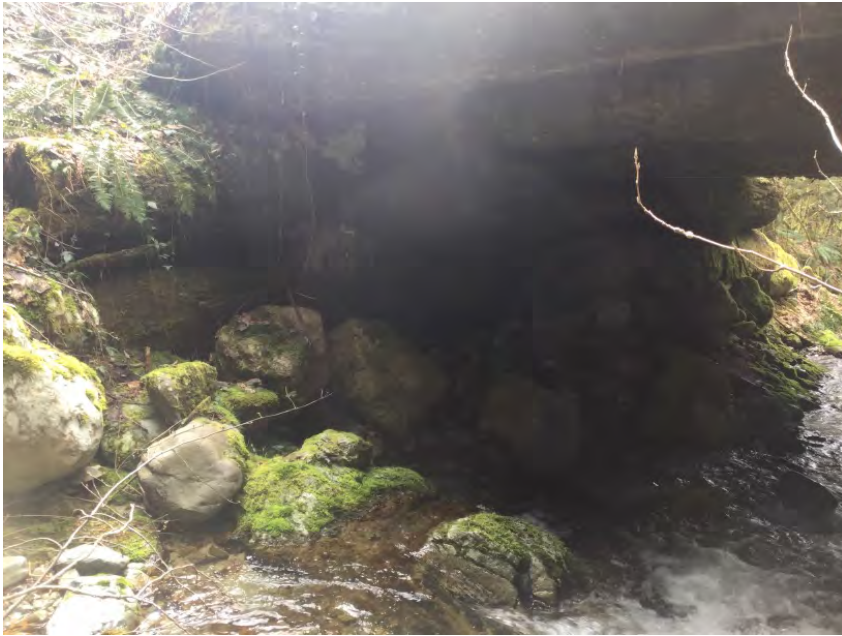
Left Bank Abutment when facing downstream

2x, indication of insect damage

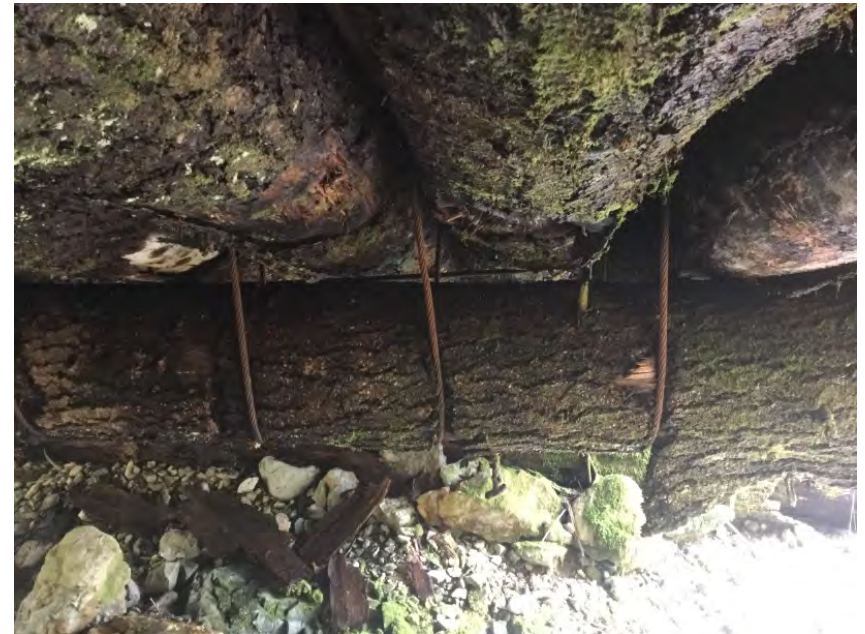
Ineffective needle beam

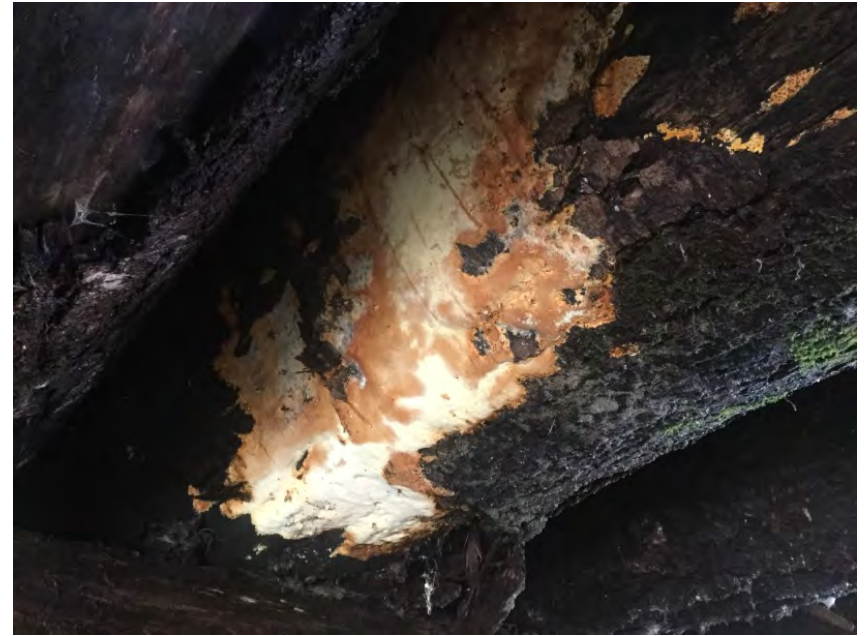
Stringer 5

| 5 | Fd | N | 540 | 20 | | |

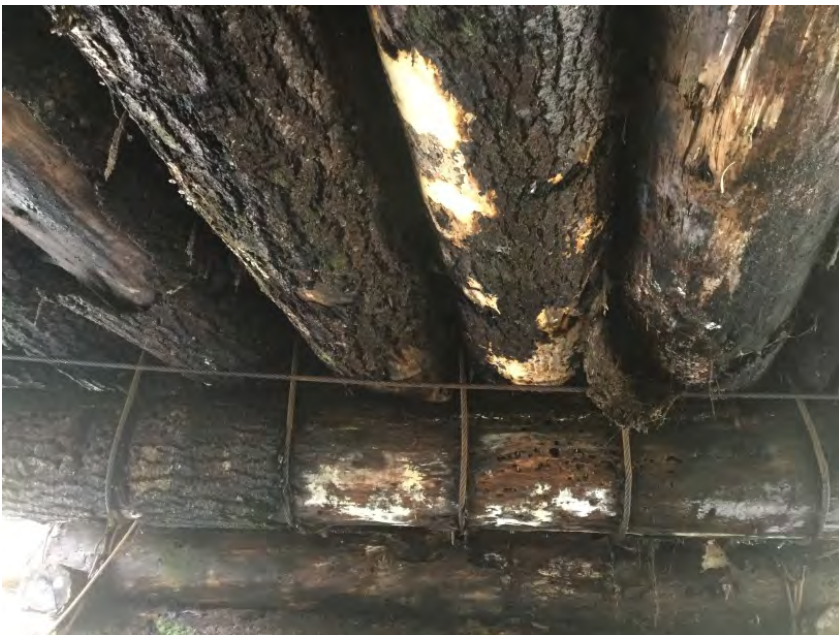
Stringers

The structure continues to degrade. Limit loading to L30 or 27 tonnes. Plan to replace the entire structure if industrial activity is required. There is limited gravel surfacing on the downstream portion of the bridge and recommend placing a curb log along the running surface to keep traffic from driving to that side of the structure. Post updated load rating sign.

| 2 | Low | Replace with industrial activity |

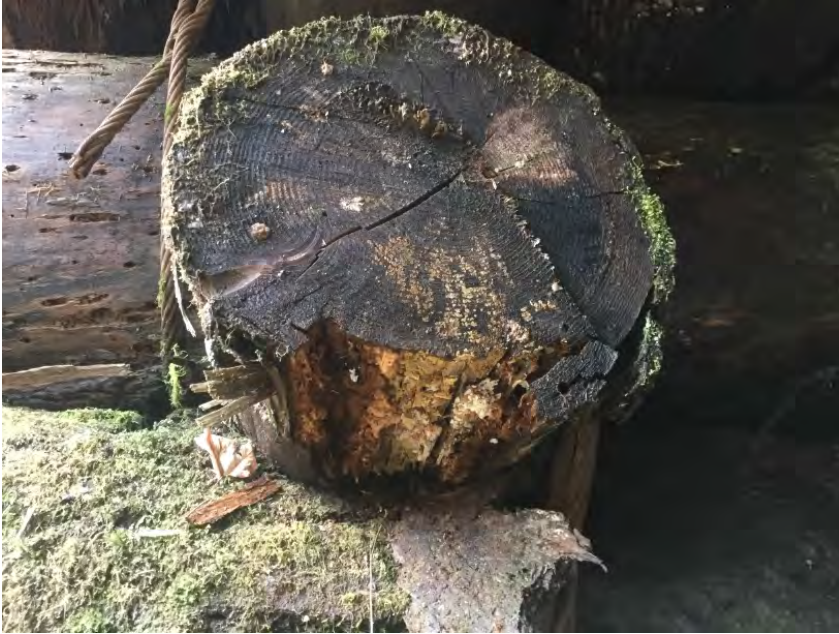
2x

Tieback condition

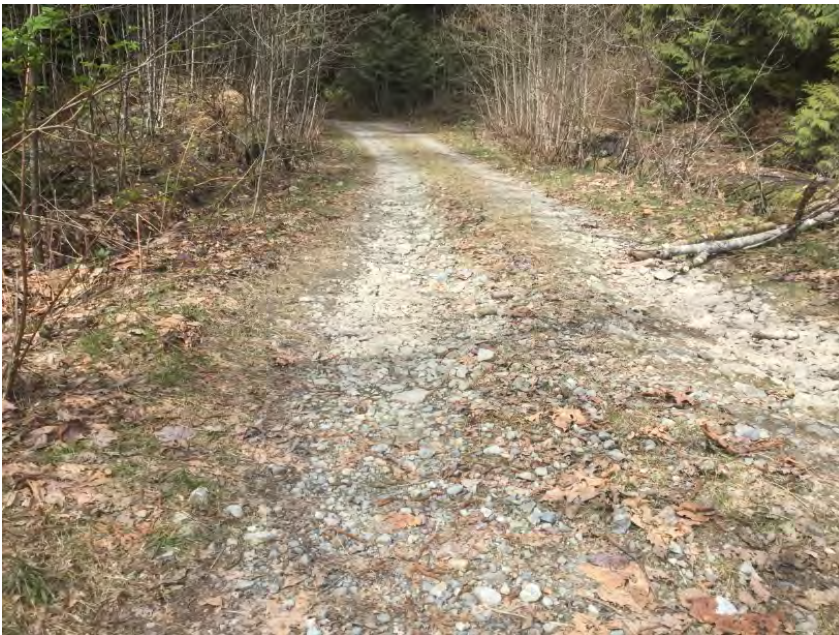
No downstream curb log and gap in surfacing

Place downstream curb log to limit access to the middle of the structure or block access

| Repair Item | Priority | Repair Description |
|---|---|---|
| 1 | High | Post load rating sign and place downstream curb log |
