CK-2506

STATLU 1800 0.2km

2018 Inspection

| Crossing Name | Alf Creek | | |

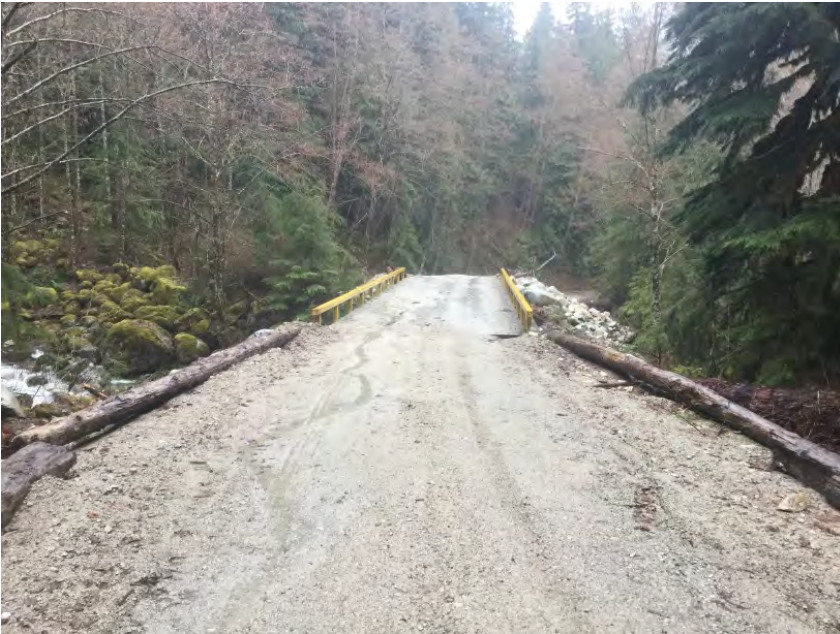
Alignment Poor

Heavy VC both approaches limits visibility

Approach from Right Bank when facing downstream

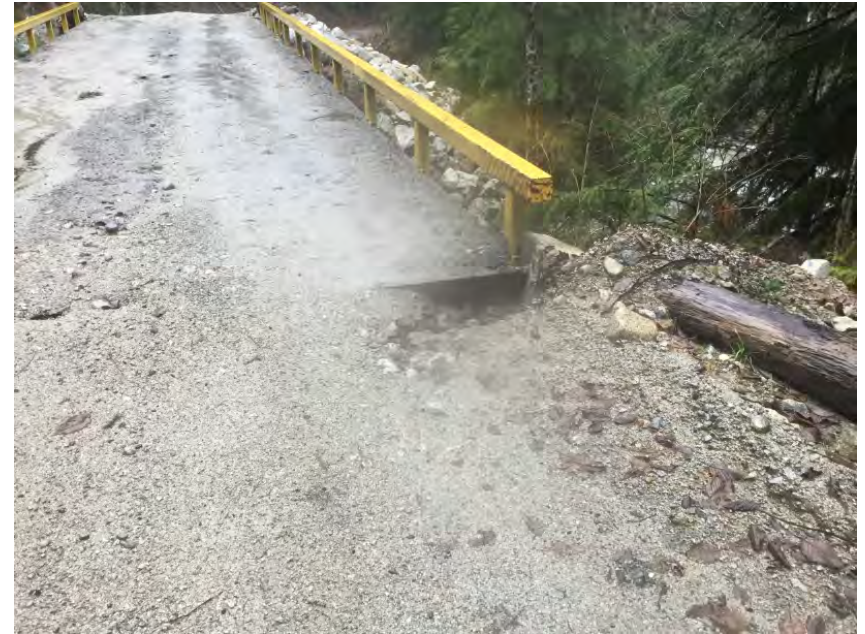
DS right approach losing surfacing material

| 1 | Medium | Replace all 4 fender logs with appropriately sized ones and replace eroded approach fill downstream right approach |

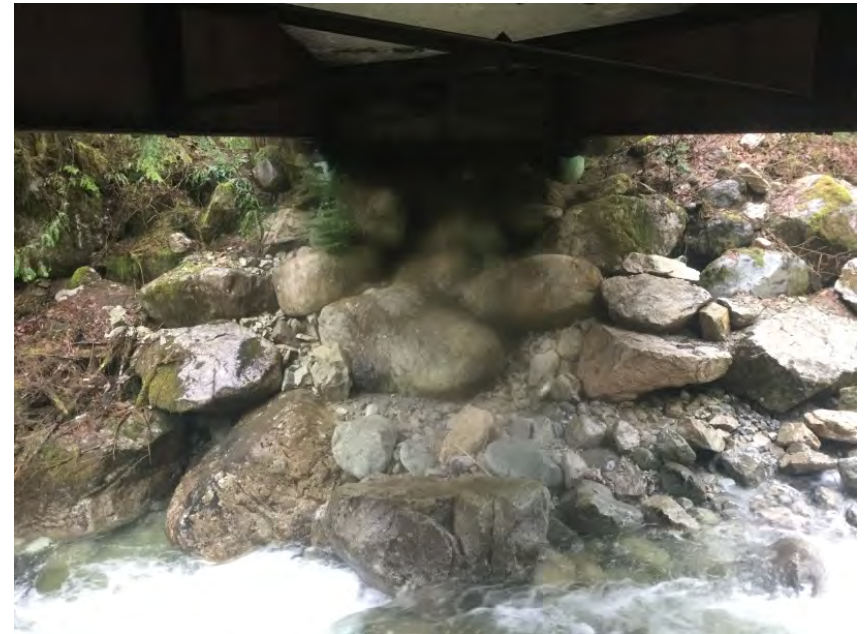
The downstream right bank footing is now completely covered with riprap and obstructed from view. Review record drawings to ensure material under previously exposed footing pad was replaced and proper bearing. If this is the case then the original structure loading can be reinstated.

Right Bank Abutment when facing downstream
