CK-2507

WINSLOW 5.4km

2018 Inspection

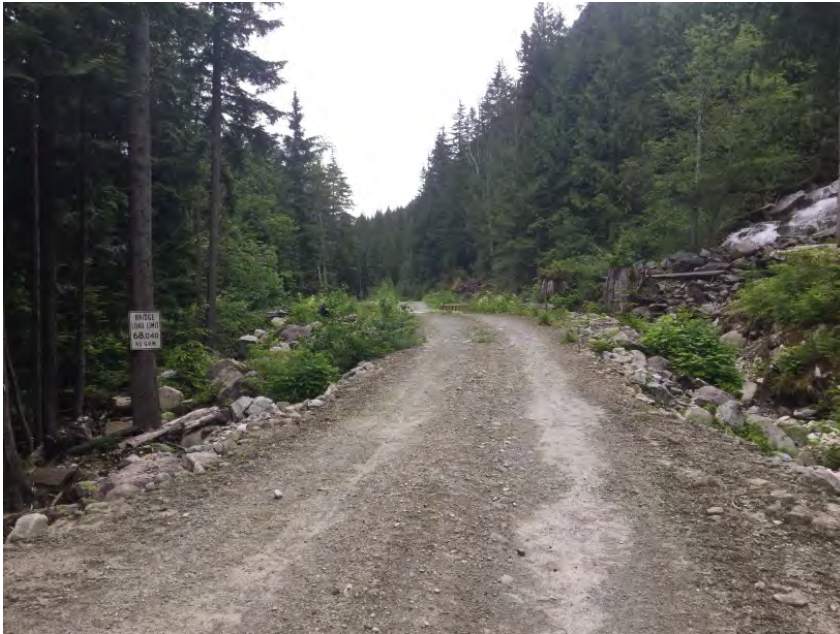
Approach from Left Bank when facing downstream

Delineator Missing  
Left ☐ 0 ☐ 1 ☒ 2

Delineator Missing  
Right ☐ 0 ☐ 1 ☒ 2

Post all 4 delineators. Present load rating of L75 or 68 tonnes to continue.

| Item | Priority | Repair Description |
|---|---|---|
| 1 | Medium | Post delineators at all 4 corners |

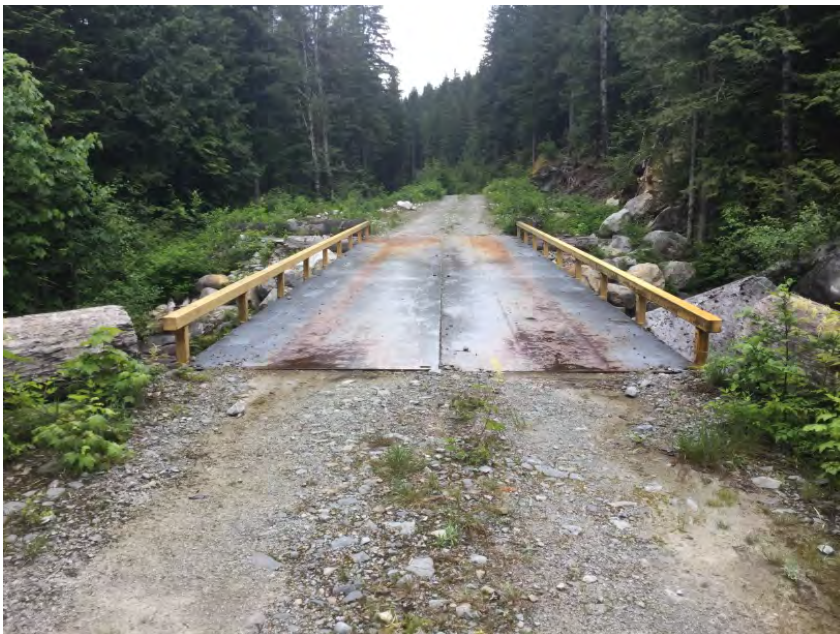
Steel Deck Plate      **Fair**

Overall Deck Condition      **Fair**

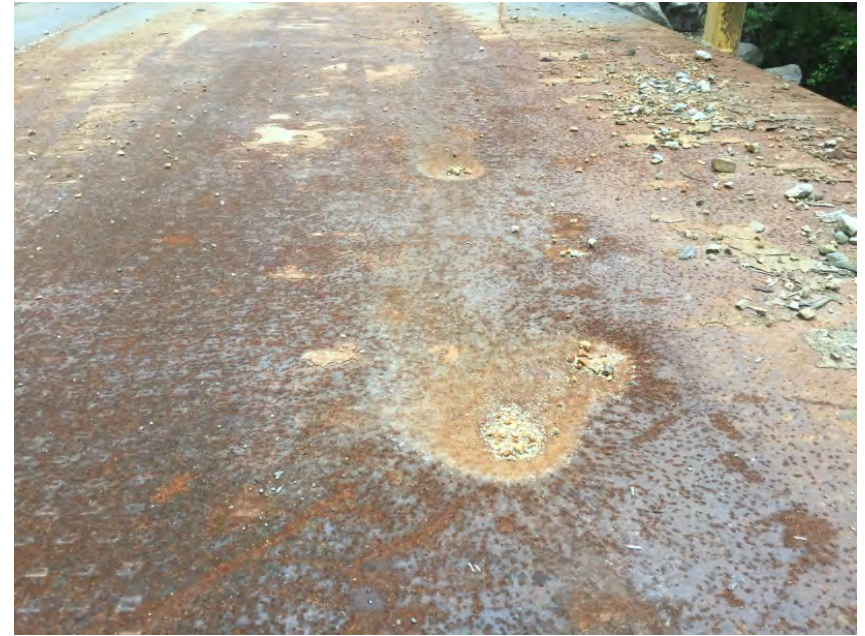
Minor deck deformation

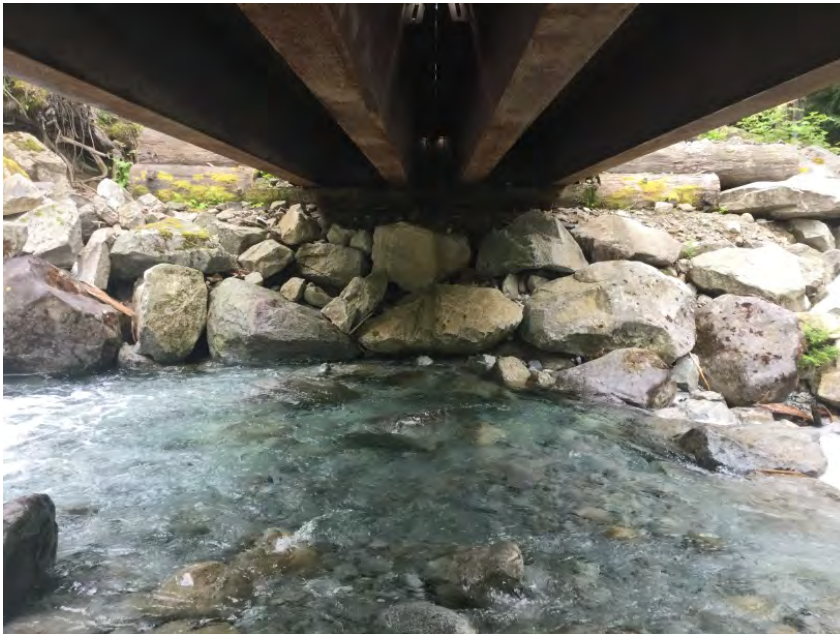
Left Bank Abutment when facing downstream

Caps or Sills Good Single log sills

Ballast Wall Good Logs
