CK-2508

WINSLOW km

2018 Inspection

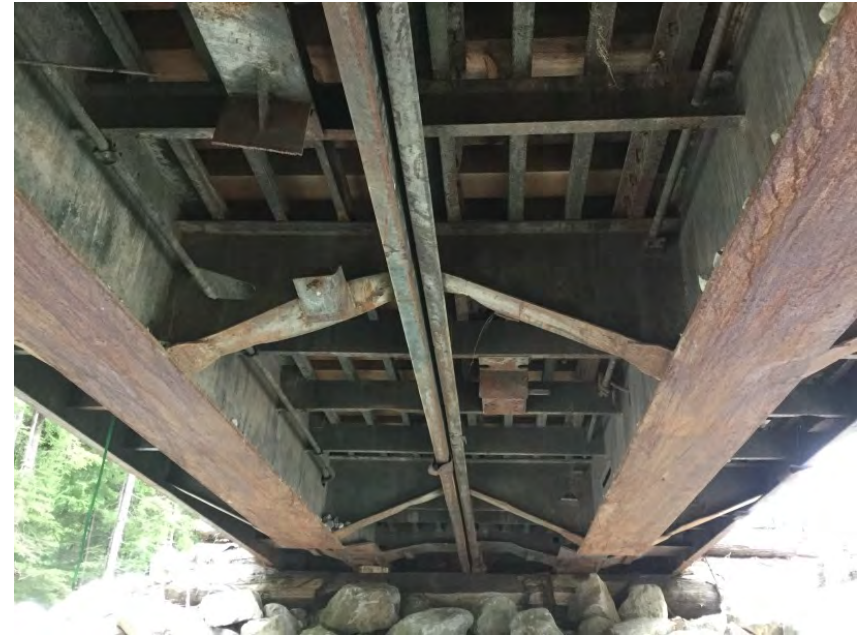
Superstructure

Girders Fair 2 different styles of rail cars

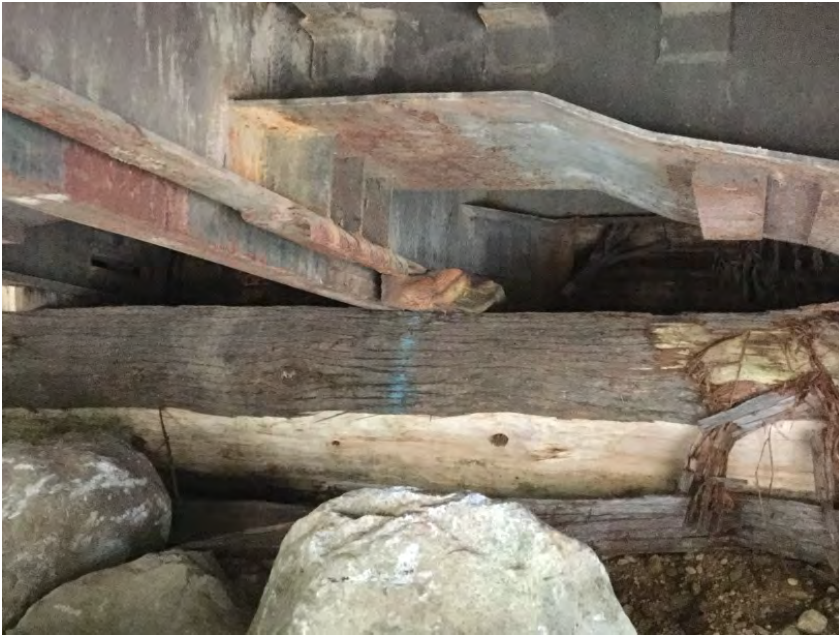
Railcars are not a matching pair and hence one set had to be shimmed level

Wooden shims used on various baring points to level

Wooden shims

Monitor shim condition

| Item | Monitor Description | Frequency |
|---|---|---|
| 1 | Shim condition - bearing | Routine Inspection |
