CK-2509

STATLU 11.2km

2018 Inspection

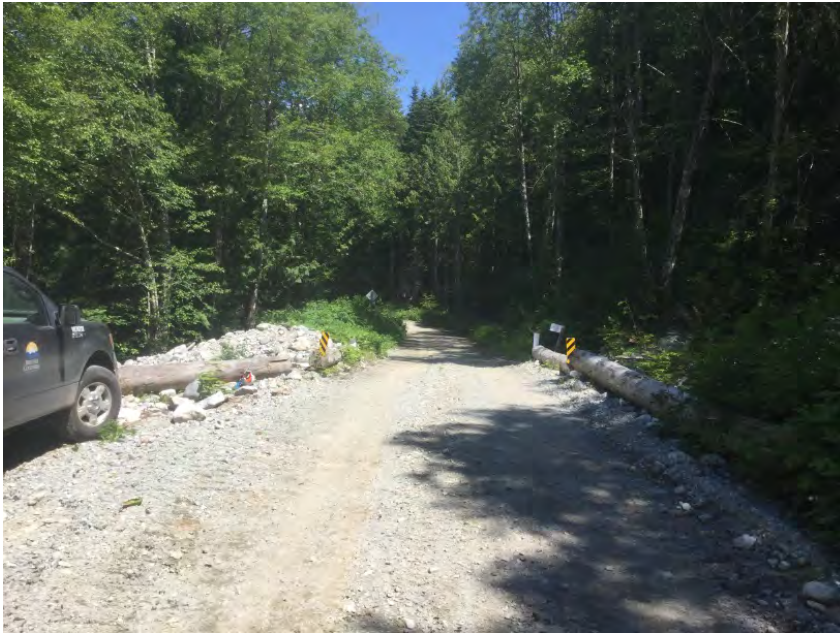
Approach from Left Bank when facing downstream

Alignment Fair

VC left approach limits visibility

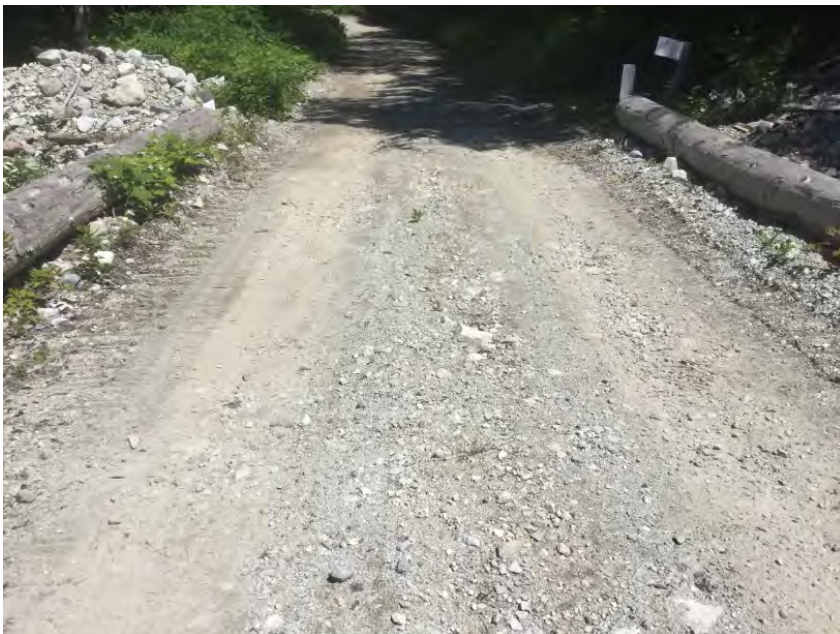
Deck

Hardware Poor Curb log not lashed or pinned

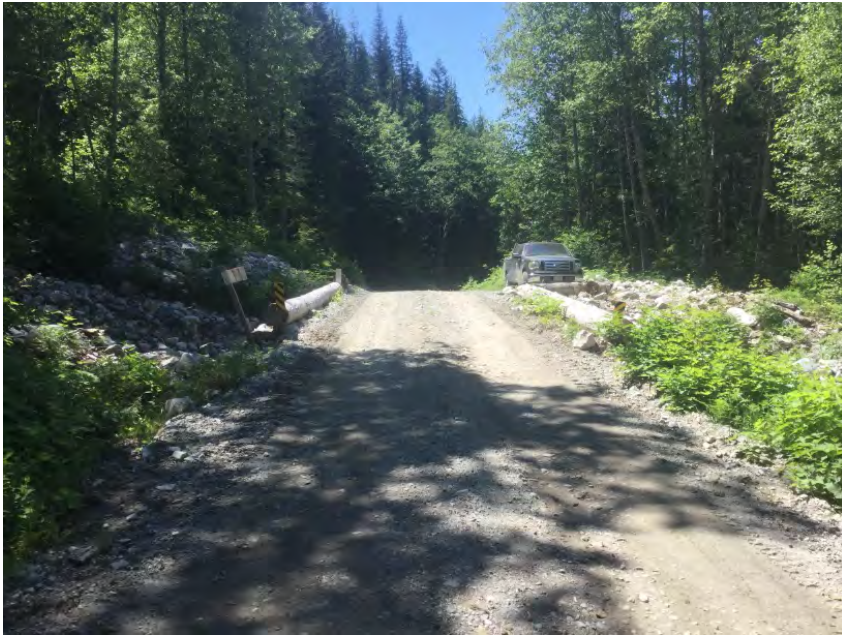
Approach from Right Bank when facing downstream

None at right approach

| 1 | Low | Replace missing fender logs |

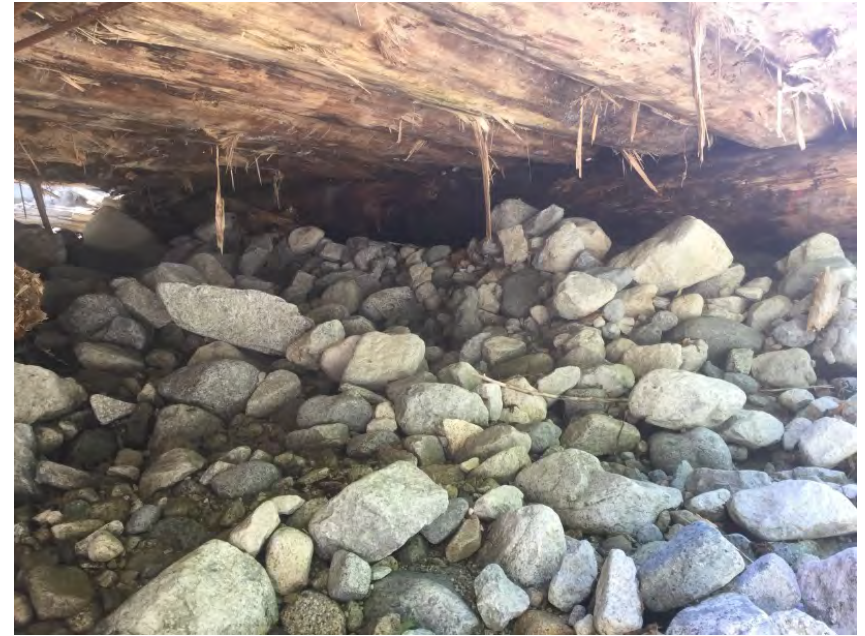
Left Bank Abutment when facing downstream

Both ends have eroded with high flows

Downstream left sill slightly scoured

| 2 | Medium | Repair scour noted at downstream left bank |

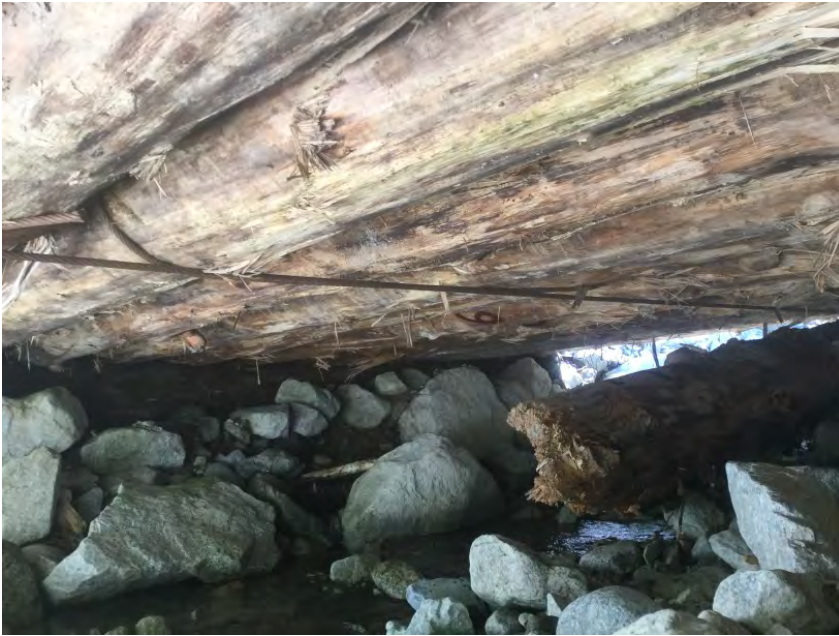
Stringers

| Stringer<br>Number | Species | Peeled | Diameter<br>(mm) | Rot Depth<br>(mm) | Condition | Comment |
|---|---|---|---|---|---|---|
| 4 | Fd | Y | 570 | | Fair | Large knots |

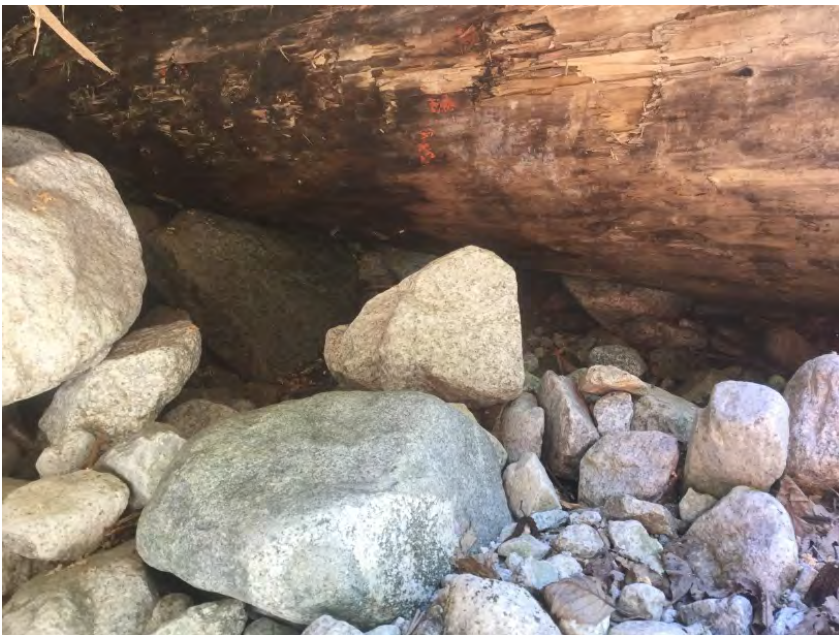
Downstream left sill has scoured but outside running width and 1.1m long section  
 6.8m span downstream  
 7.1m span upstream

Downstream left sill scour

Repair the scour noted at the downstream left bank abutment. Replace the missing fender logs and monitor the especially following heavy rainfall or rain on snow events. L100 or 91 tonnes load rating.
