CK-2511

BOULDER 3km

2018 Inspection

Crossing Name Boulder Creek

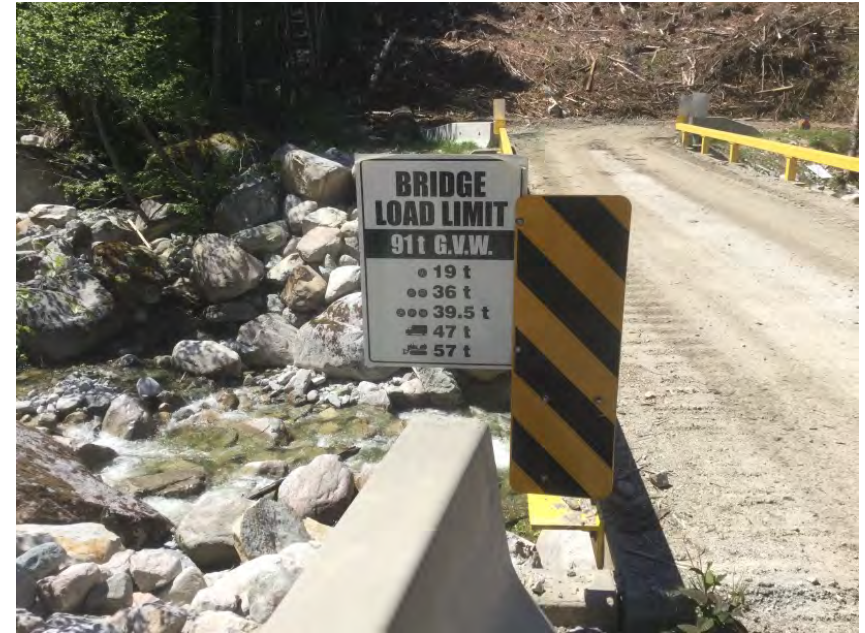
Load Rating Sign

Posted Load Rating 91 See picture

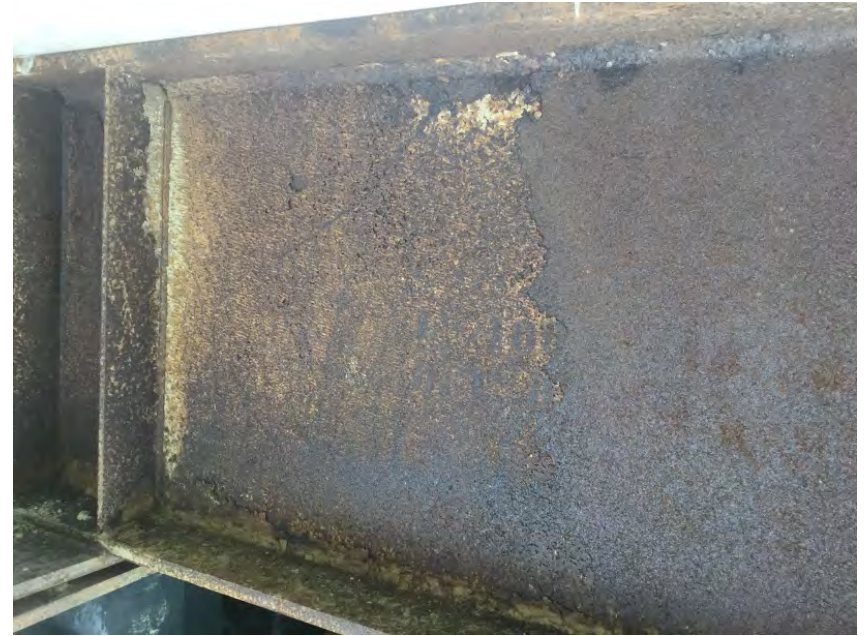
Girders Fair

Girders appear older than abutments and deck
