CK-2512

CLEAR 14.7km

2018 Inspection

| Structure Class | Major Culvert | | |

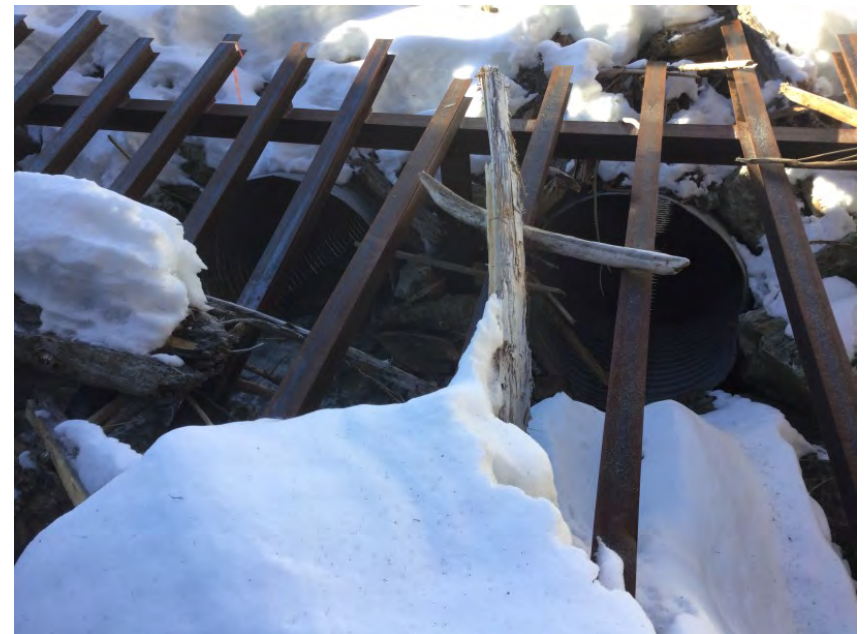
Inlet

Trash Rack Good Minor debris buildup

Monitor the outlet riprap condition and the debris accumulations at the inlet. The current load rating of L150 or 136 tonnes to continue.

2 Debris accumulations at the inlet

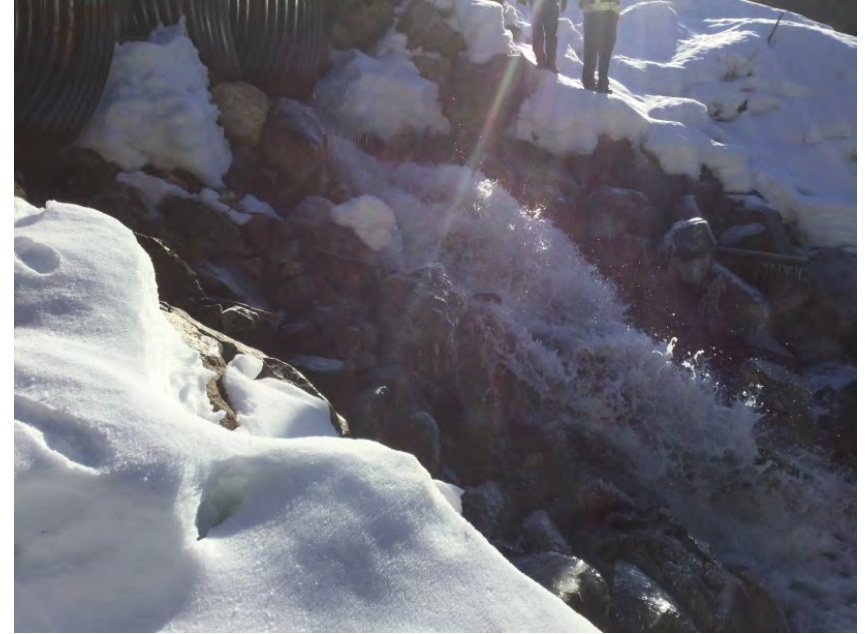
Rip Rap Fair

1 Outlet riprap
