CK-2518

AMERICAN 9.2km

2018 Inspection

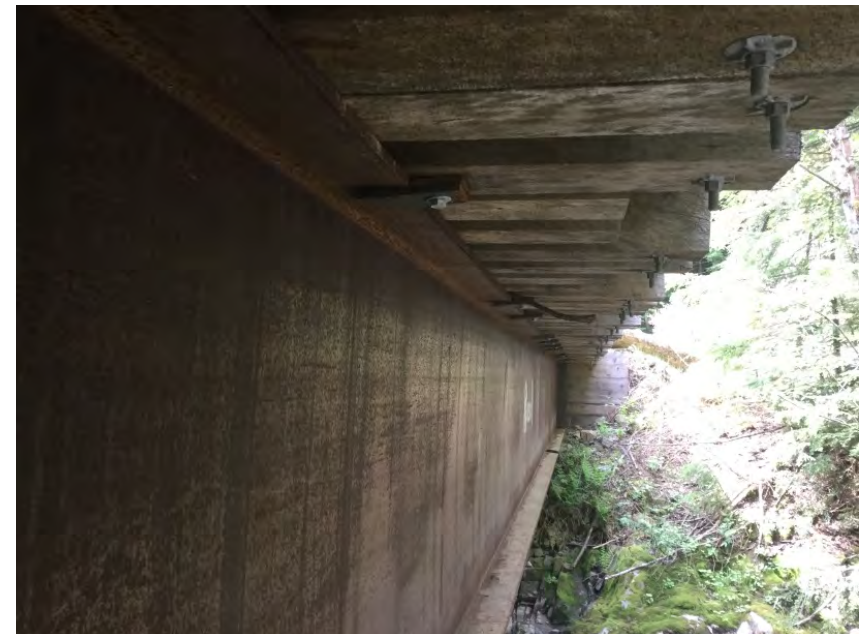
Deck clips secure bearing locations

Deck clips

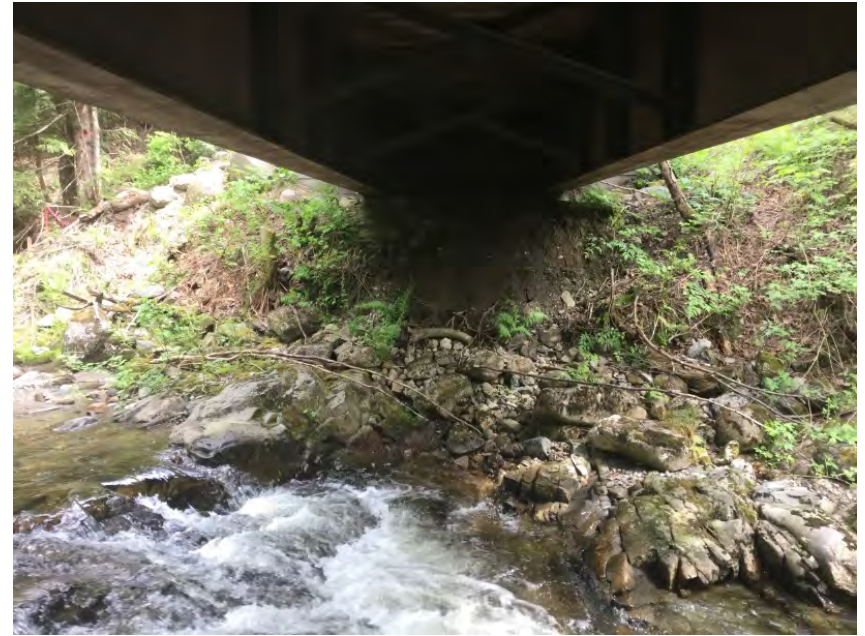
Left Bank Abutment when facing downstream

Both banks susceptible to erosion at high flows, especially left abutment

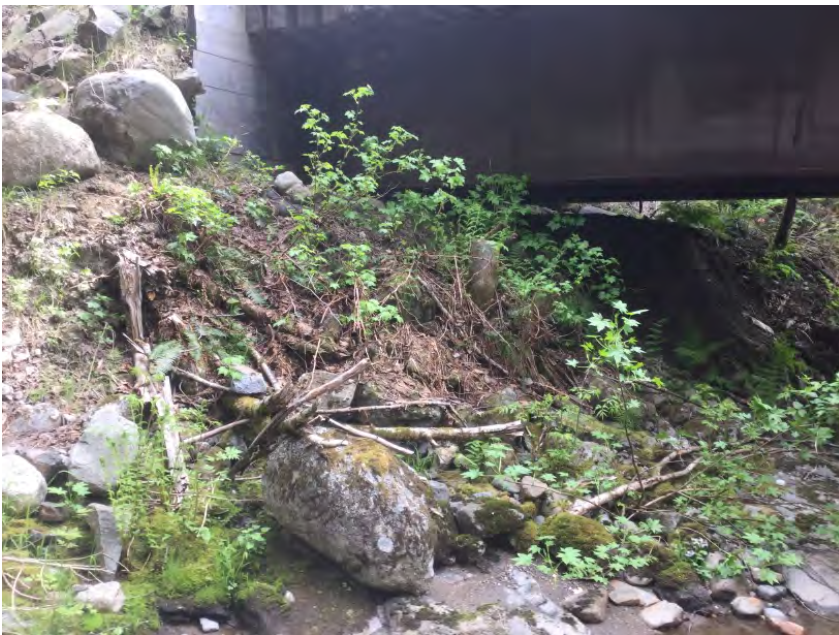
At the time of this installation a 3 year lifespan was assumed and long-term rock armouring was not added, leading to risk from scour. According to the record drawings the right bank (town end) abutment is founded on bedrock but the left bank (woods end) is founded on compacted fill, which is very susceptible to scour and needs to be monitored. According to the record drawings the load rating is L100 or 91 tonnes, which can continue; however I recommend placing riprap at the left upstream location and monitoring both abutments for scour. Replace the upstream right approach delineator with proper one.

Riprap Poor

None in front of abutments

No riprap in front of left abutment

| 1 | Abutment scour | |
