CK-2519

GARNET 9400 3.5km

2018 Inspection

| Crossing Name | East Fork Garnet Creek |

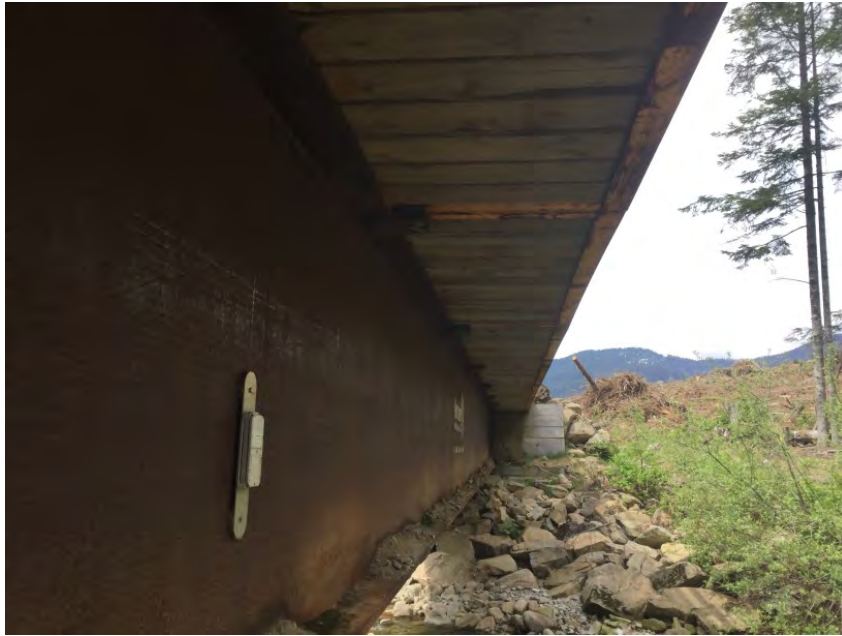
Hardware Good Bearings secured with deck clips

Deck clips

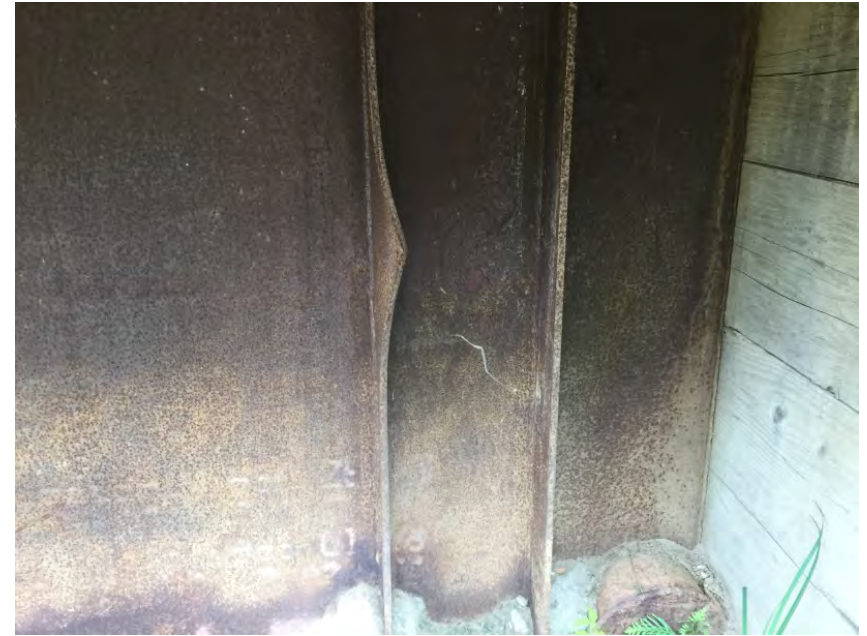
Damage noted to stiffener on downstream left abutment girder

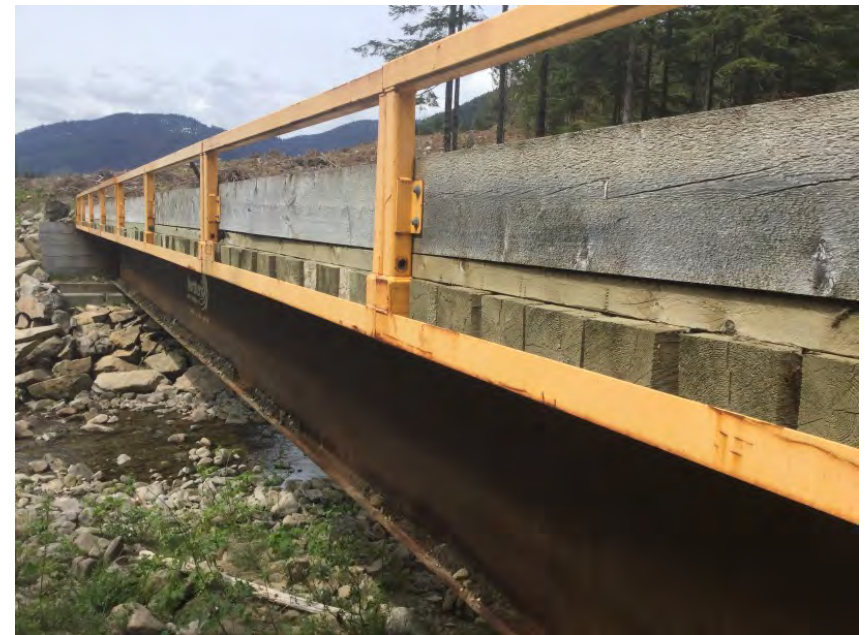
Treated ties and subdeck

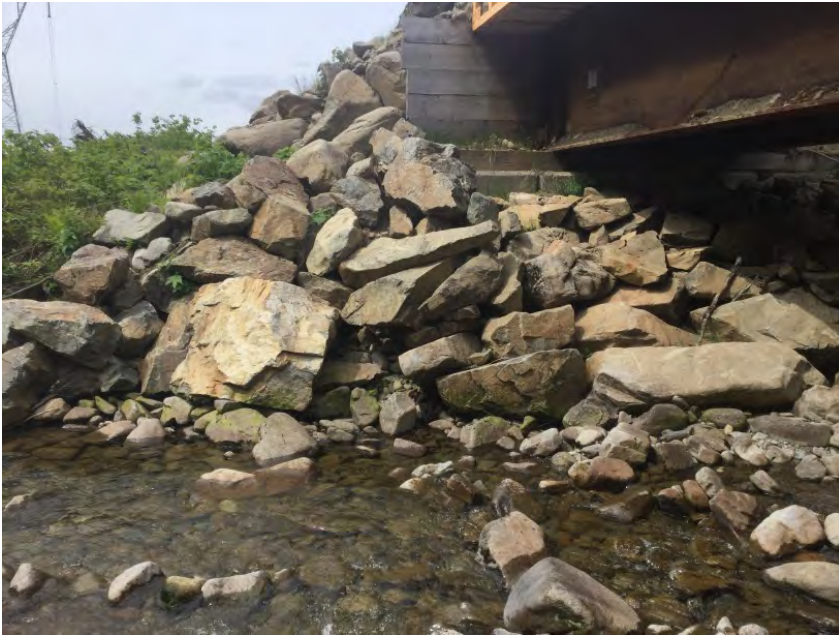
At the time of the installation a 3 year lifespan was assumed and the lock block abutments were raised in the field to accomodate increased freeboard; however over the longer term this leaves the underside of the abutment (lock blocks) at an increased risk of scour as they are higher than the streambed. At the time of inspection the riprap was in fair condition but needs to be monitored. The present load rating of L100 or 91 tonnes load rating can continue.

Eroding riprap downstream right abutment

| Item | Monitor Description | Frequency |
|---|---|---|
| 1 | Downstream right abutment riprap scour | Anually |
