CK-2521

BENCH 4.2 km

2018 Inspection

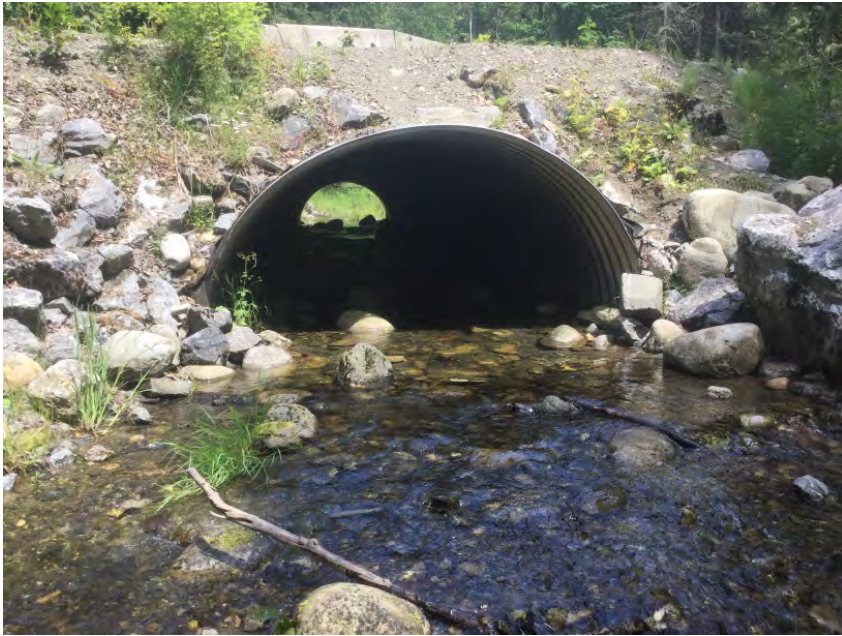
Outlet

Good

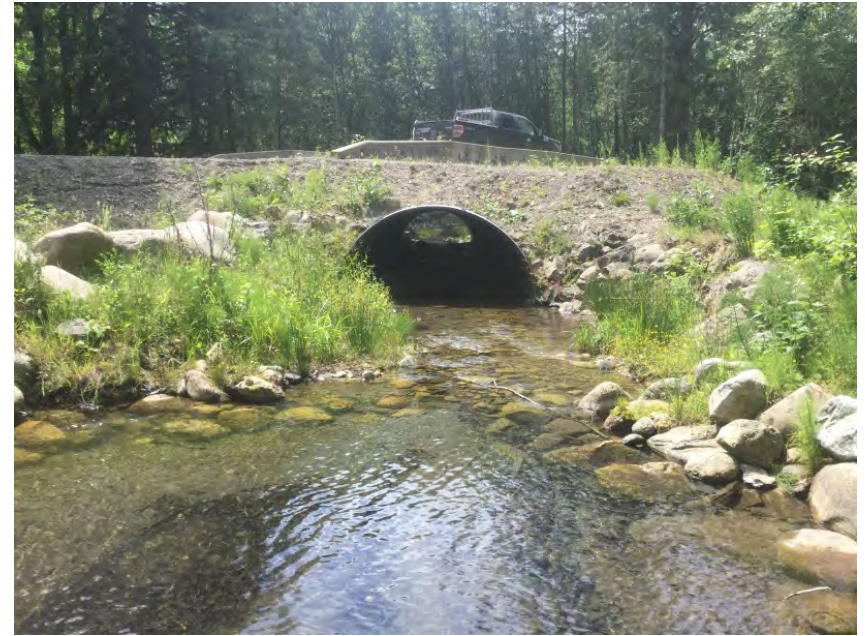
Inlet

Good
