## Log Stringer Bridge Inspection Report

| Structure #: | CK-2524 | Site #: | CK-2524 | Road Name: | BIG SILVER | Inspection Date: | 2018/06/15 |
| KM: | 0.30 | User km: | 0.30 | Crossing Name: | Big Silver River | Next Inspection Date: | 2018/11/08 |

CK-2524

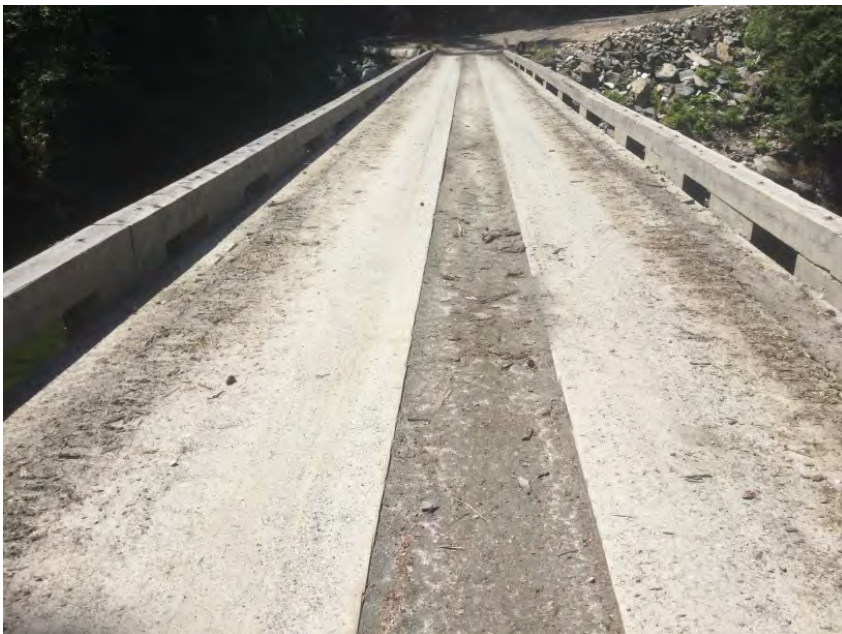
Deck

Fair

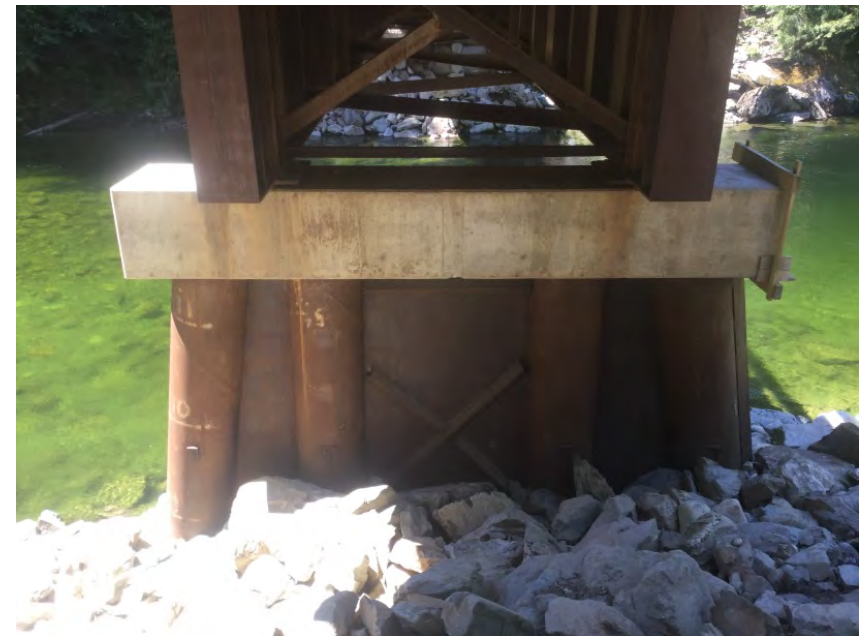
Pier

4 round piles, outside ones angled

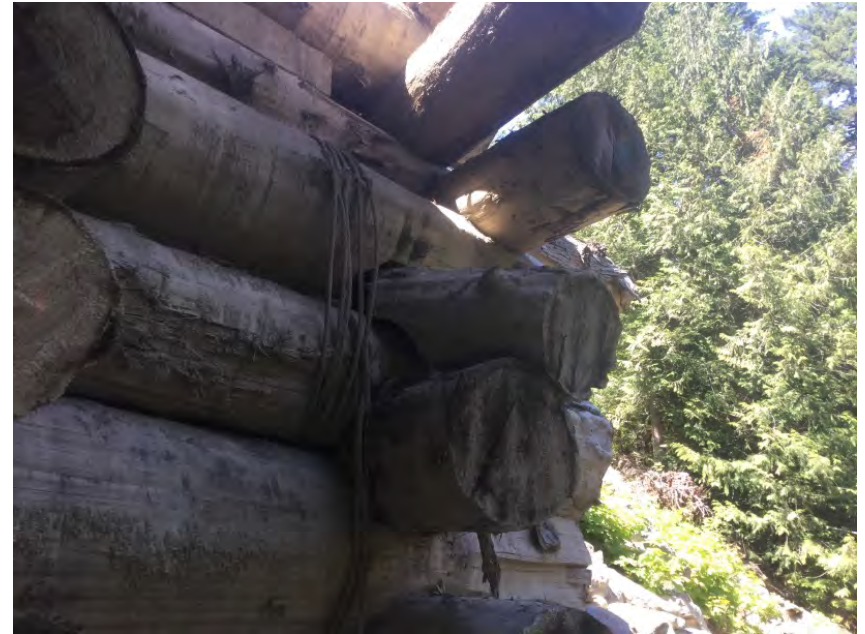
| Tie-backs | Fair | 1 broken tieback end - monitor |

Broken tieback upstream right abutment

| <b>GENERAL</b> | <b>PEng's Comment:</b> | Replace missing fender logs and monitor the upstream right abutment tieback and fill condition in this area. Present load rating of L100 or 91 tonnes to continue. | | | | | |

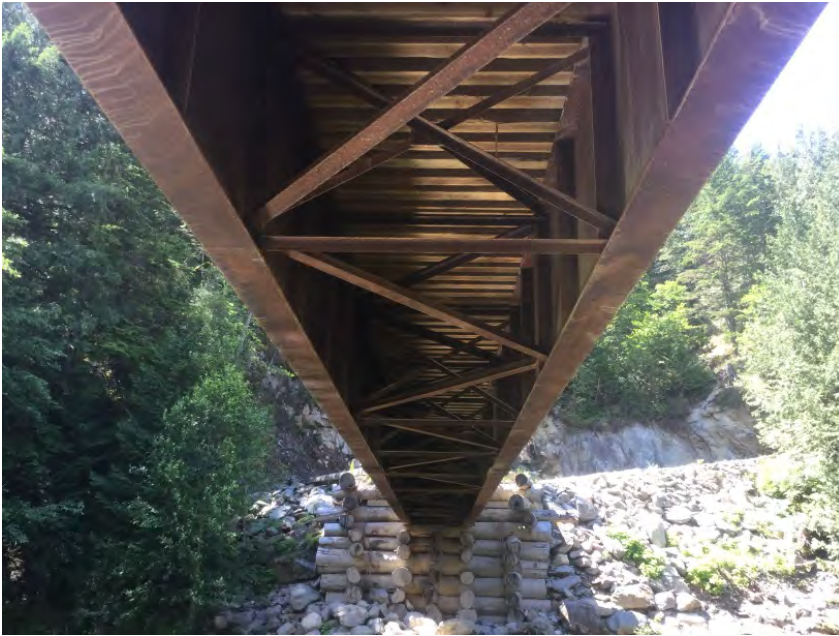
Mainspan superstructure

| <b>Bracing</b> | Fair | main span | | | | | |
| <b>Diaphragms</b> | Fair | main span | | | | | |
| <b>Girders</b> | Fair | main span | | | | | |

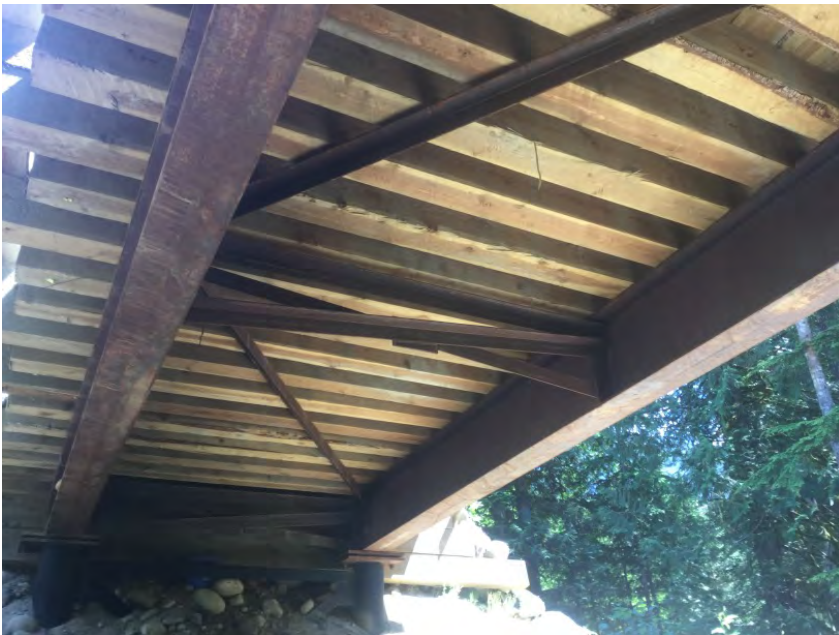
Jump span superstructure

| <b>Diaphragms</b> | Good | Jump span | | | | | |
| <b>Girders</b> | Good | Jump span | | | | | |
