CK-2525

BIG SILVER 2.5km

2018 Inspection

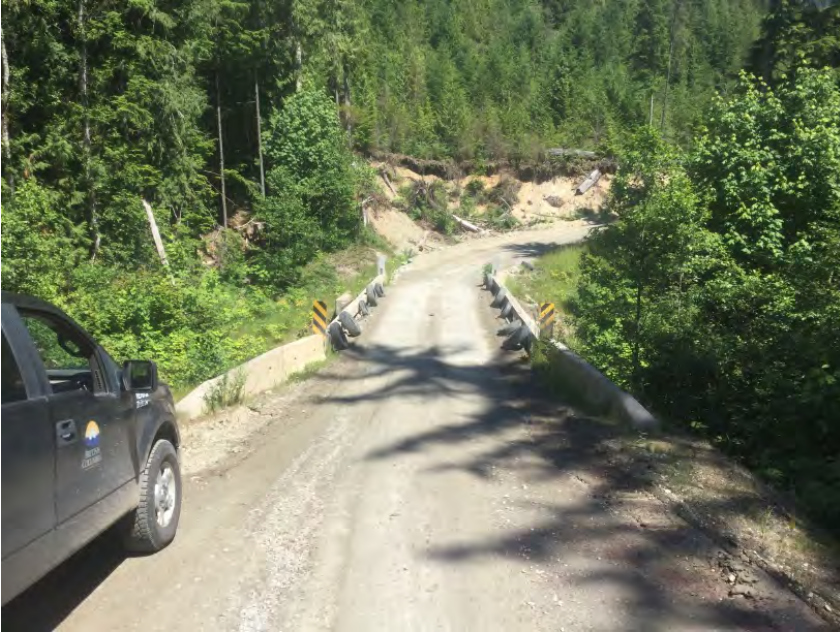
Approach from Right Bank when facing downstream

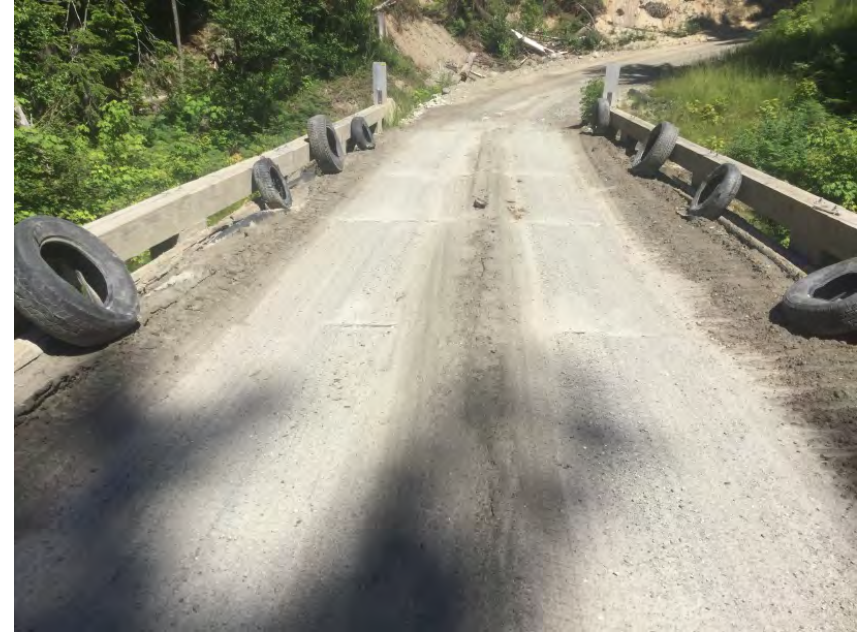
Deck

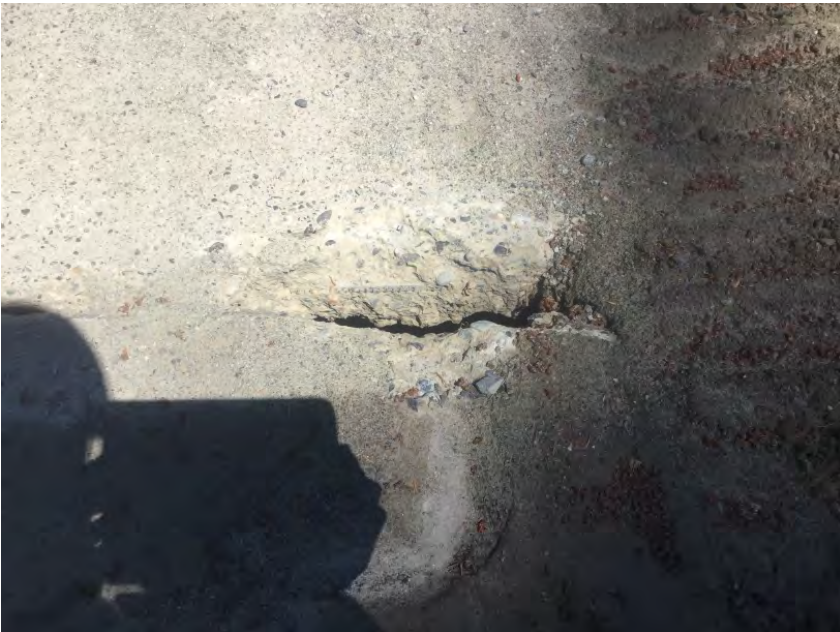
Concrete Deck Fair Damage noted to panel 1 right bank

Deck damage right bank

Repair the damage to deck panel 1 consistent with the Concrete Repair Guide for Concrete Bridge Components FLNRO (2017) and replace all deck joint seals. Present load rating of L75 or 68 tonnes to continue.

| 1 | Medium | Repair damage to deck panel 1 |

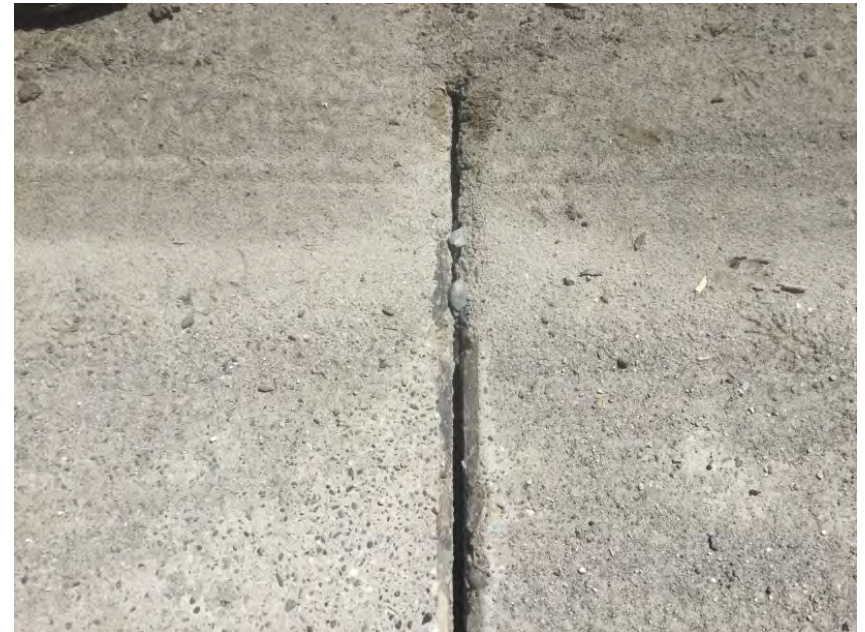
Deck Joints Poor None in place

Deck joints missing rubber seals

| 2 | Medium | Replace all deck joint seals |

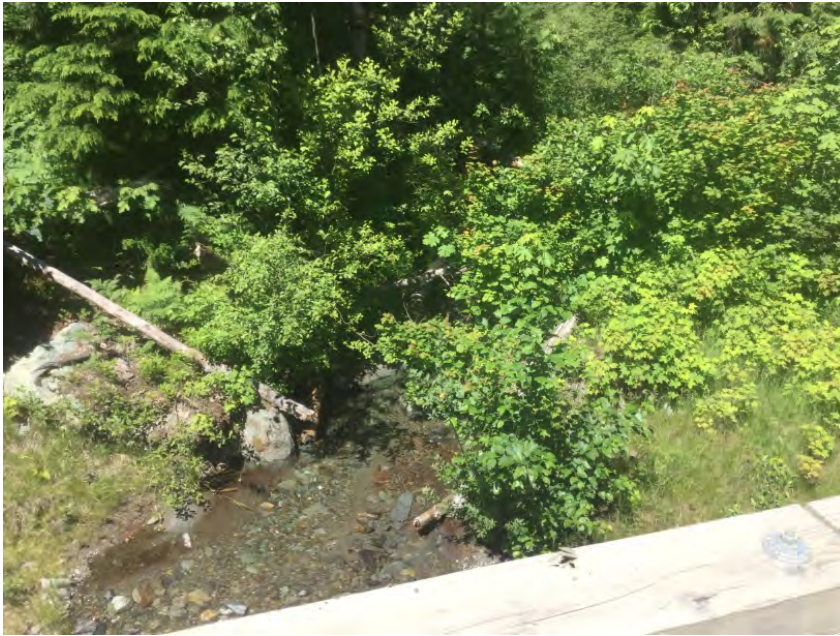
Upstream from Crossing

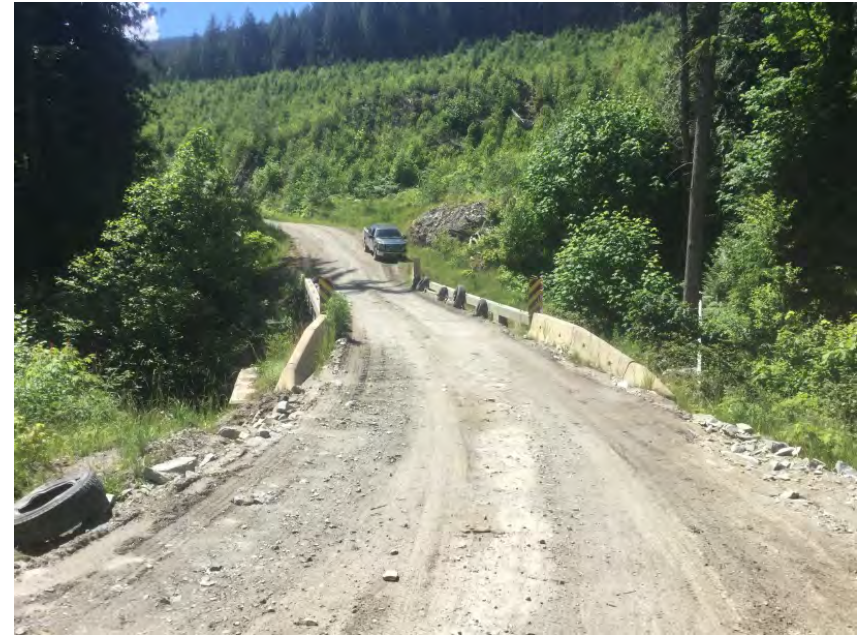
Approach from Left Bank when facing downstream

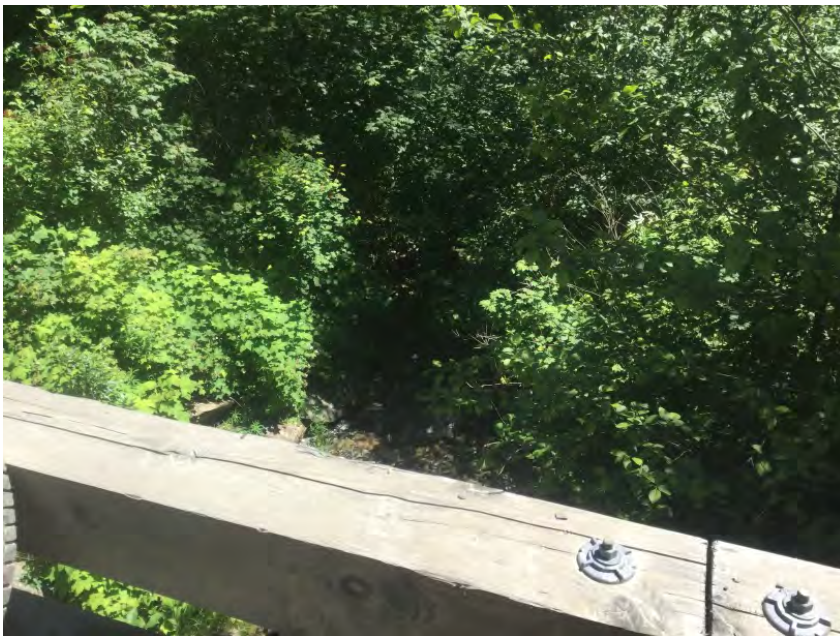
Downstream from Crossing

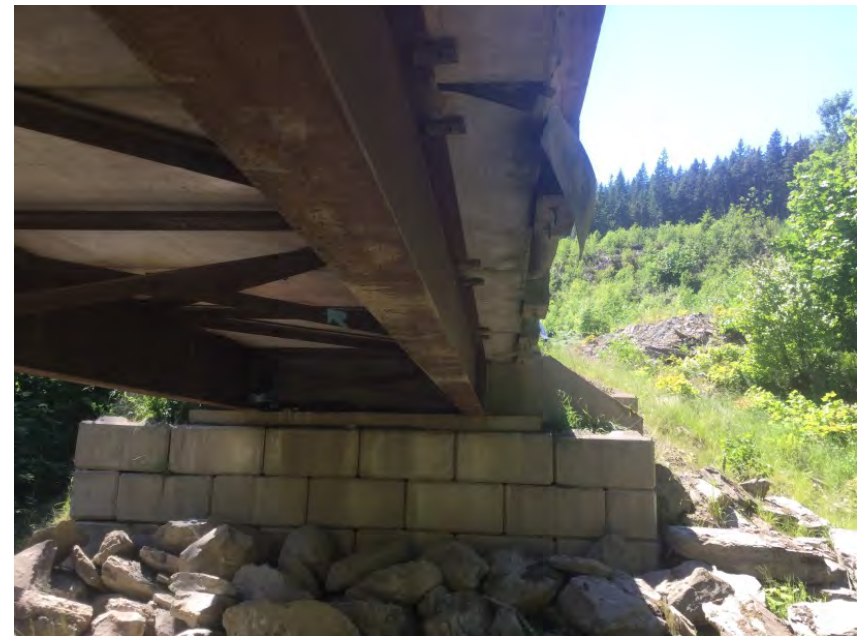
Deck clips

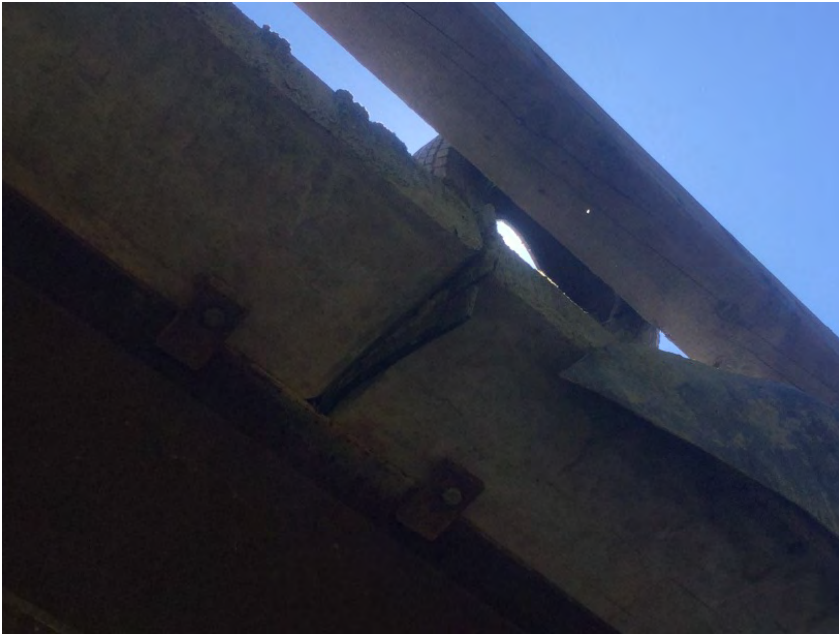
Deck seals failing

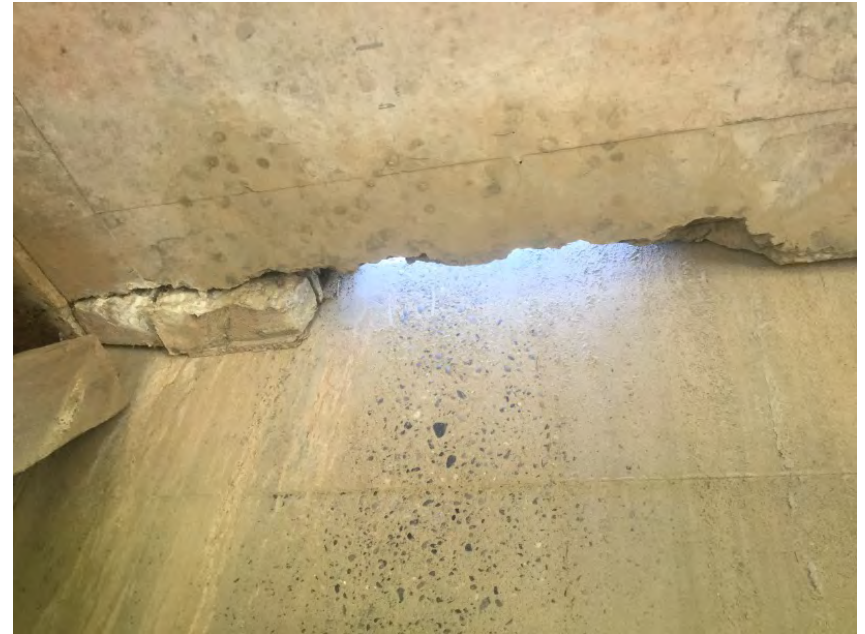
Damage to panel 1 right bank

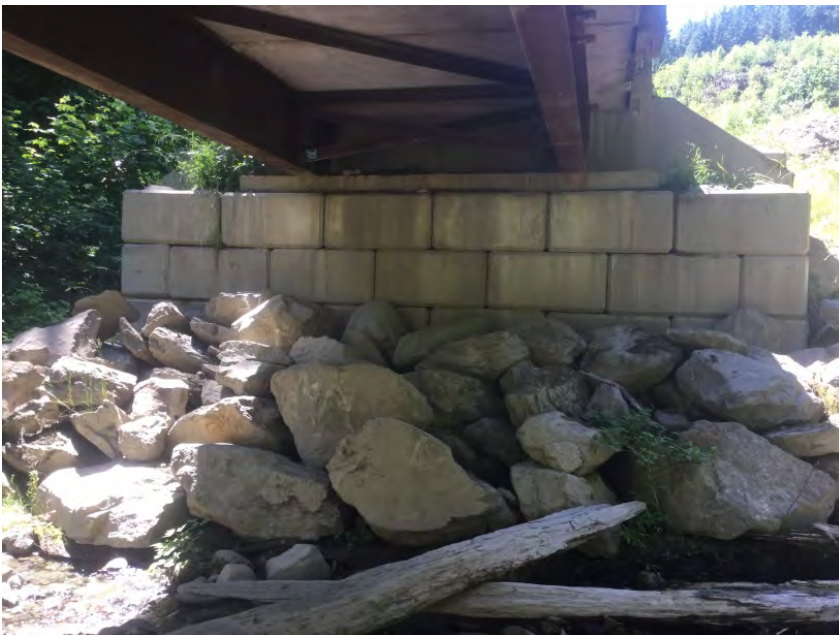
Right Bank Abutment when facing downstream

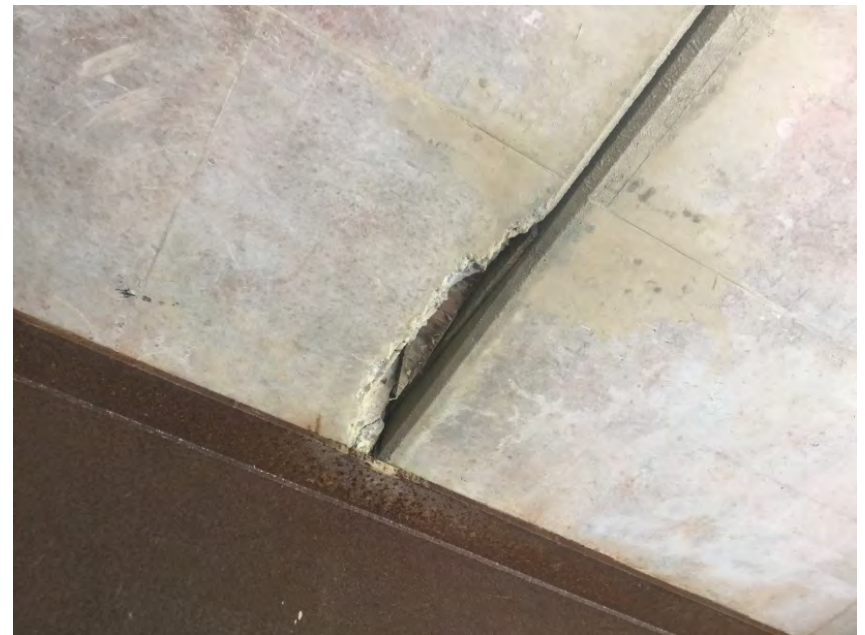
Damage to panel 1 right bank
