CK-2532

Nicklemine 7.2km

2018 Inspection

2 x 1200mm heavy gauge smooth wall steel pipes - modified ford

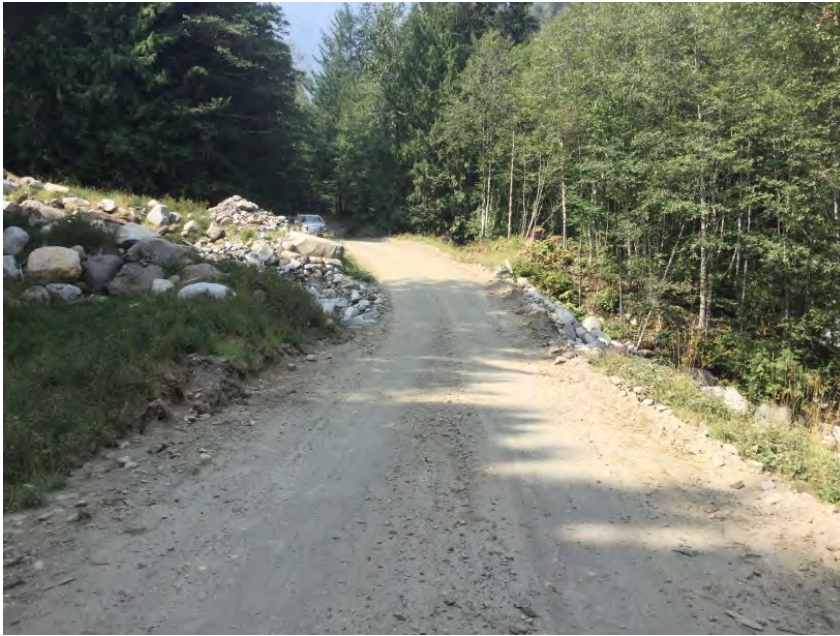
Approach from Right Bank when facing downstream

Heavy VC right approach limits visibility

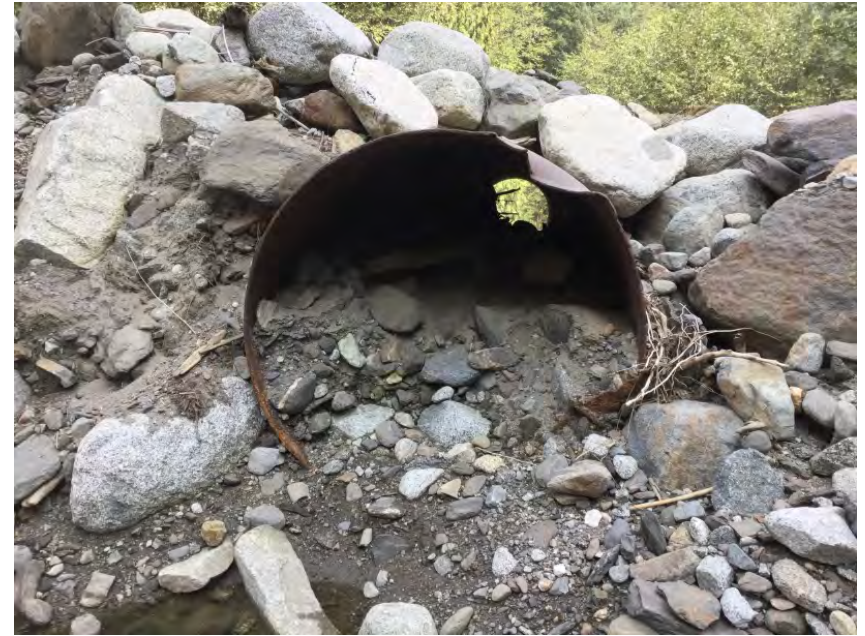
| Inlet | Fair | 1 culvert 50% plugged |

Right culvert 50% plugged

Monitor bedload accumulations at the inlet and surfacing material following heavy rainfall or rain on snow events. The current load rating of L100 or 91 tonnes to continue.

| Item | Monitor Description | Frequency |
|---|---|---|
| 1 | Bedload at inlet and surfacing material | Annually |
