CK-2533

DEWDNEY 6000 km

2018 Inspection

| Road Name | DEWDNEY 6000 | | |

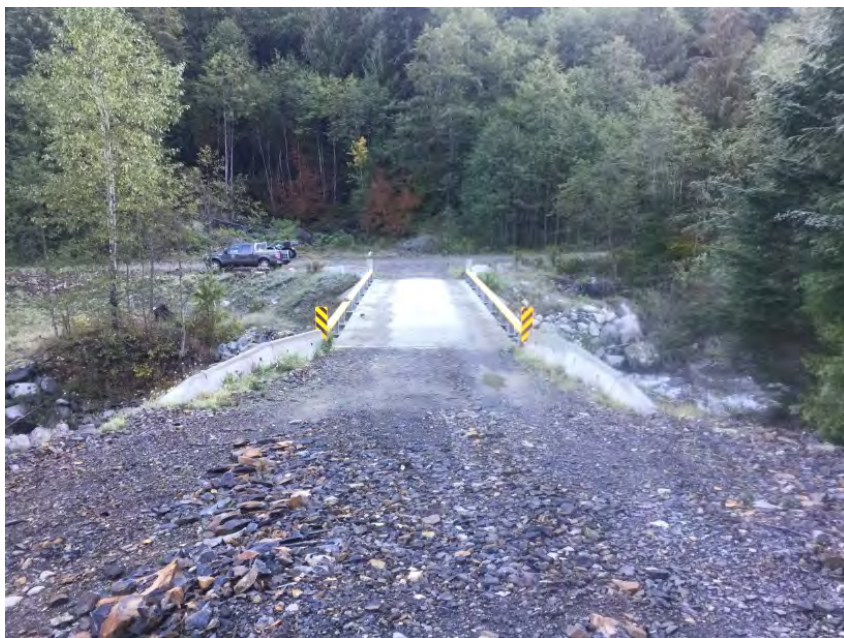
Bridge Ahead Signs  
Missing ☐ 0 ☒ 1 ☐ 2

Approach from Left Bank when facing downstream

| 2 | Low | Post bridge ahead sign at left approach |

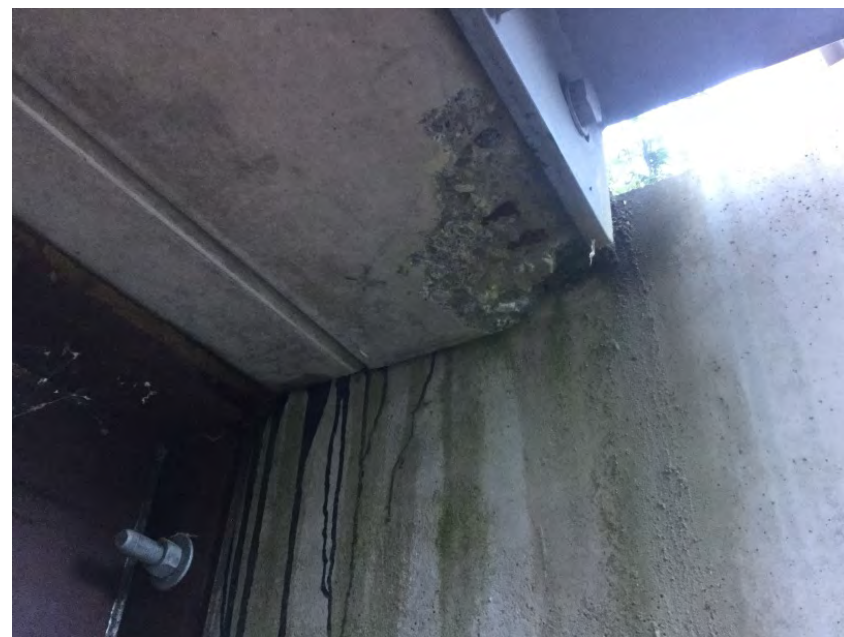
Damage under panel 1 at downstream left bank

Repair damage to panel 1 at downstream left approach consistent with the Concrete Repair Guide for Concrete Bridge Components (MFLNRO 2017) and post missing bridge ahead sign. Present load rating of L100 or 91 tonnes to continue.

| Item | Priority | Repair Description |
|---|---|---|
| 1 | Low | Repair damage to deck panel 1 at downstream left approach |
