CK-2536

STULKAWHITS CK ONE km

2018 Inspection

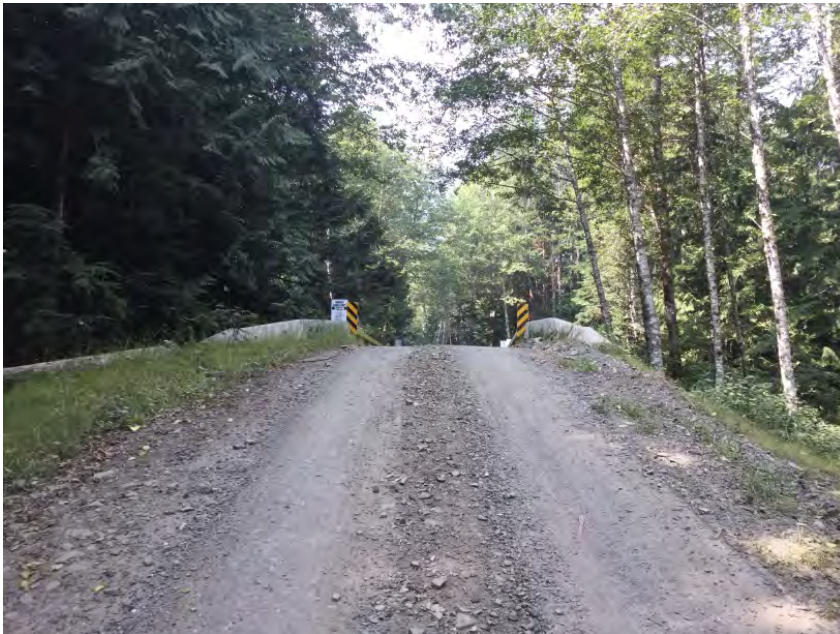
Approach from Right Bank when facing downstream

Heavy VC on right approach limits visibility
