CK-2547

EIGHT MILE 6.0 km

2018 Inspection

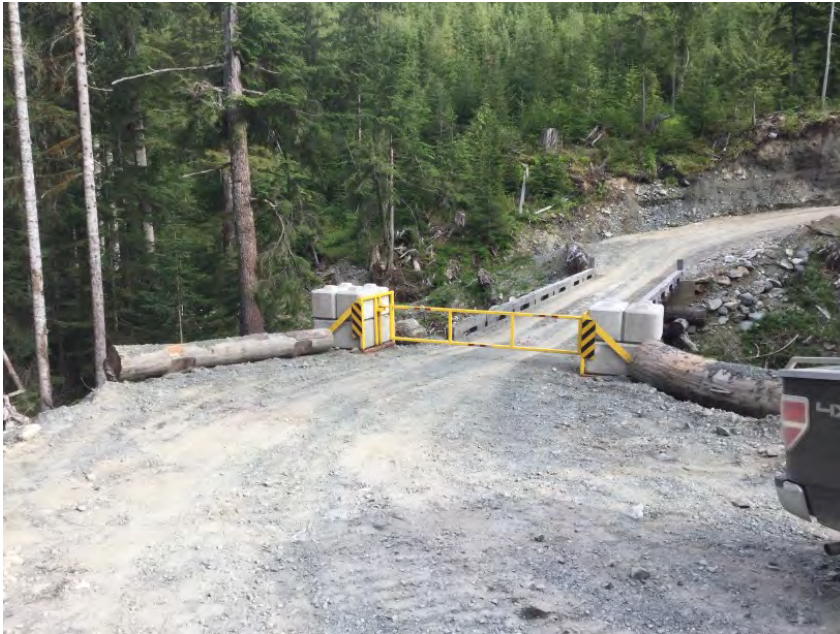
Approach from Left Bank when facing downstream

Alignment Poor

HC and VC both approaches, with 16% adverse

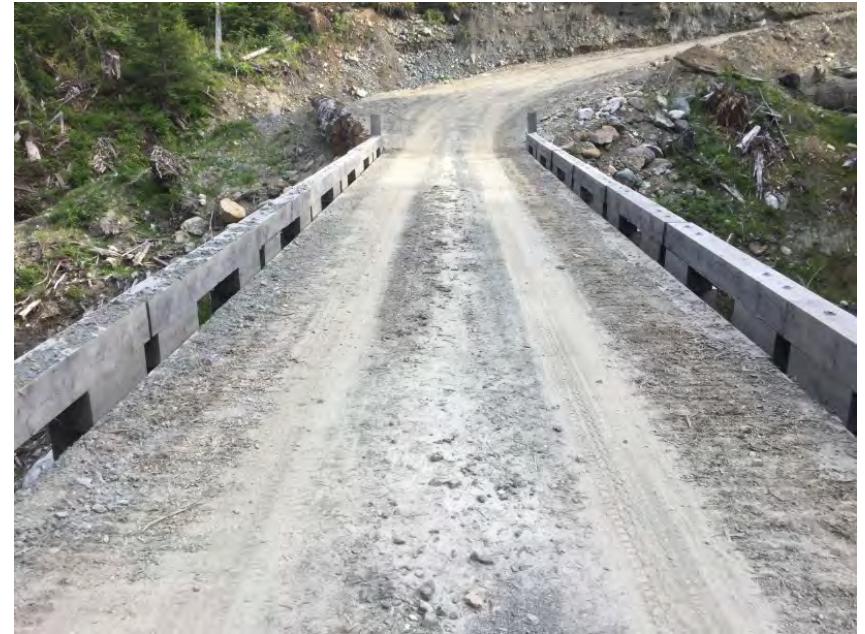
Overall Deck Condition      **Good**

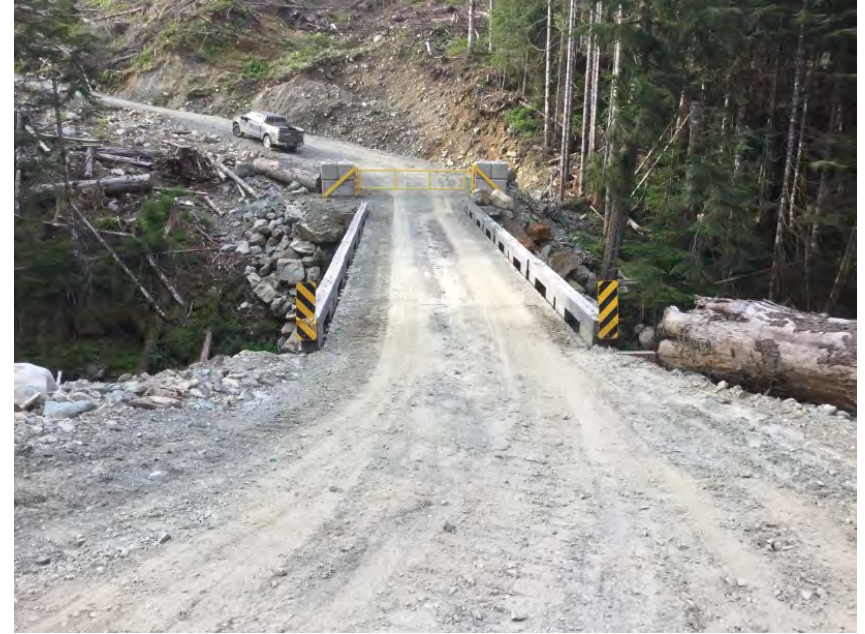
Approach from Right Bank when facing downstream

Missing upstream right fender

| Repair Item | Priority | Repair Description |
|---|---|---|
| 1 | Medium | Replace missing fender log |

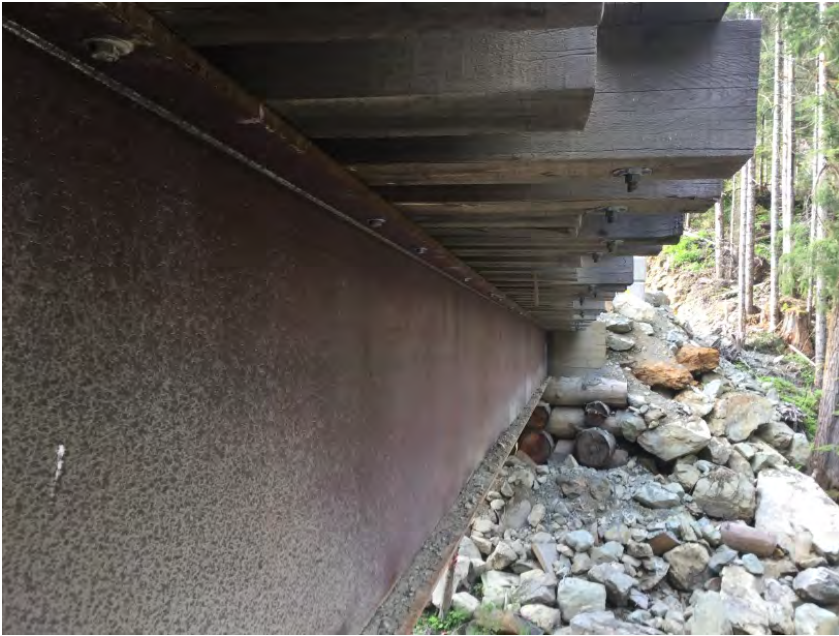
Deck panels bolted to ties

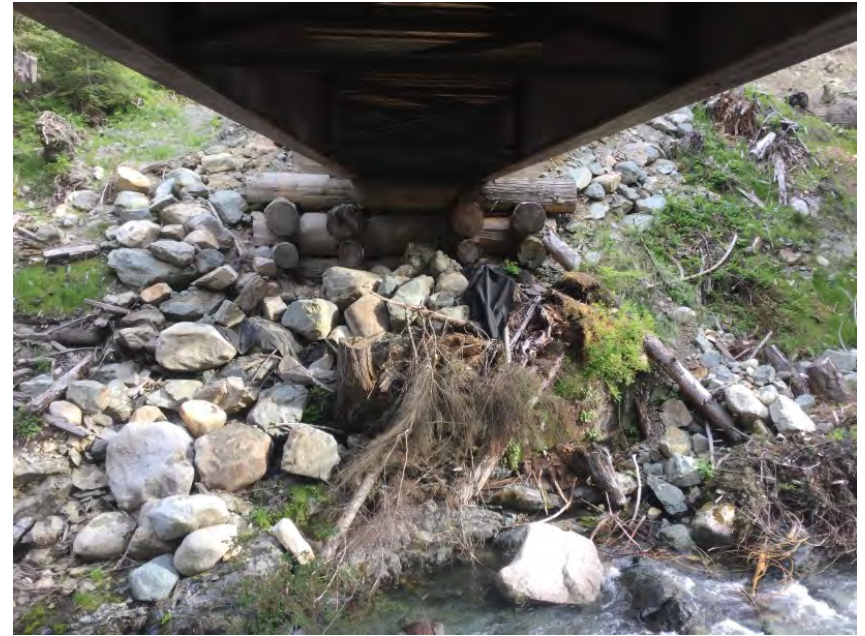
Right Bank Abutment when facing downstream

3x, Fd face logs with Cw top log on the right bank

Over steepened in locations

Does not result in a well keyed in rock mass. Round rocks with voids between individual pieces have been used and therefore monitoring is recommended

| Item | Monitor Description | Frequency |
|---|---|---|
| 2 | Fill and riprap condition | Routine inspection |

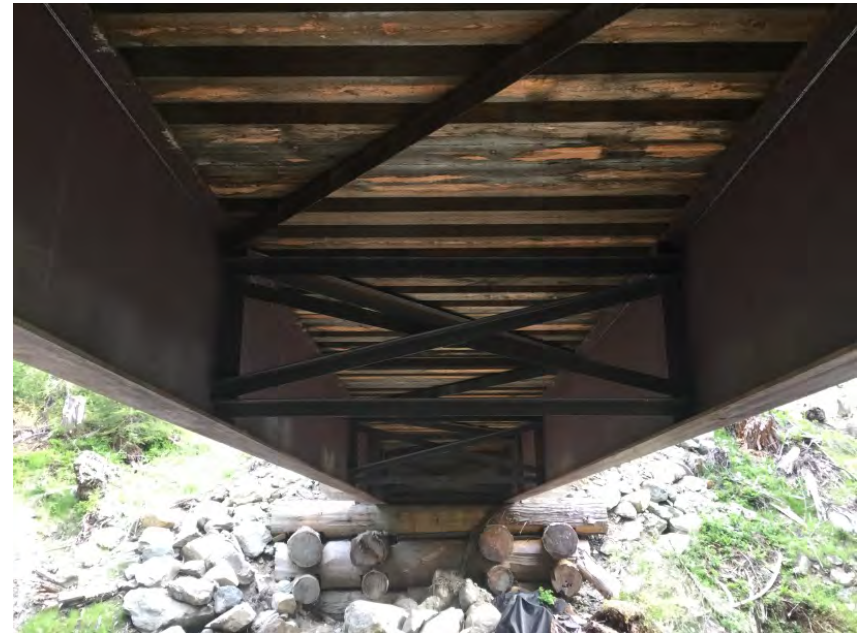
Superstructure

Girders Good

Diaphragms Good 4 welded bays
