CK-2550

PURCELL km

2019 Inspection

| Structure Class | Major Culvert | | |

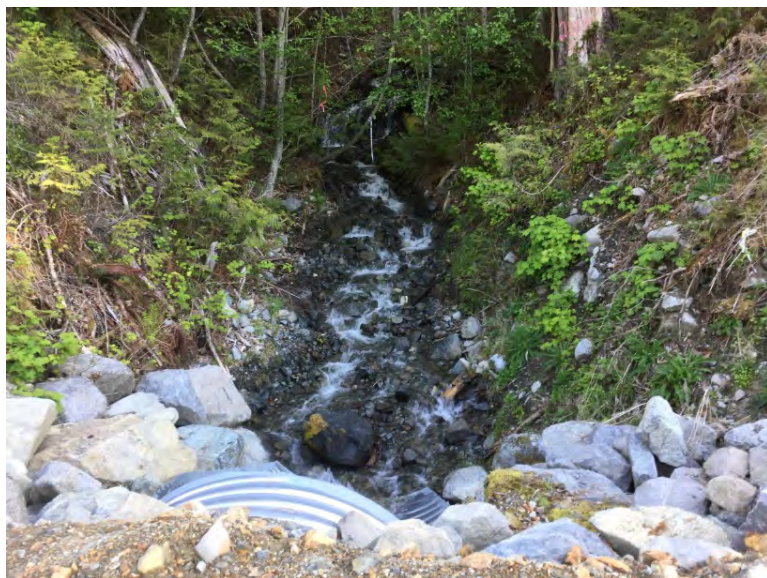
Upstream from Crossing

Minor material deposition is starting to occur, along with debris accumulations noted upstream.

| Item | Monitor Description | Frequency |
|---|---|---|
| 2 | Inlet debris accumulations and aggradation | Routine Inspection |

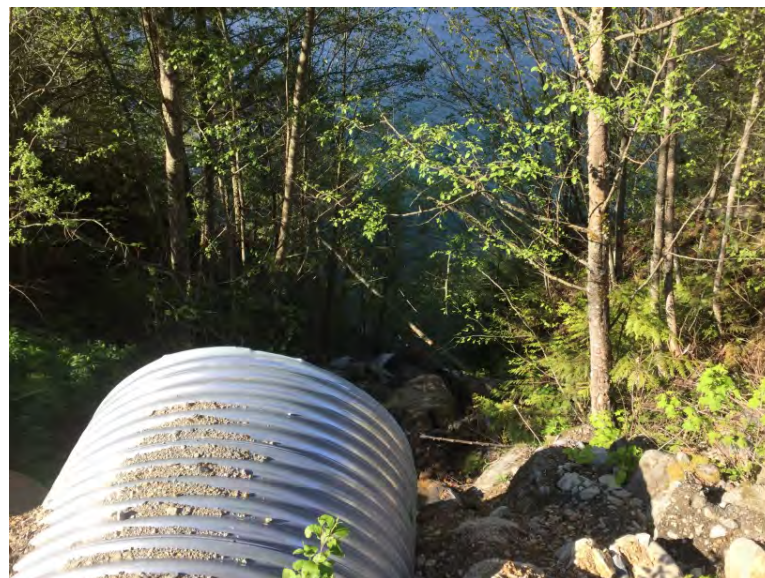
Downstream from Crossing

The riprap installed below the culvert intersects with exposed bedrock at an angle of 1.25:1. The long term stability of this riprap requires monitoring.

| Item | Monitor Description | Frequency |
|---|---|---|
| 1 | Riprap stability located downstream of the culvert | Routine Inspection |

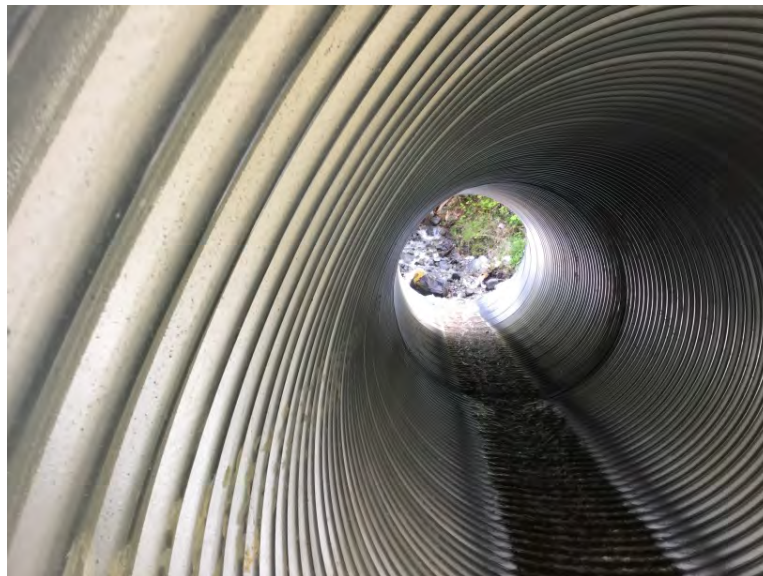
The 2 culvert lengths are slightly misaligned at coupler location

Culvert slightly misaligned at coupled location
