CK-2551

PURCELL km

2019 Inspection

Structure Class Temporary Bridge

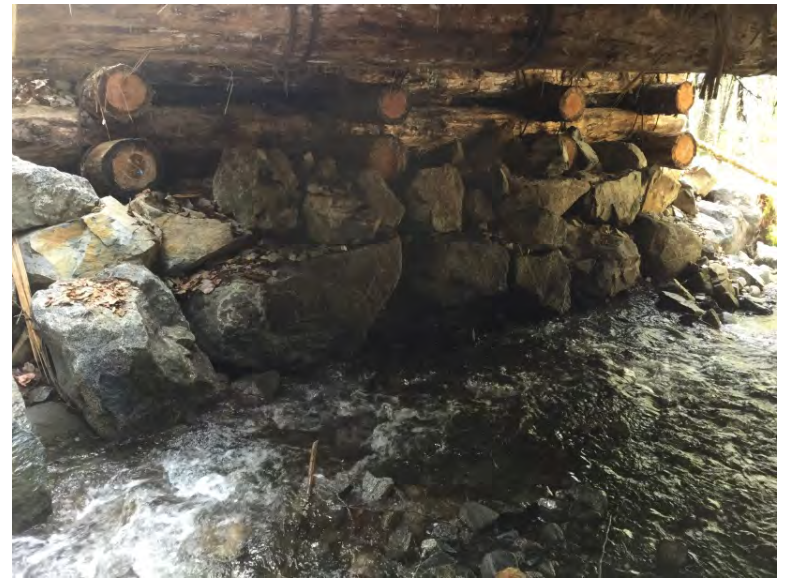
Left Bank Abutment when facing downstream

3x open face left bank

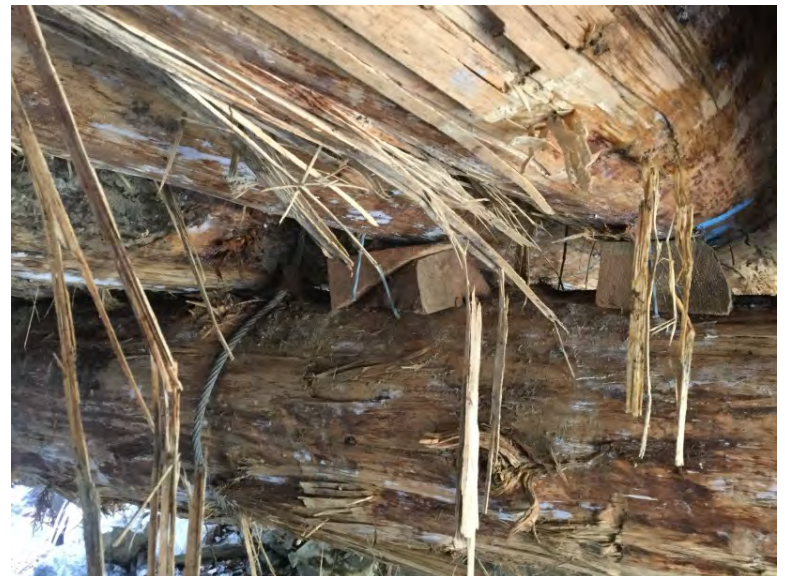
Replace/add hardware to all signs. Monitor the condition of the riprap as it's steep at 1:1 slope. The timber shims that have been placed between the needle beam and stringers are loose and ineffective. Limit loading to BCL-625 or 64 tonnes and post load rating signs.

Poor shims

In order to increase the load limit to L100 or 91 tonnes I recommend adding 100mm gravel fill to the deck (ensure 600mm total depth); replace/add proper shims to ensure the needle beam is sufficiently tight to ALL stringers; and secure a 600mm diameter guard log (full length) to the downstream side of the bridge, located inside of the existing one, to restrict traffic off stringer #12.

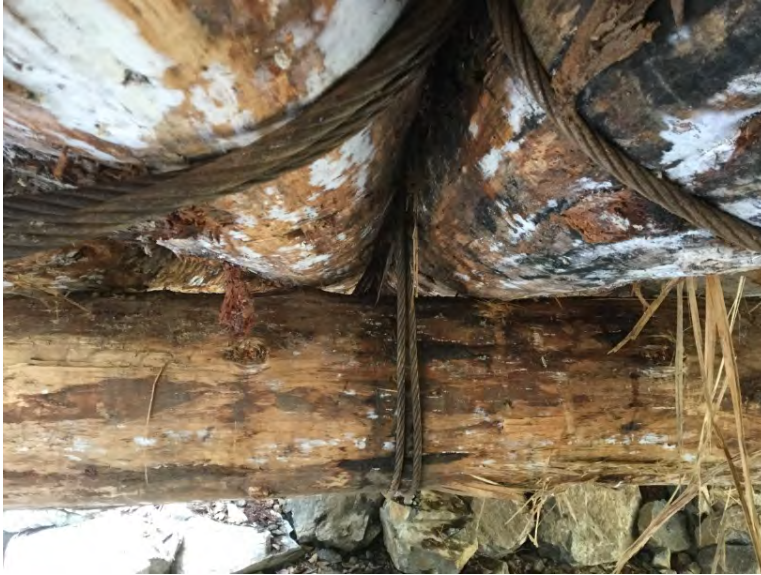
8.0m span upstream  
 8.1m span downstream  
 Riprap at 1:1 slope  
 Timber shims between needle beam and stringers not sufficiently tight  
 Add hardware to all signs

Needle beam not sufficiently tight to stringers

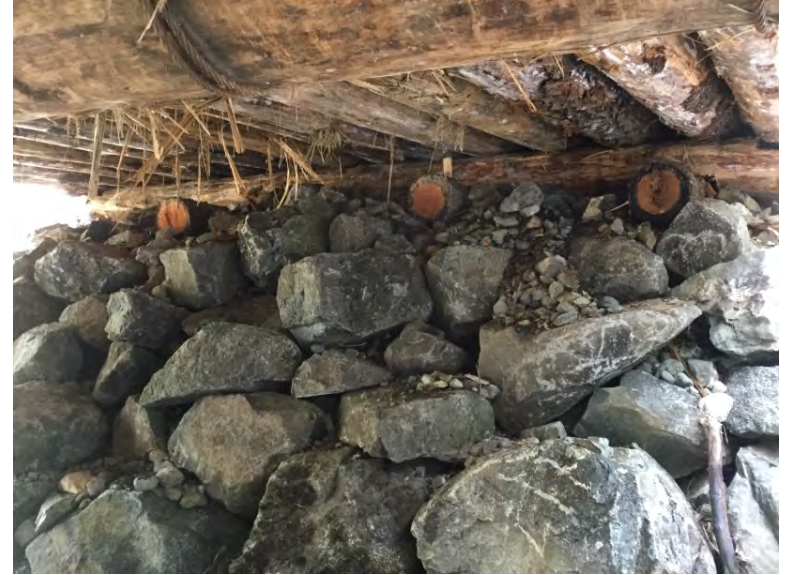
Right Bank Abutment when facing downstream

Single log right bank
