CK-2552

PURCELL km

2019 Inspection

Structure Class Temporary Bridge

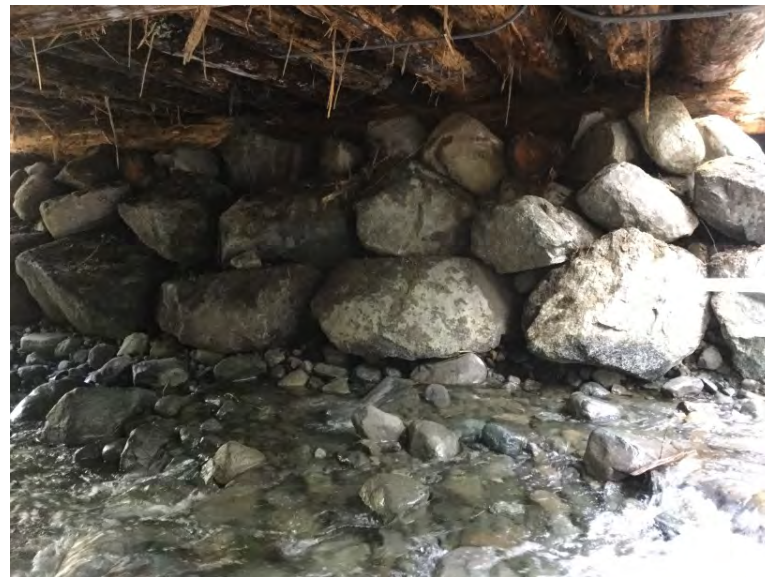
Right Bank Abutment when facing downstream

Riprap Good Steep at 1:1

| Item | Monitor Description | Frequency |
|---|---|---|
| 1 | Riprap condition | Routine Inspection |

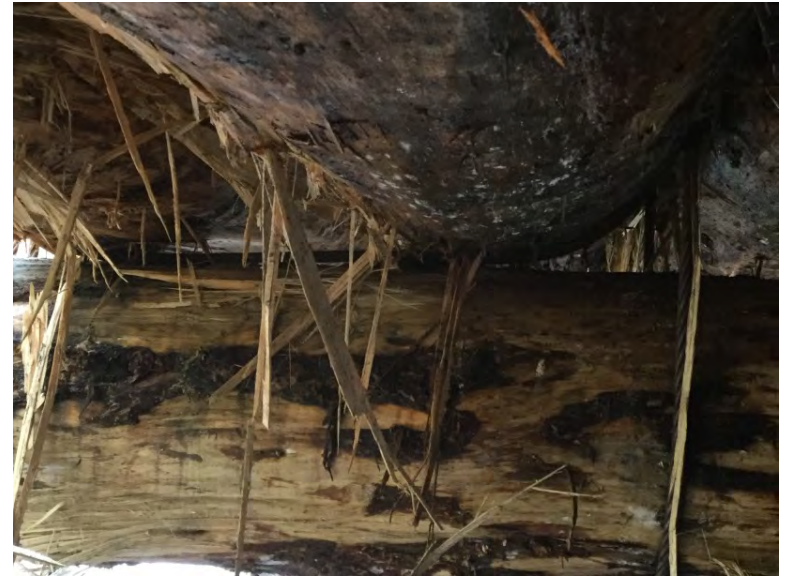
Replace/add hardware to all signs. Monitor the condition of the riprap as it's steep at 1:1 slope. The timber shims that have been placed between the needle beam and stringers are loose and ineffective. Limit loading to L75 or 68 tonnes and post load rating signs.  
 In order to increase the load limit to L100 I recommend adding 200mm gravel fill to the deck (ensure 600mm total depth); and replace/add proper shims so that the needle beam is sufficiently tight to ALL stringers.

Needle beam not tight to stringers or structural guard log

8.4m span  
 needle beam not tight to stringers or structural guard log at upstream or downstream  
 Look to add gravel fill and/or add adequate shims to stringer/needle beam interface  
 Add hardware to signs

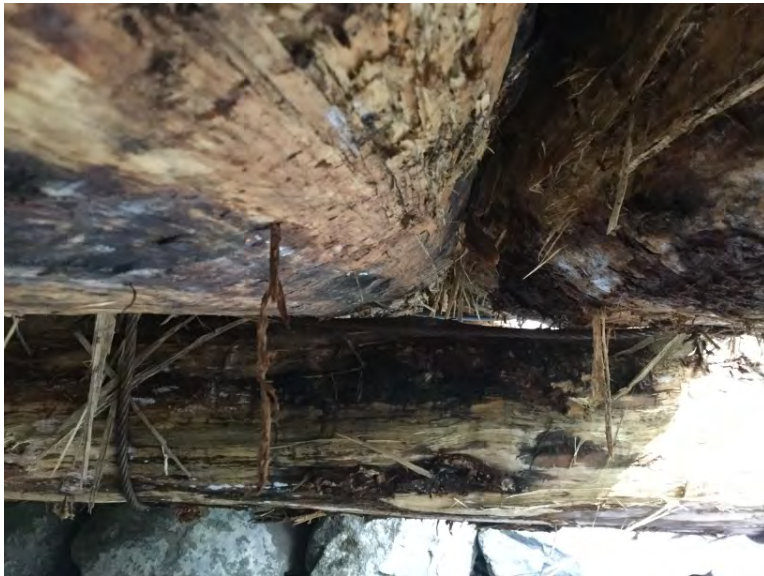
Needle beam not tight to stringers or structural guard log
