CK-2553

Stave River 1.1km

2018 Inspection

4 - 600mm heavy guage smooth wall culverts

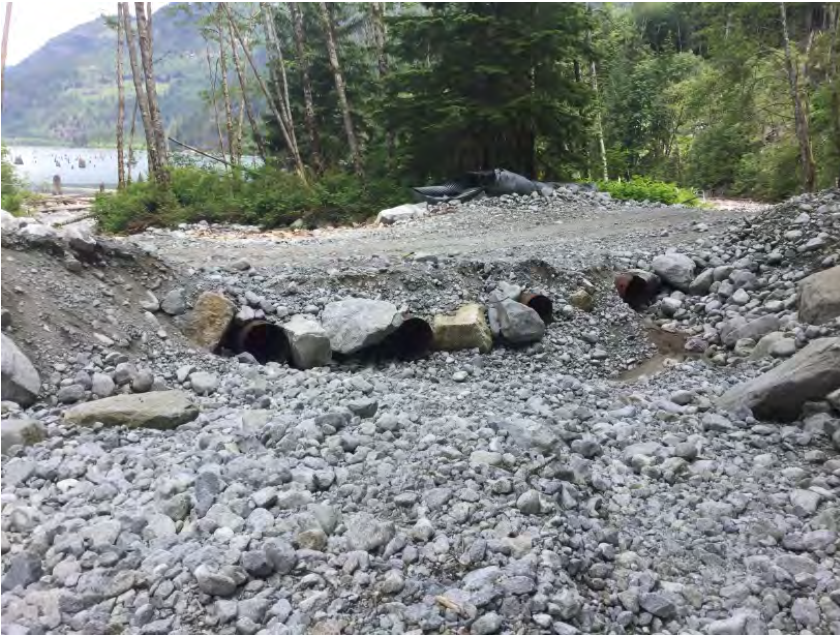
Inlet Fair Aggrading

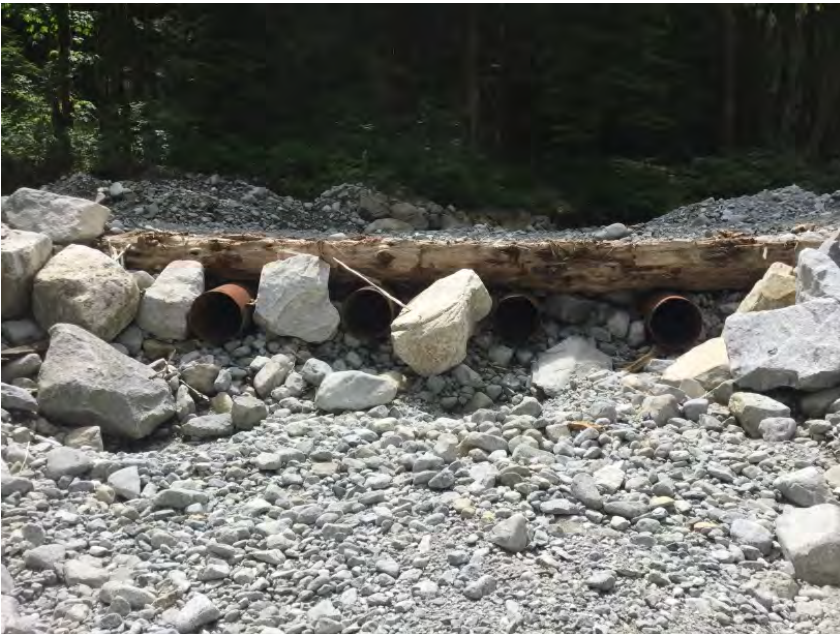
Outlet Fair
