CK-2554

Stave River 32.0km

2018 Inspection

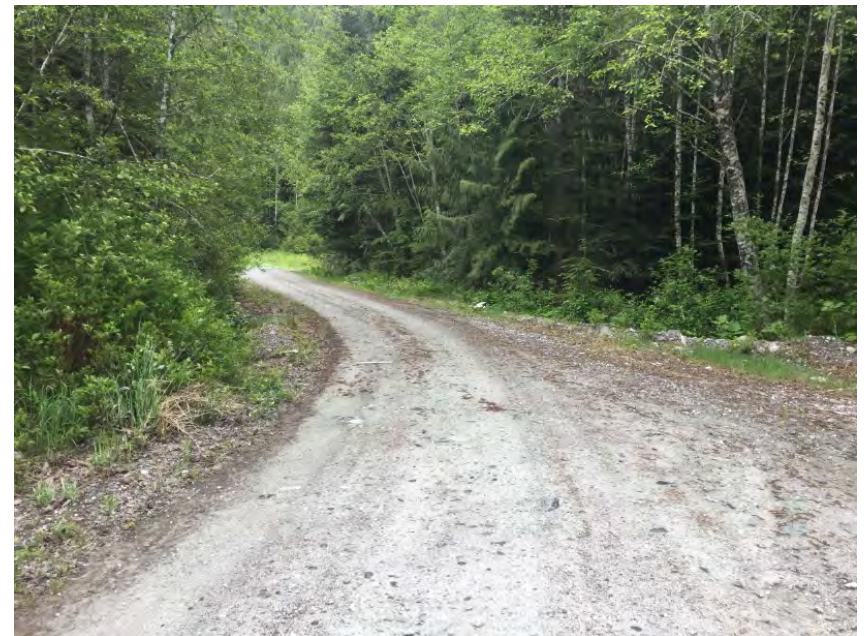
Approach from Right Bank when facing downstream

HC right approach

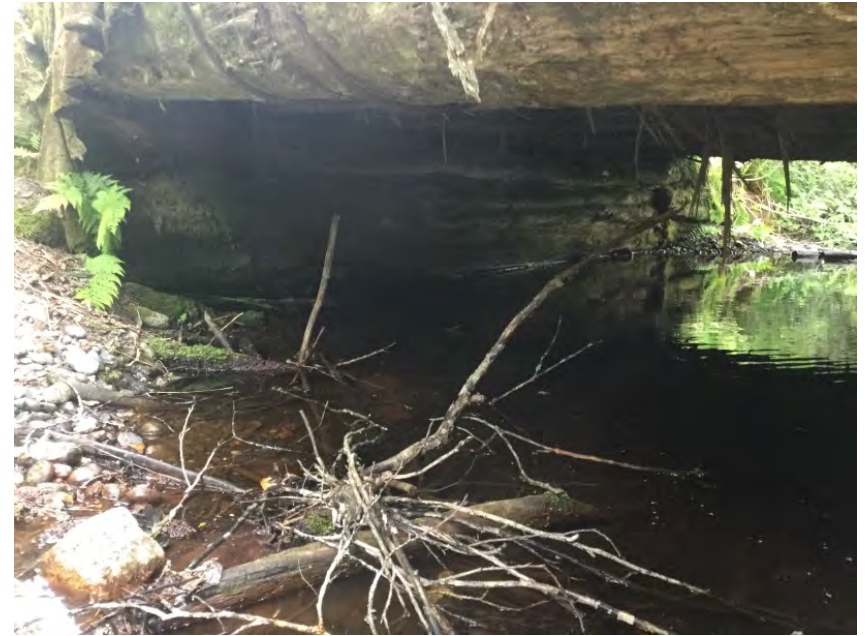
Left Bank Abutment when facing downstream

Large diameter single sills
