CK-2005

ANDERSON 2.7km

2019 Inspection

| Structure Class | Major Culvert |

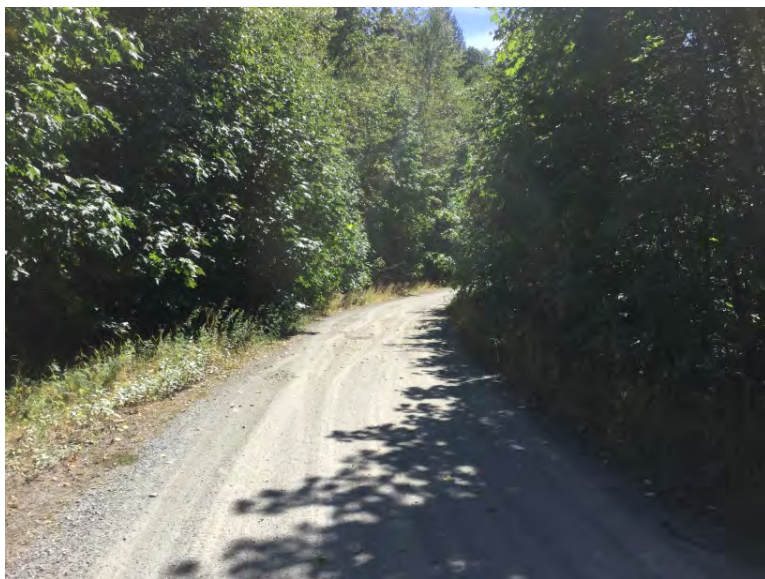
Approach from Right Bank when facing downstream

Brush approaches to improve vehicle sight lines. The current load rating of BCL-625 or 64 tonnes to continue.

| Item | Priority | Repair Description |
|---|---|---|
| 1 | Low | Brush approaches |

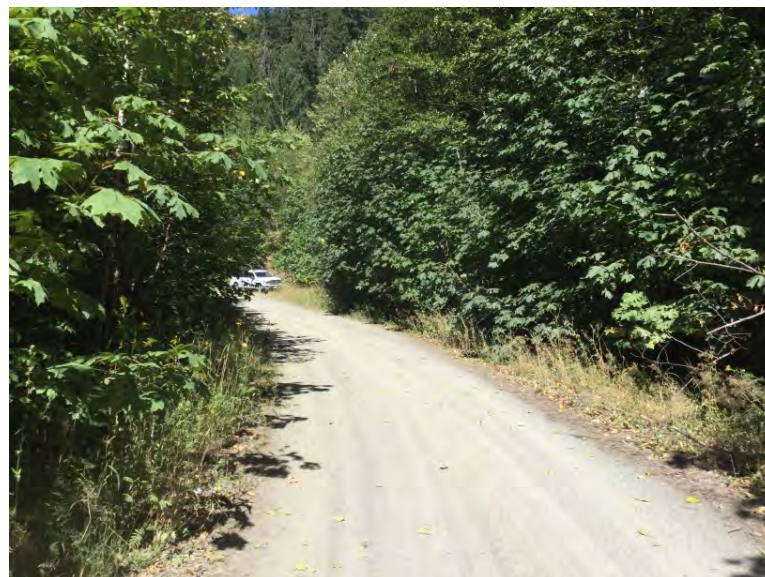
Approach from Left Bank when facing downstream

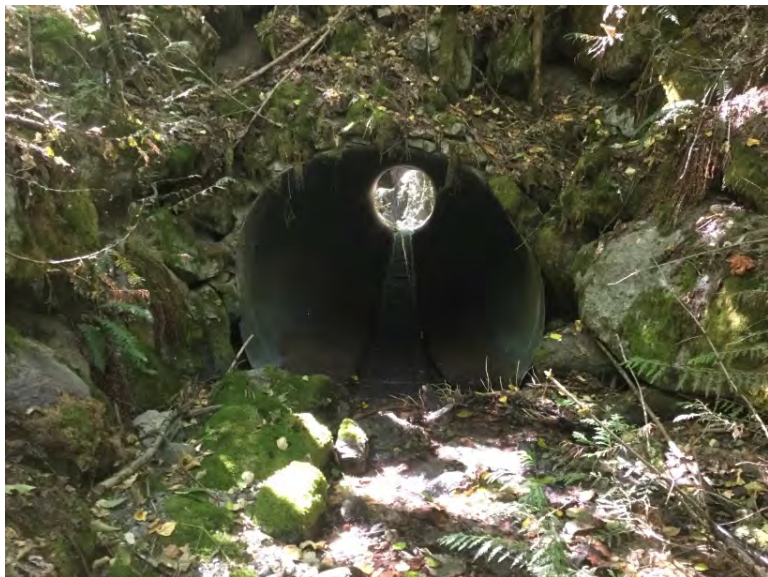
Inlet

Slight erosion at both inlet and outlet

Material aggrading into inlet and rock stacked steep

| Item | Monitor Description | Frequency |
|---|---|---|
| 1 | Monitor erosion at both the inlet and outlet | Routine Inspection |
| 2 | Monitor the aggradation at the inlet | Routine Inspection |

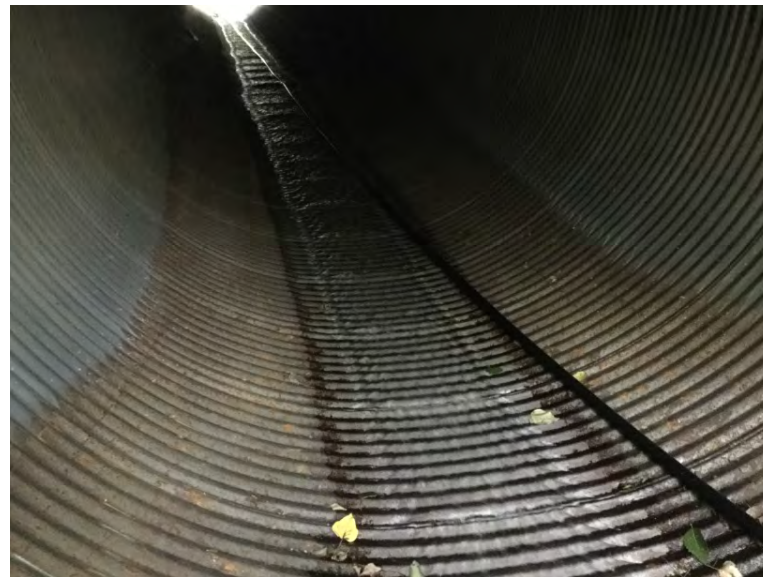
Water line thru pipe

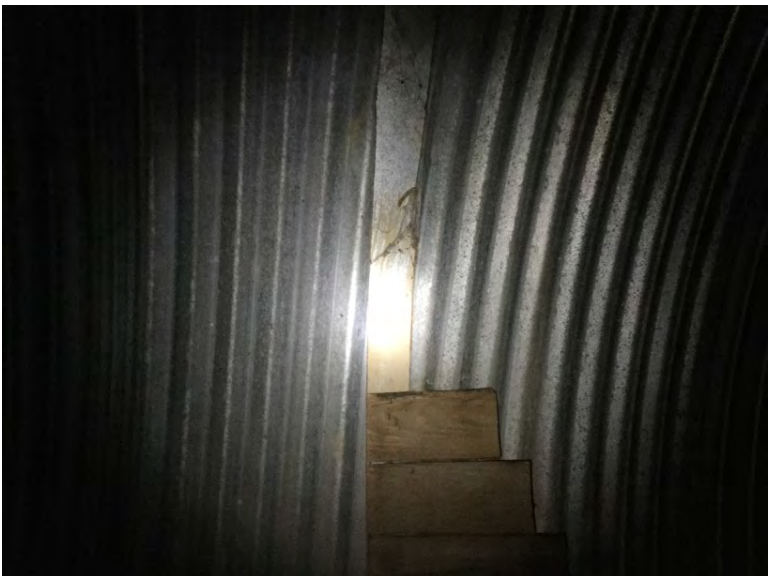
Coupler

Timber shims, tight

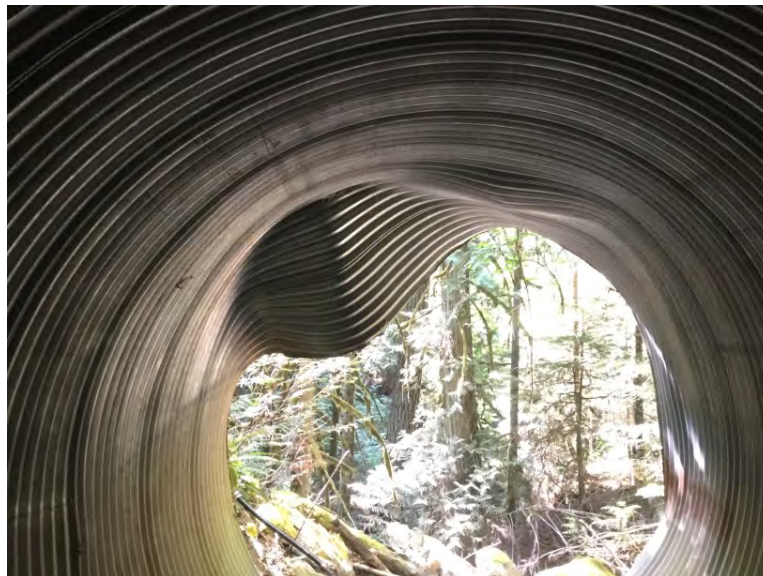
Damage noted to over steepened fill but still functional

Damage at outlet

Damage to outlet
