CK-2012

BLUE MOUNTAIN 300 0.8km

2019 Inspection

| Crossing Name | McFadden Creek | | |

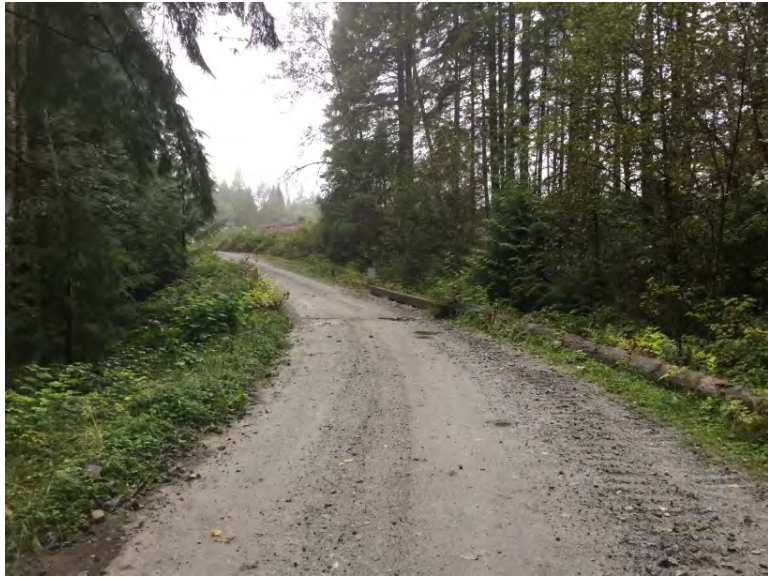
Approach from Left Bank when facing downstream

Delineator Missing  
 Left ☐ 0 ☒ 1 ☐ 2

Fender Condition Poor

Old logs, too low

| 1 | Medium | Replace fender logs |
| 2 | Low | Replace missing delineator |

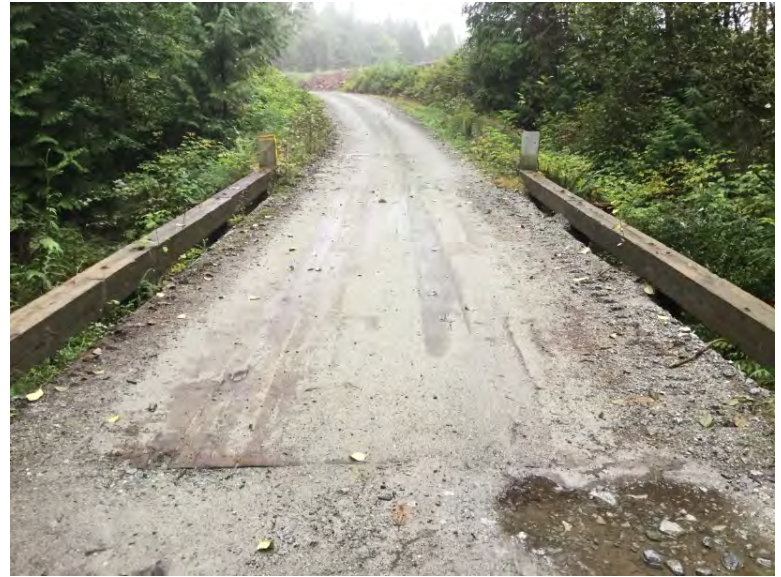
Overall Deck Condition      Good

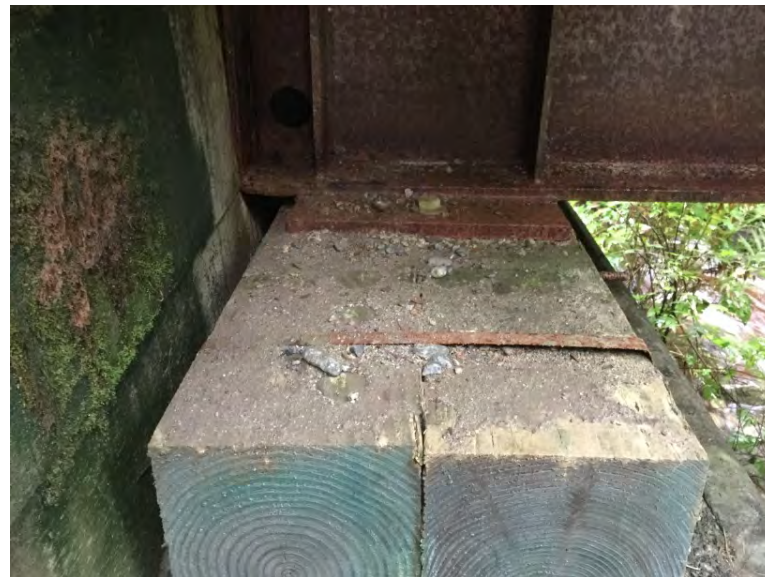
Typical bearing

Bearings Fair

Timber sills shimmed upstream left and downstream right

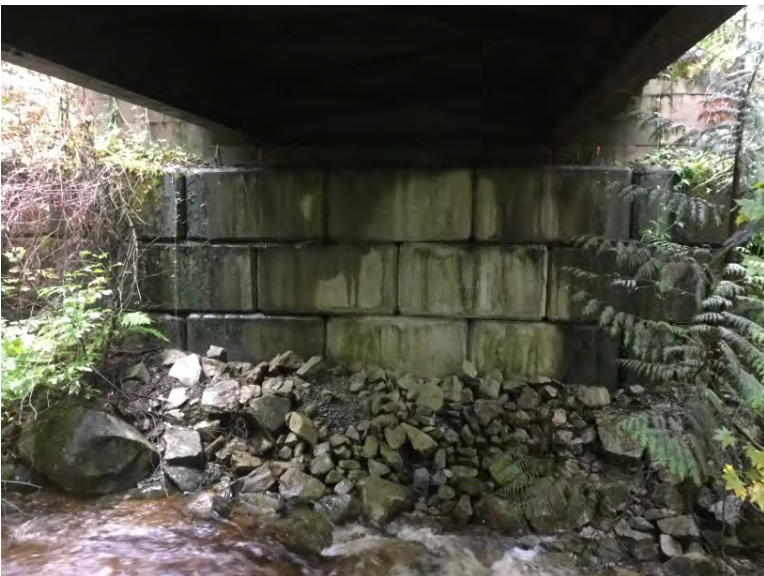
Left Bank Abutment when facing downstream

Concrete Fair

3x Lock blocks both abutments

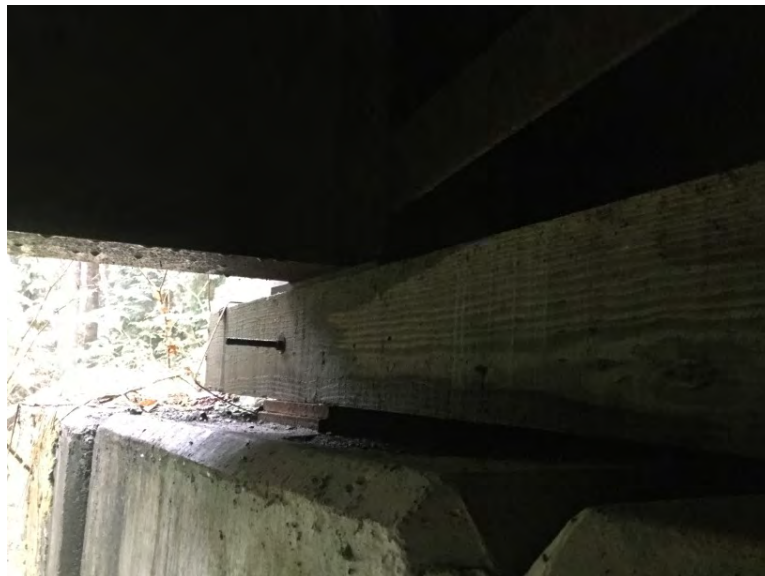
Downstream right bank timber sill shimmed

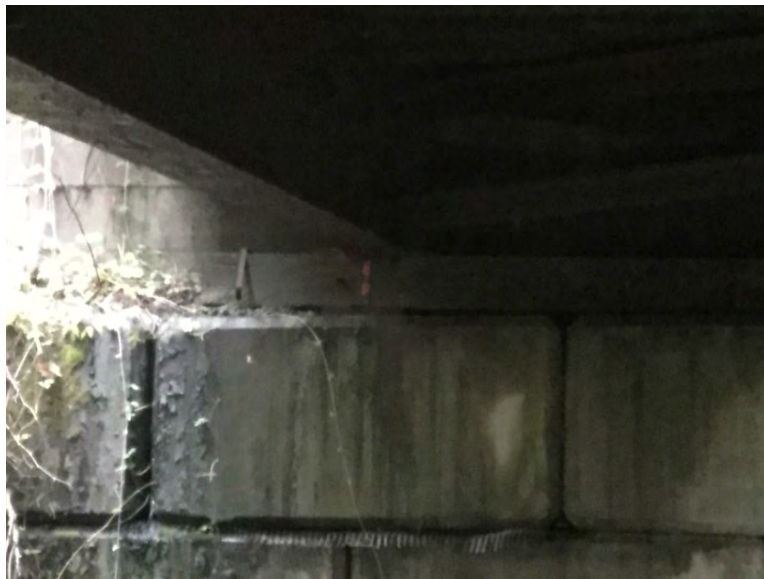
Upstream left bank shimmed

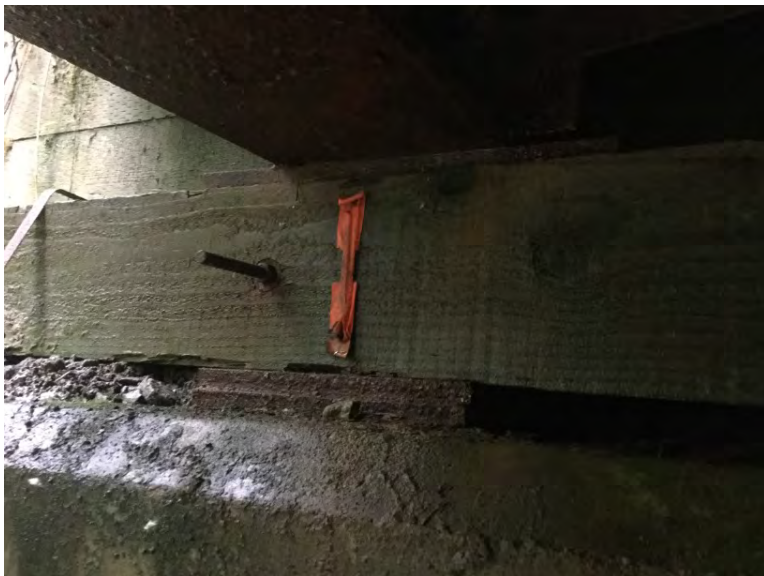
Upstream left bank shim

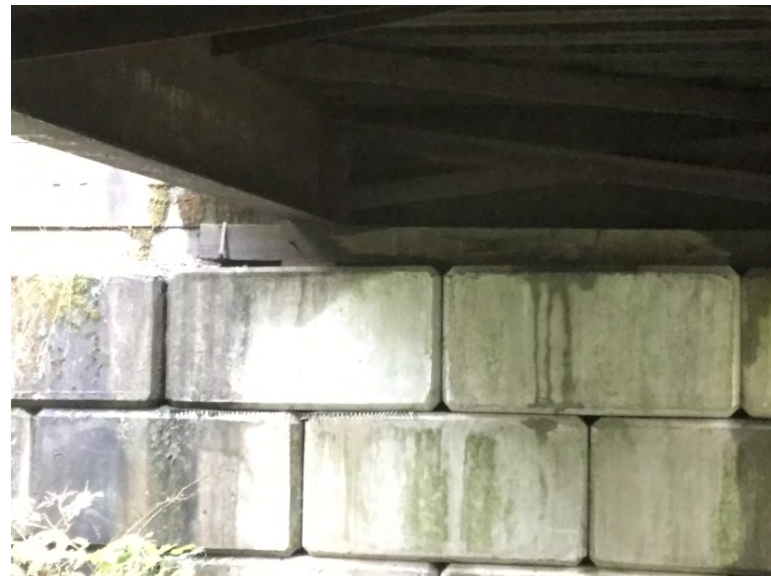
Downstream right bank shim

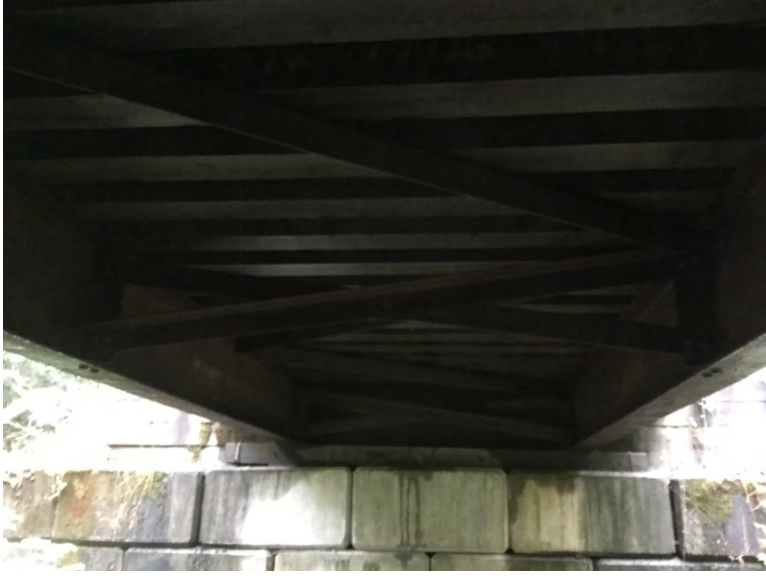
Superstructure

Girders Fair minor corrosion

Bracing Fair minor corrosion
