CK-2019

CAYOOSE 0.1km

2019 Inspection

| Crossing Name | Skagit River | | |

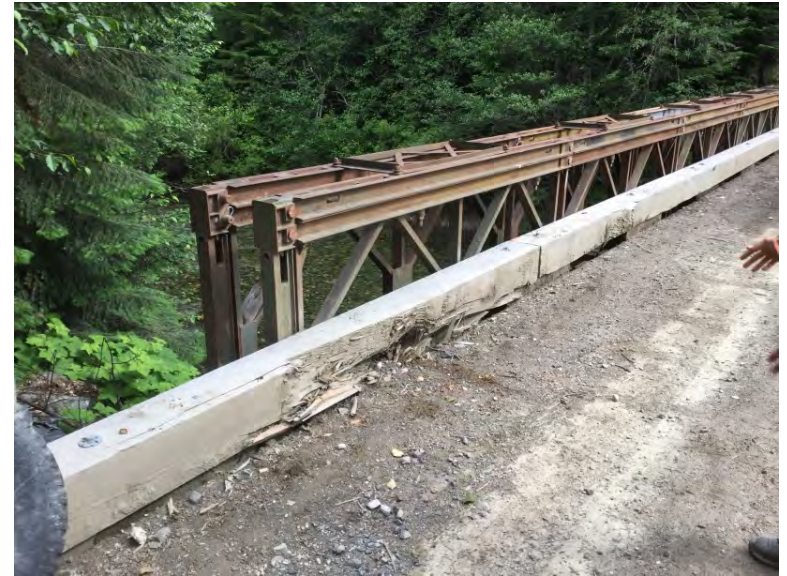
Curb Rail/Blocks/Posts      Fair      Left approach slight damage and missing hardware

Guard Rail damage noted at down stream left approach

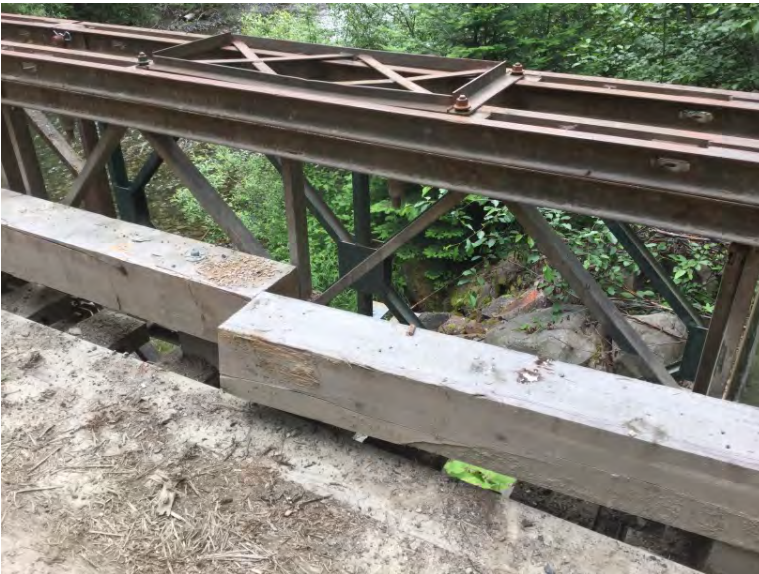
Hardware      Fair      Missing single guardrail bolt

Up stream left approach guard rail missing hardware

| Item | Priority | Repair Description |
|---|---|---|
| 1 | Medium | Replace missing hardware at upstream left approach guardrail |

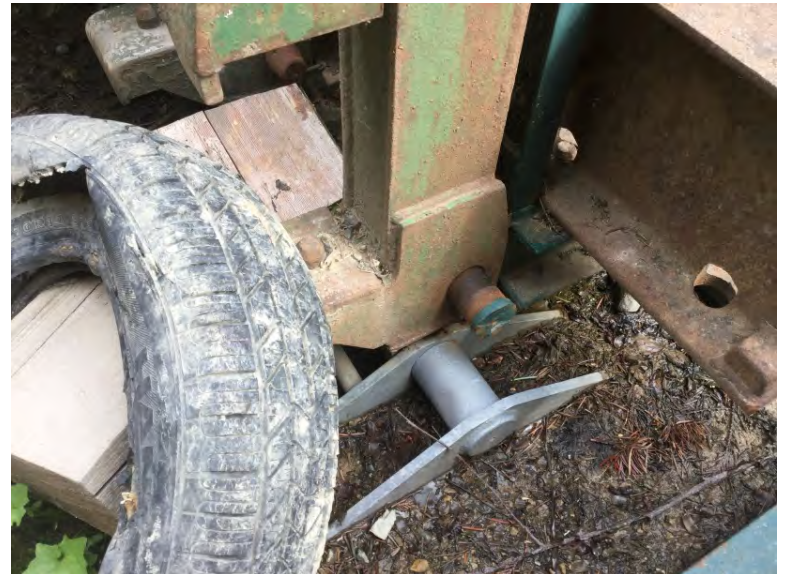
Upstream left approach pin loose

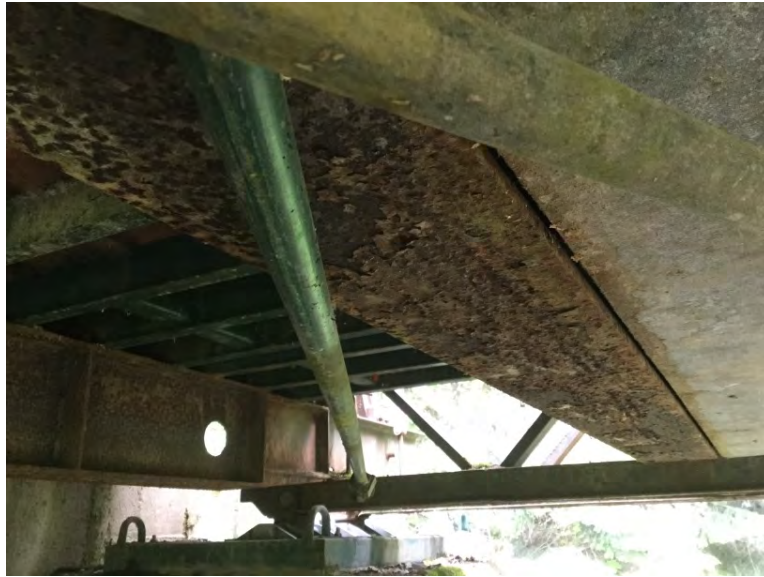
Double single reinforced Acrow/Bailey with corrosion on all components, minor damage noted on some components

Transom corrosion - typical

| Item | Monitor Description | Frequency |
|---|---|---|
| 1 | Steel condition | Routine Inspection |

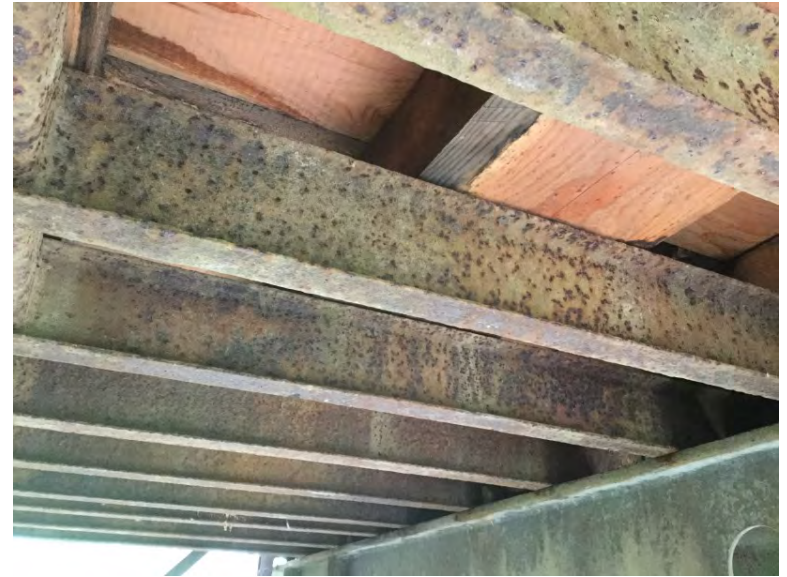
Some swaybracing loose

Bracing condition - typical

| Item | Priority | Repair Description |
|---|---|---|
| 3 | Medium | Replace missing cotter pins, tighten loose swaybraces and transom set bolts/fasteners |

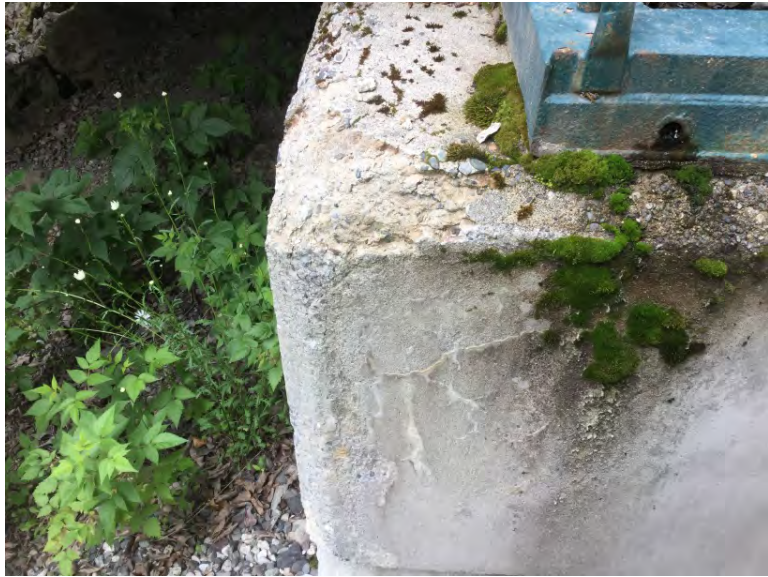
Lock block columns at each corner and spalling

Right upstream lock block spall

| Item | Monitor Description | Frequency |
|---|---|---|
| 2 | Spalling concrete | Routine Inspection |

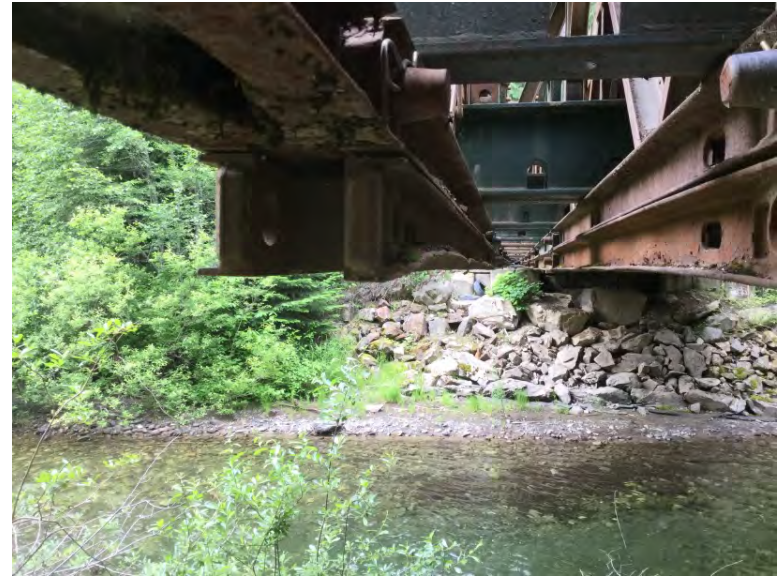
Up stream right bank chord condition

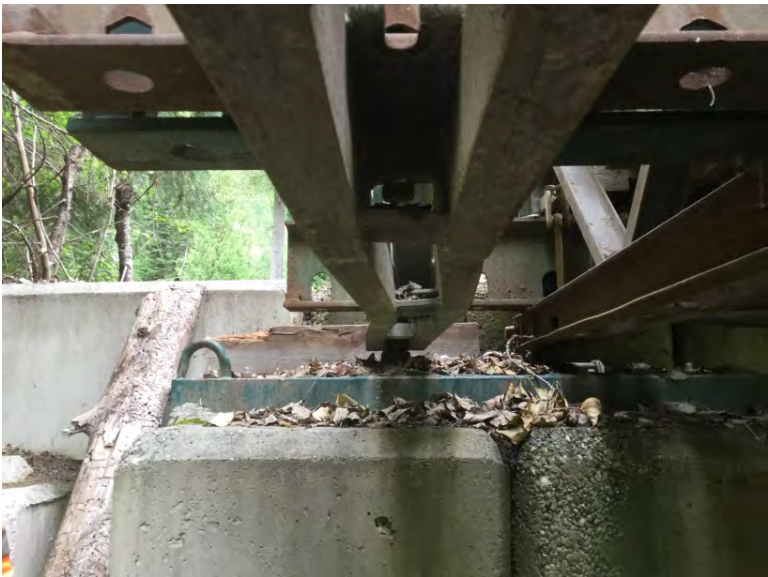
Down stream. Right bank chord condition
