CK-2020

CHEHALIS 6km

2019 Inspection

| Crossing Name | Pretty Creek | | |

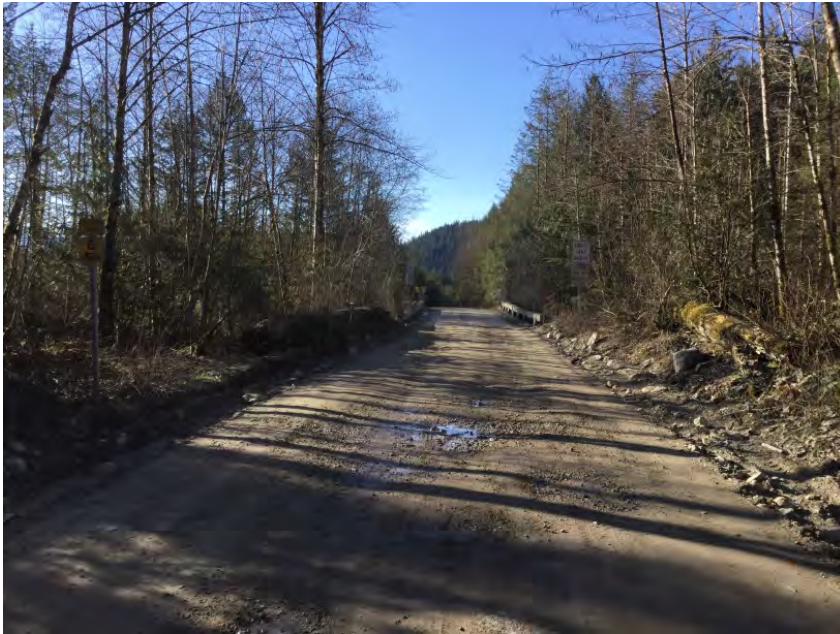
Approach from Left Bank when facing downstream

Road Surface Fair Potholes at approaches

2 Medium Grade approaches

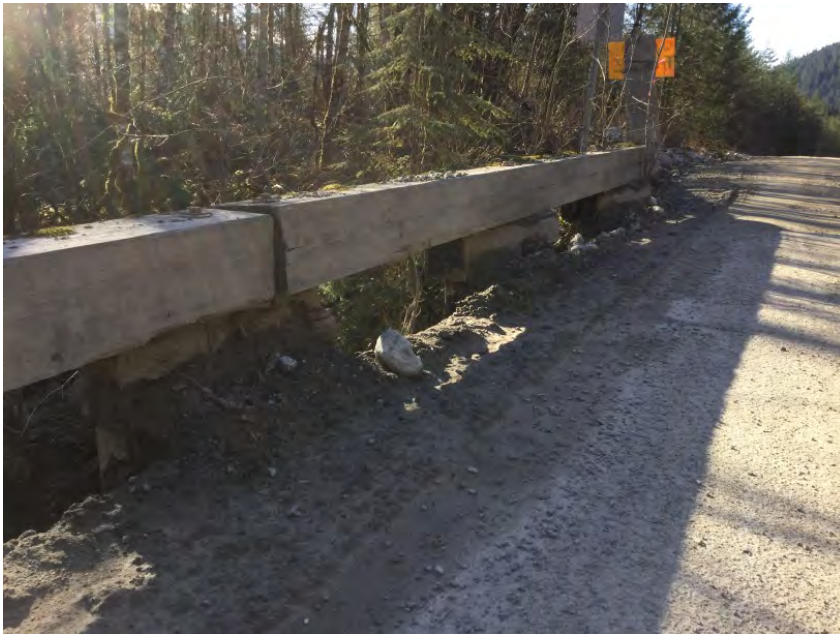
| Curb Rail/Blocks/Posts | Poor | Rotten and loose |

| Hardware | Poor | Loose rail |

| Overall Deck Condition | Poor | Due to rail condition |

Guardrail condition

| Repair Item | Priority | Repair Description |
|---|---|---|
| 1 | Medium | Replace guardrail, risers and blocks |

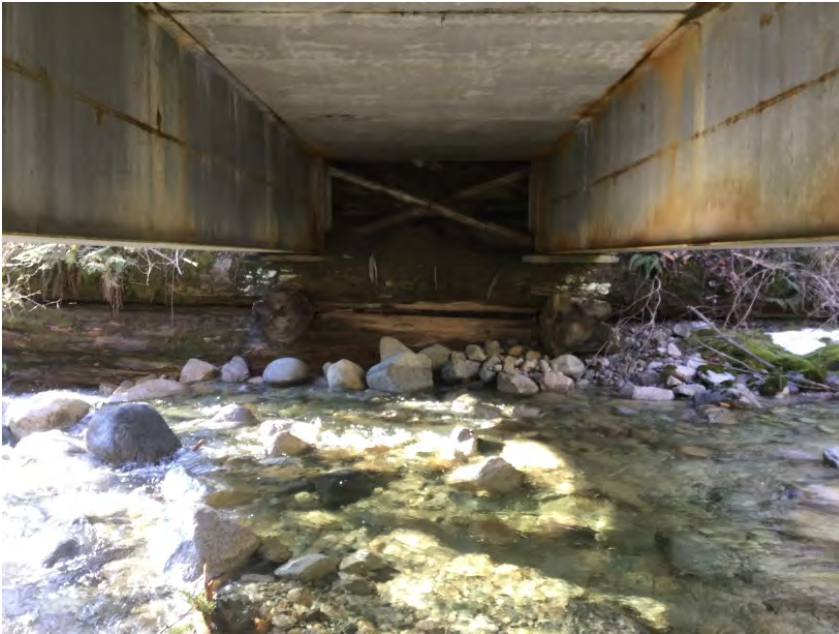
Right Bank Abutment when facing downstream

Log/Timber Cribs Fair 2x, right bank only with up to 40mm sap rot

Tie Backs Fair 2x with up to 40mm sap rot

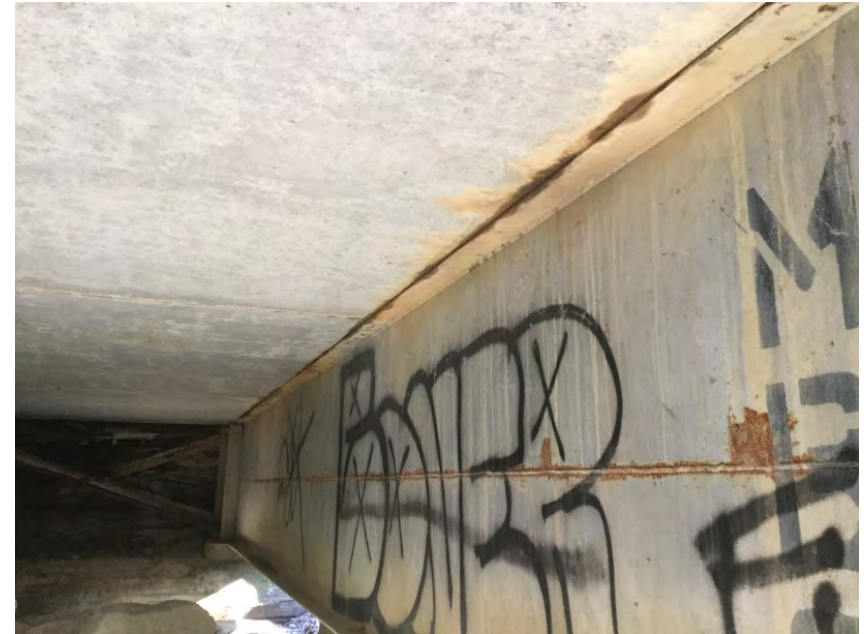
Indication of water leaking through deck joints and grout pockets

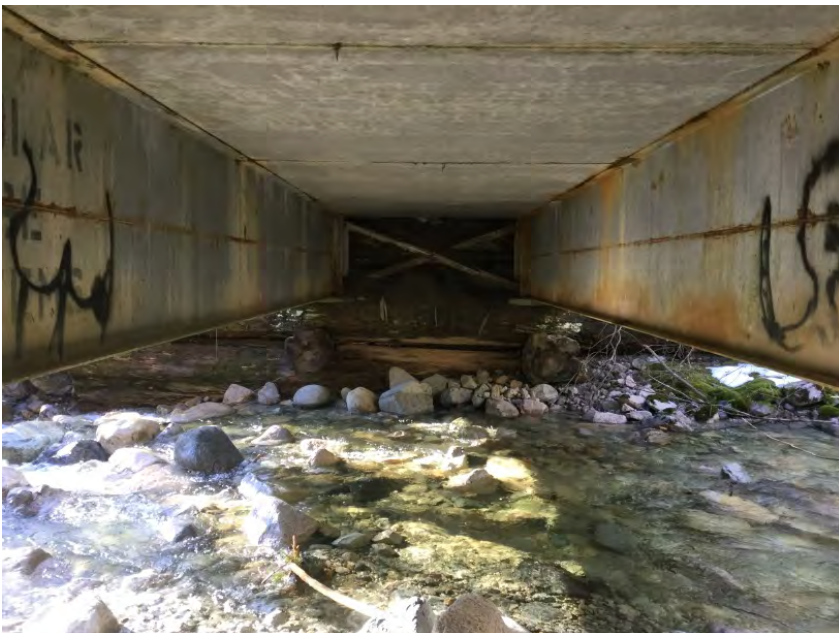
Superstructure

Painted box beams with minor corrosion

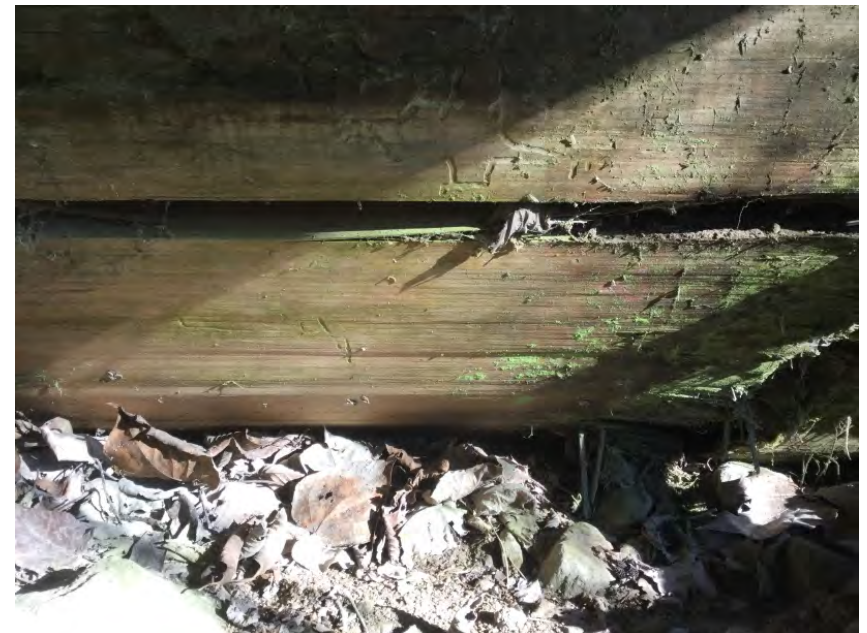
The abutments have been rated as fair; however the log sill and timber shims are starting to deteriorate and the log ballast wall is continuously rotting. The left bank log sill has a 30mm wide horizontal crack along the full visible length and the timber shims are starting to crush and needs to be monitored when being used for industrial purposes. The guardrail, risers and blocks are in poor condition and require replacement. The current load rating of L165 or 150 tonnes to continue, however monitor the condition of the abutments and if they deteriorate any further contact the undersigned for another inspection. Given the condition of the entire structure plan for a complete replacement soon.

Caps or Sills Fair Left bank, 30mm wide horizontal crack full visible length with crushing timber shims - monitor

Horizontal crack on left bank log sill; full visible length 30mm gap

Consideration should be given to replacing the entire structure given the condition of the abutments

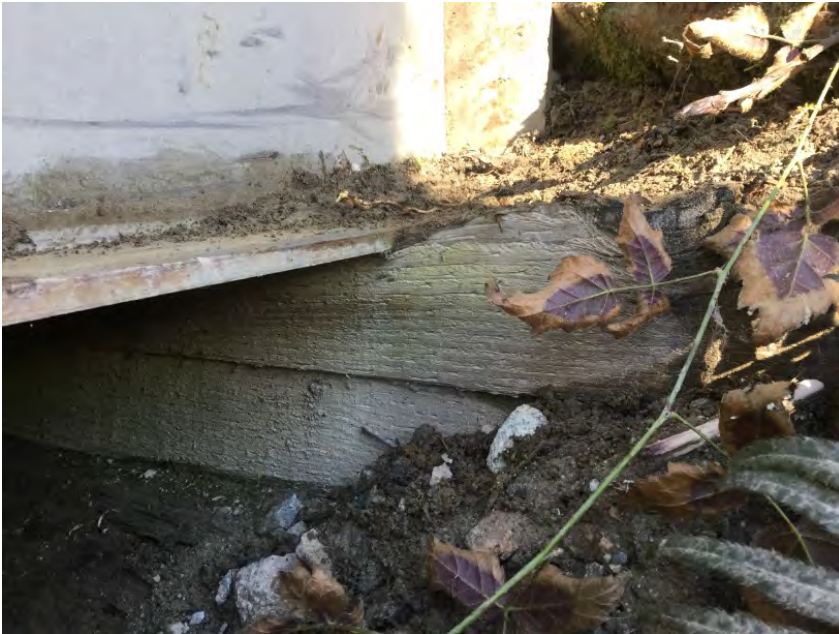
Bearings Fair Left bank timber shims crushing and girders settling - monitor

Timber shims on left abutment rotting and indications of crush, downstream shim shown here

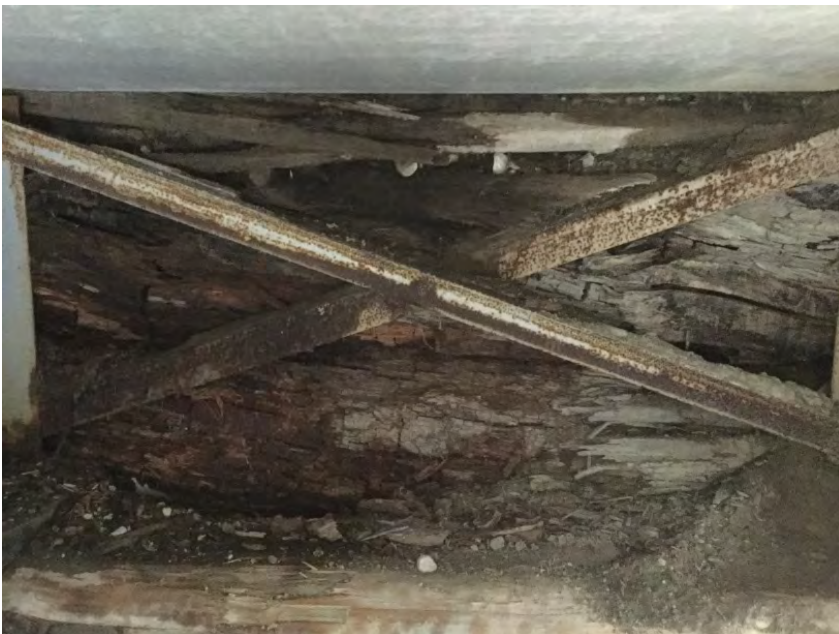
Ballast Wall Fair Rotten logs both abutments but still functional

Ballast wall condition, left bank

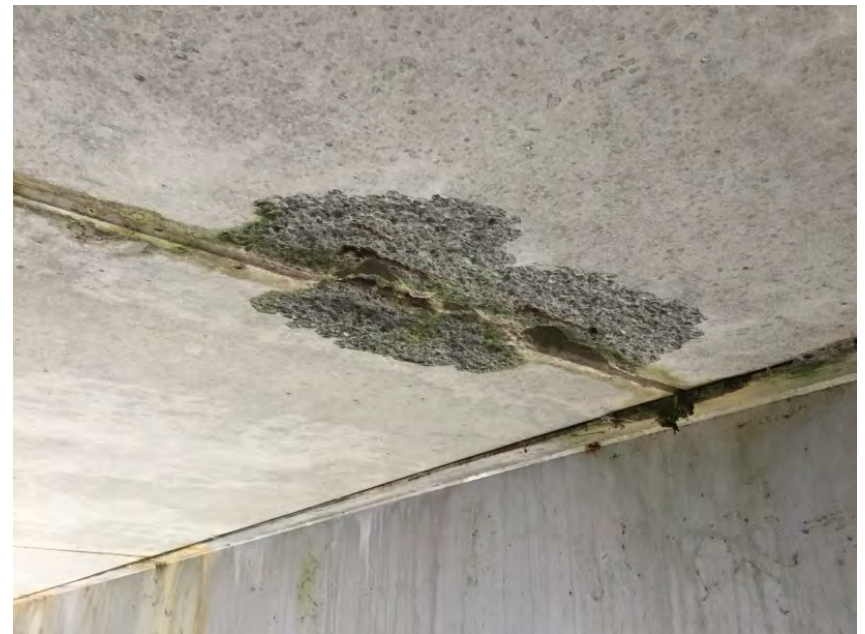
| Item | Monitor Description | Frequency |
|---|---|---|
| 2 | Spalling concrete underside of panels 1 and 2 at right bank | Routine Inspection |

Damage noted to panels 1 and 2 on right approach
