CK-2022

CHEHALIS 15.2km

2019 Inspection

Crossing Name Statlu Creek

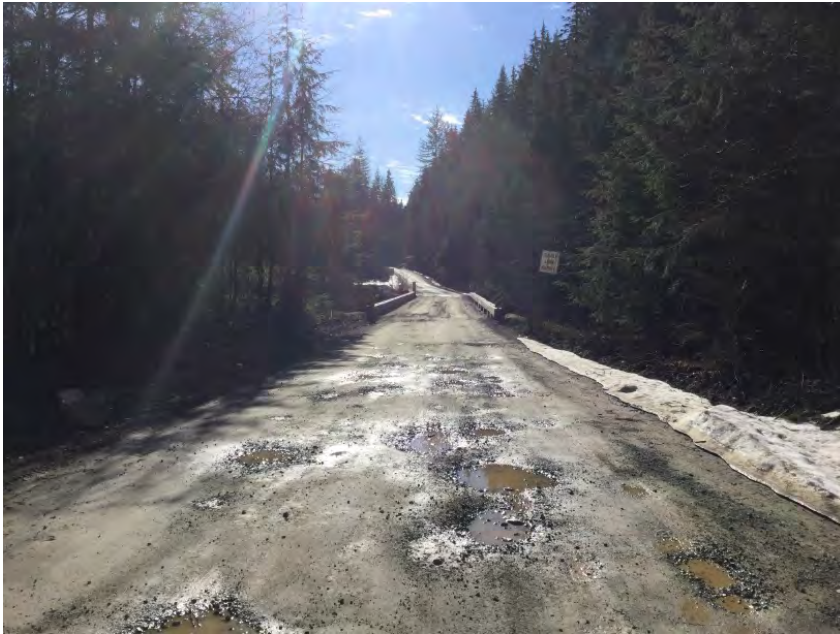
Approach from Left Bank when facing downstream

Fender Condition Fair Logs, small diameter at left approach

1 Medium Replace left approach fender logs with new ones, minimum 600mm diameter x 6m length

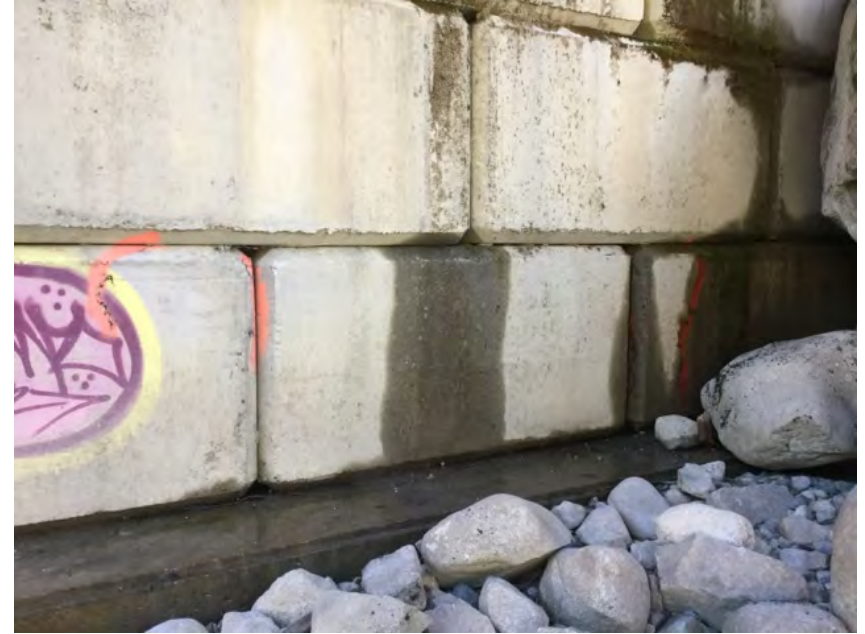
Concrete Fair Old CIP left bank, lock blocks right bank with minor damage noted to 3 bottom row of blocks

Lock block damage at right abutment

2 Lock block condition at right bank

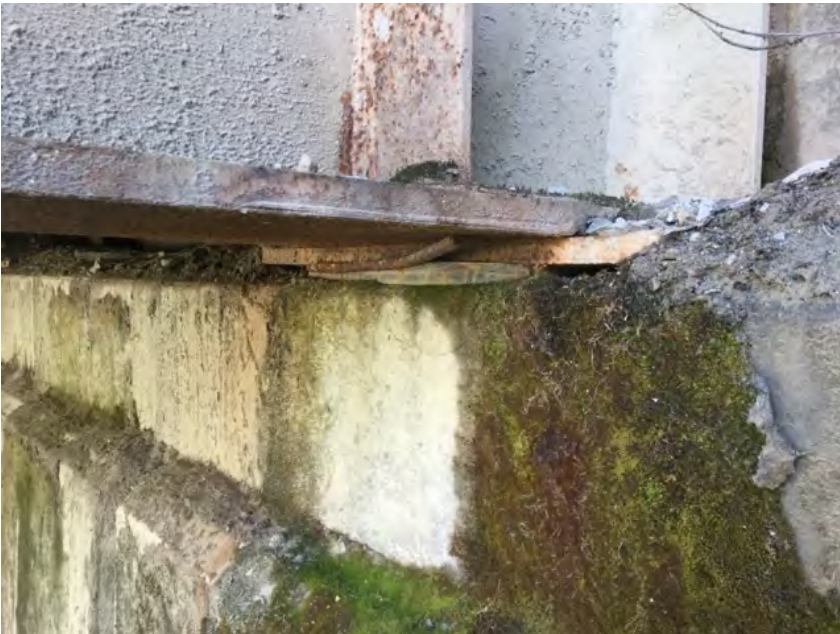
Bearings Fair Keepers have separated from the bearing plates, but do not appear to be any different then previous inspections

Keeper at US right bank

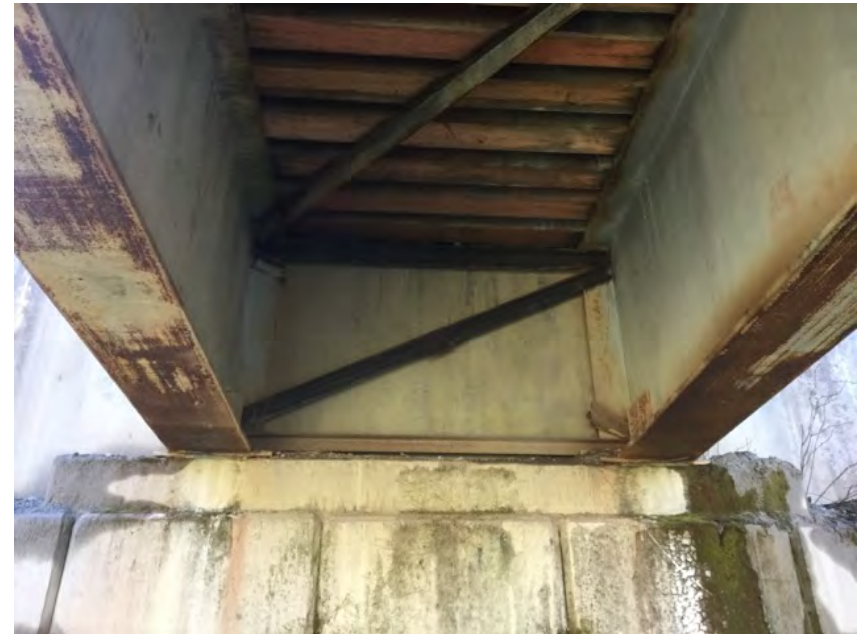
New end diaphragm at right abutment

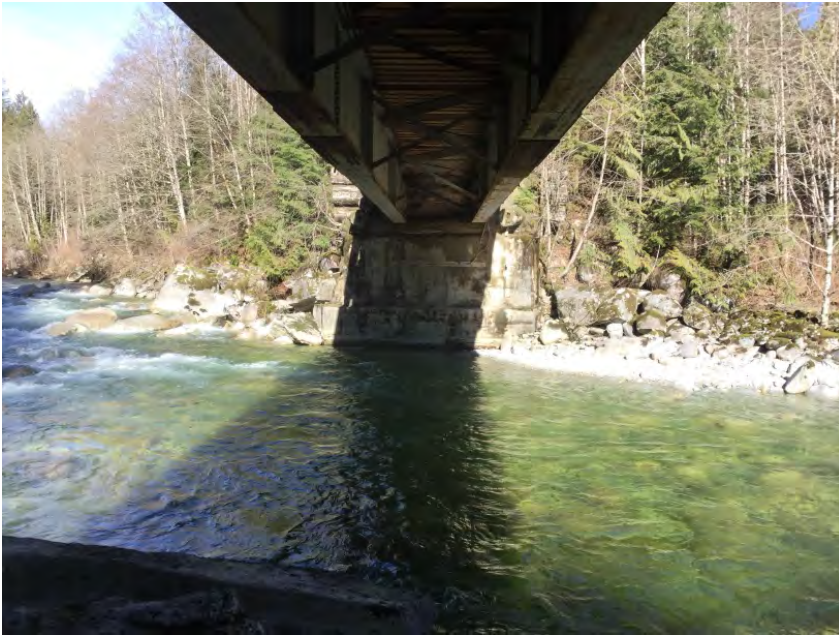
Left Bank Abutment when facing downstream

Caps or Sills Fair Concrete cap right bank is good, log left bank is old and in fair condition

Ballast Wall Fair Concrete right bank in good condition, logs left bank

1 Left bank abutment condition

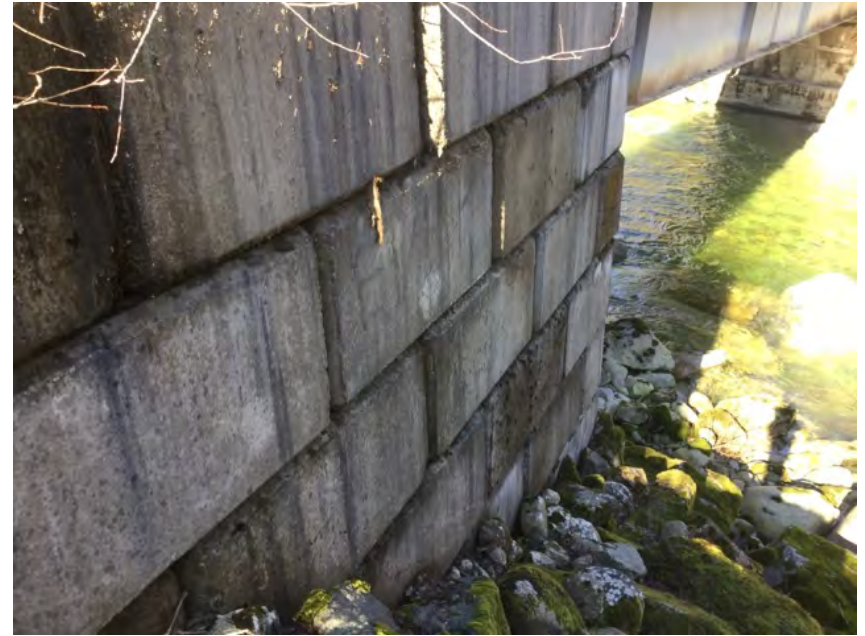
Wing Wall Fair Logs left bank and lock blocks downstream right bank

Lock block wingwall at DS right abutment

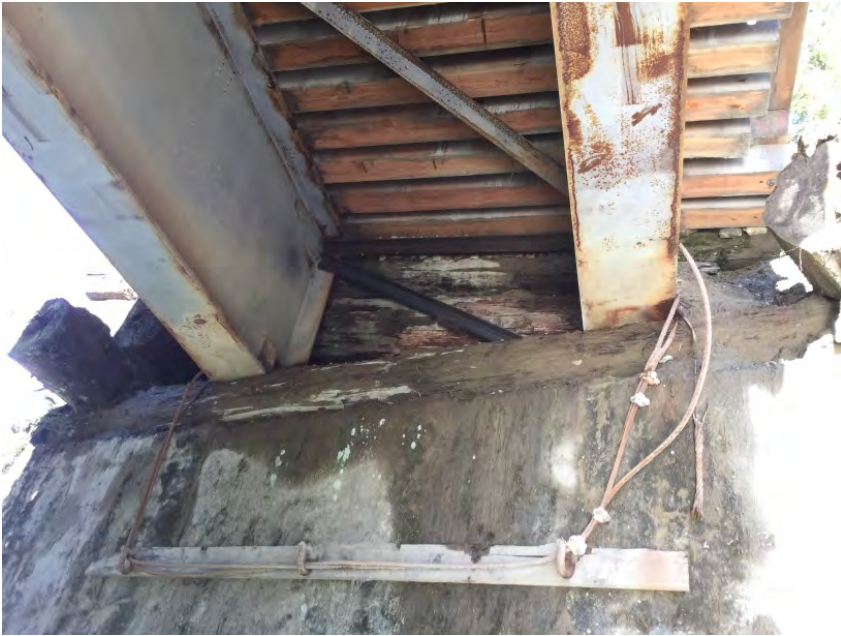
New end diaphragm at left abutment

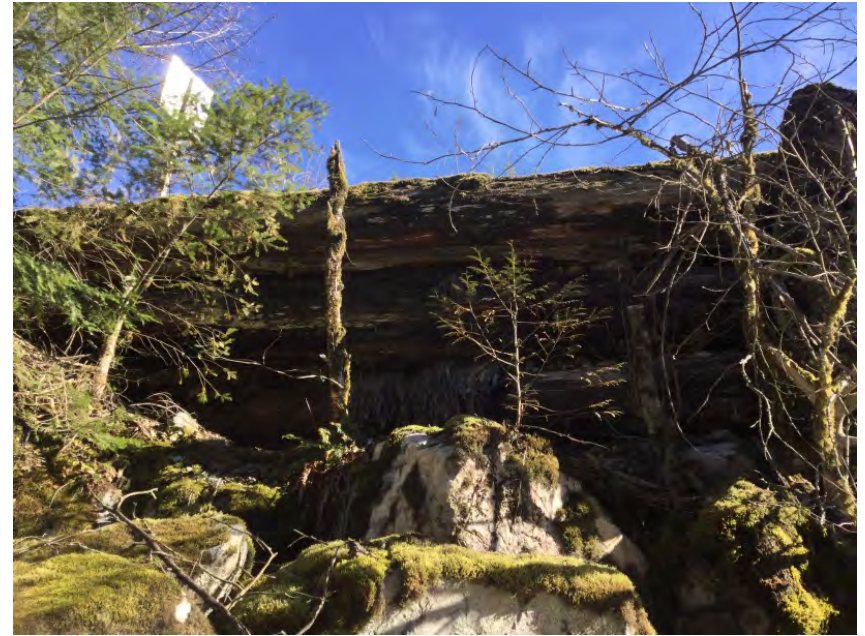
Wingwall upstream left bank

Riprap Fair Upstream left bank needs to be monitored as it is not well graded and has holes, also has old logs and large round rock for protection

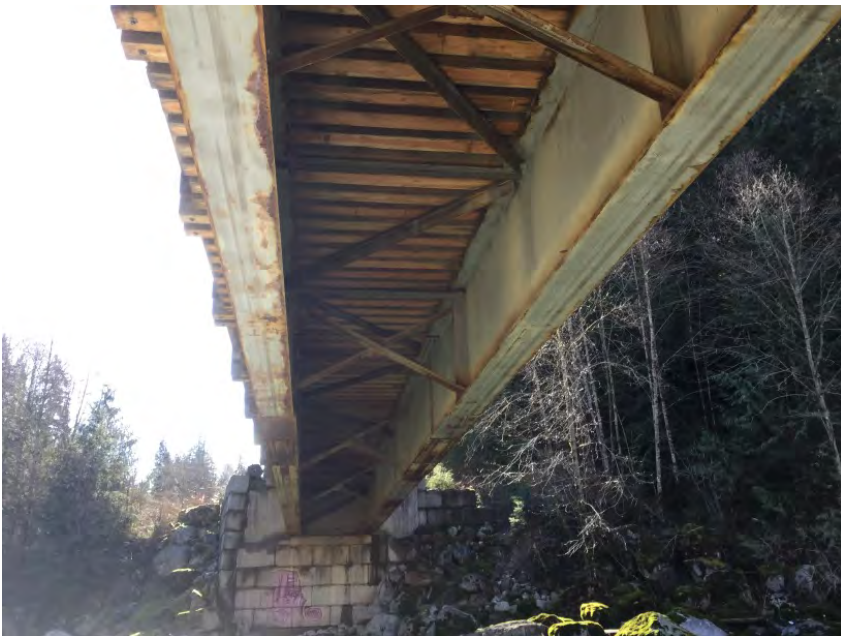
Superstructure

Painted girders with minor corrosion
