CK-2031

STATLU 1.7km

2019 Inspection

| Crossing Name | Statlu Creek |

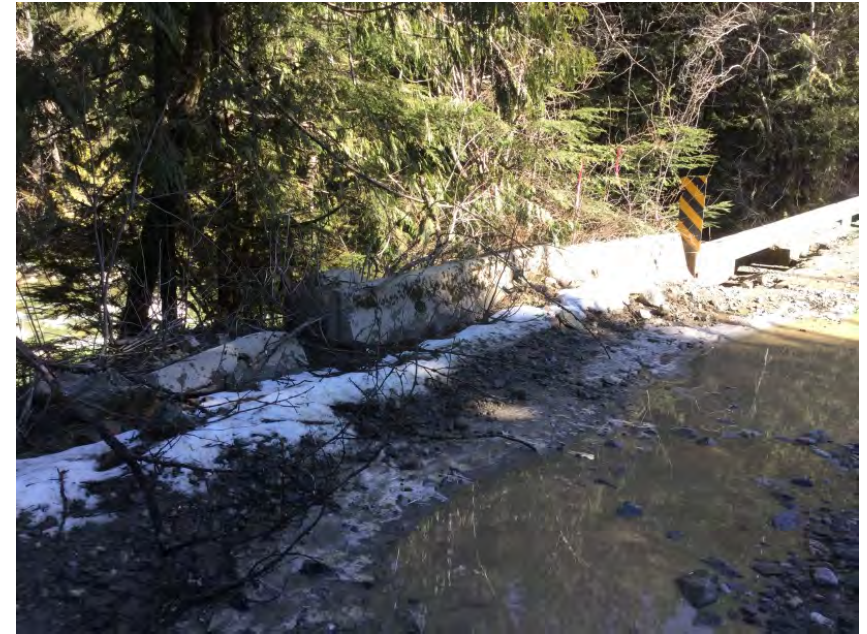
Concrete no posts off road at upstream left approach and misaligned others

Upstream right approach no posts

| Item | Priority | Repair Description |
|---|---|---|
| 1 | High | Repair approach fills and realign all concrete no post barriers |

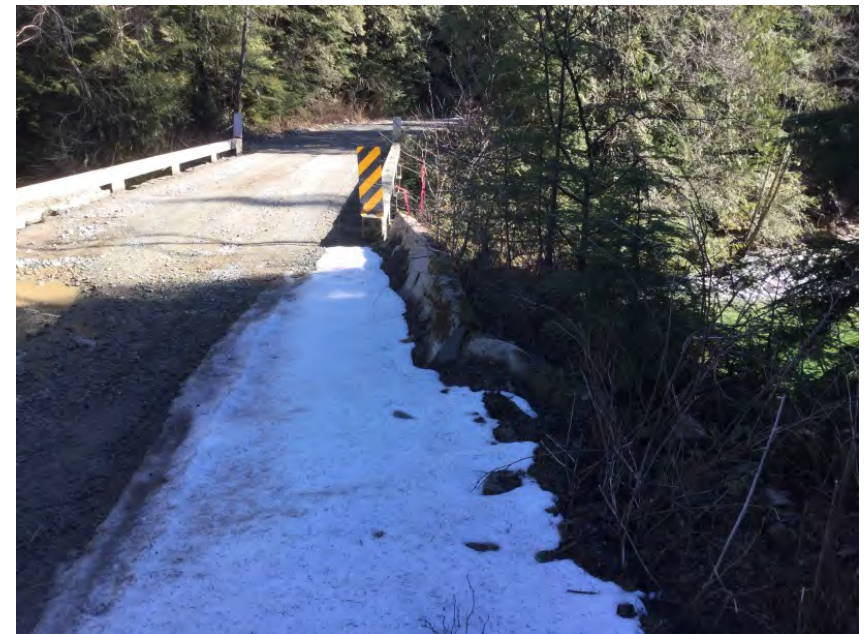
Downstream right approach no posts

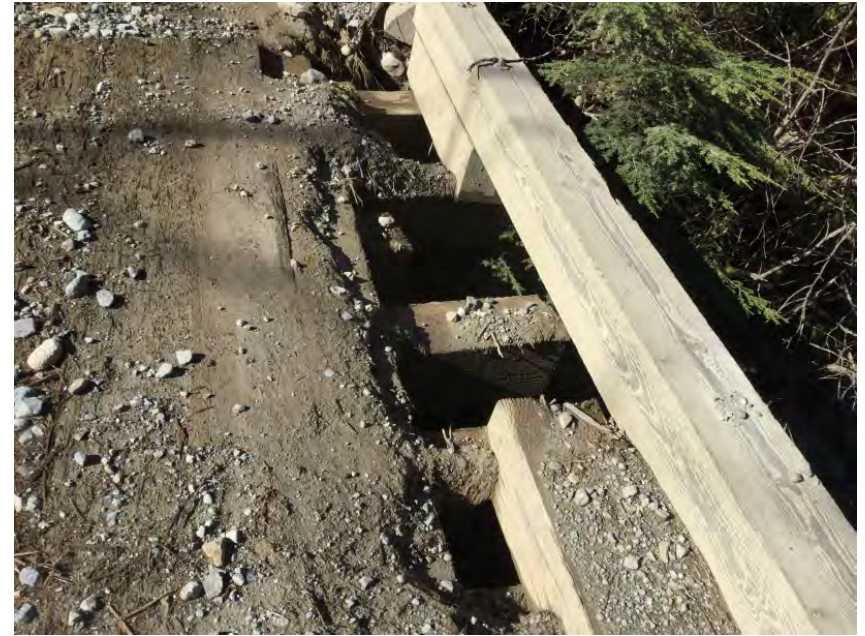
Treated timbers but inconsistent alignment at right bank, up to 600mm on centers for 2m length

Tie alignment at right bank not consistent, upstream shown

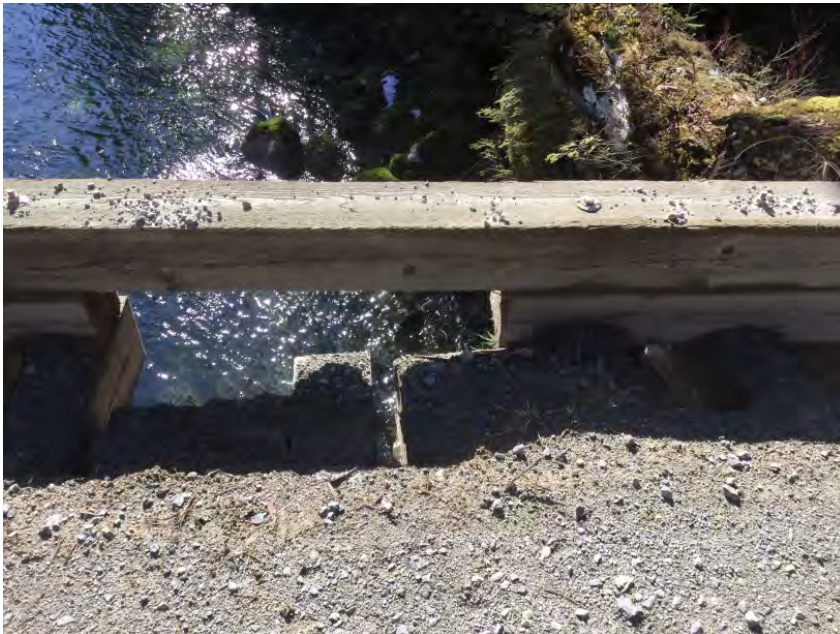
Tie alignment at right bank not consistent, downstream shown

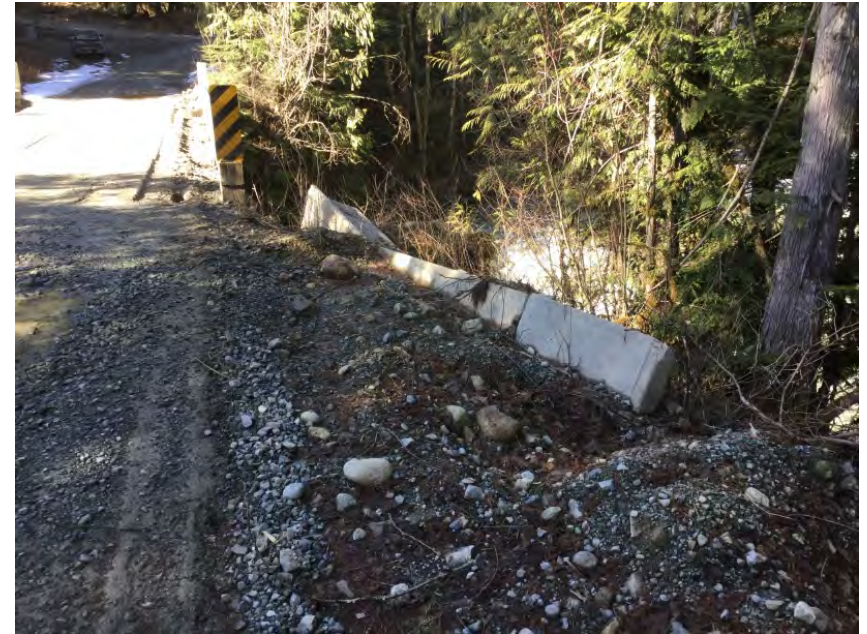
Upstream left approach no posts off road

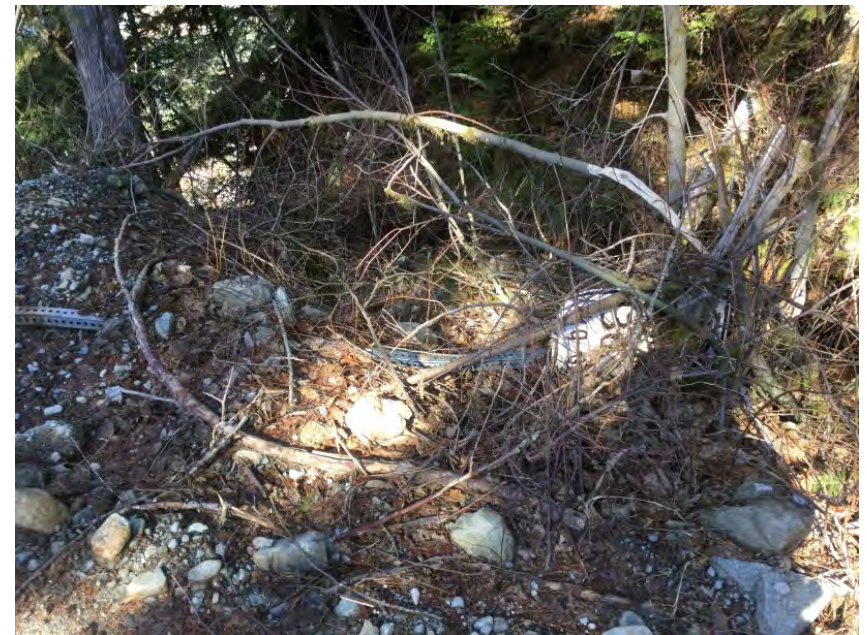
Left approach load rating sign

| Item | Priority | Repair Description |
|---|---|---|
| 3 | Low | Reset left approach load rating sign |

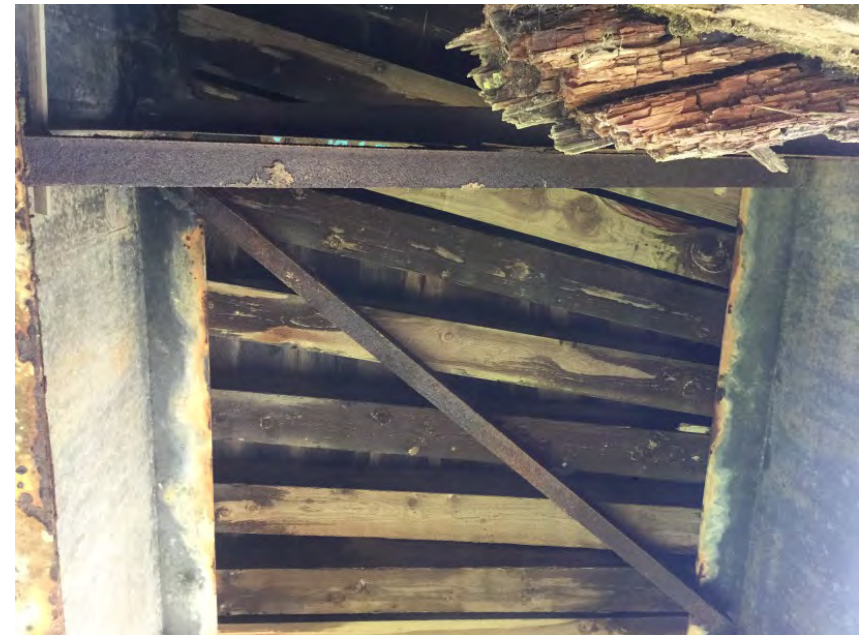
Tie misalignment

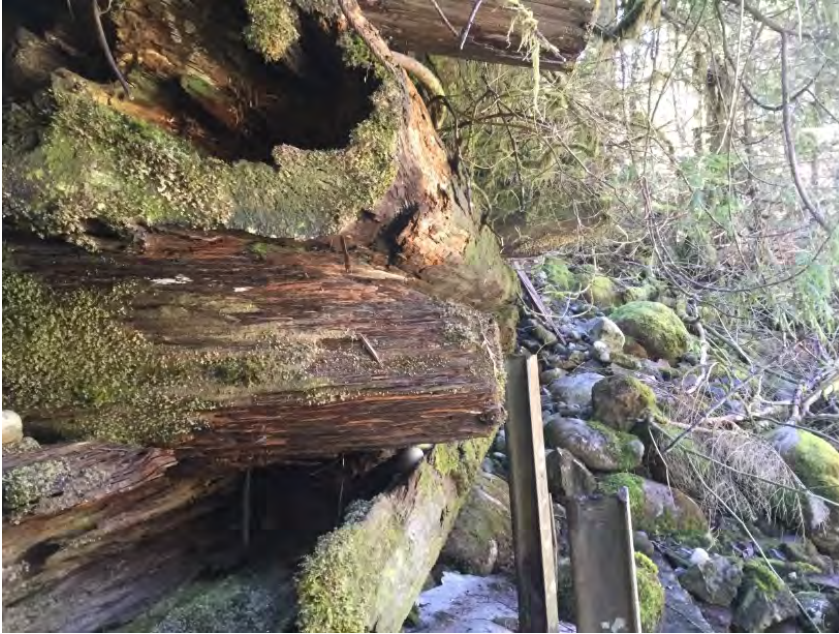
Upstream right bank poor, others are fair to poor

Upstream right bank wingwall condition

| Item | Monitor Description | Frequency |
|---|---|---|
| 1 | Monitor wingwall condition | Routine Inspection |

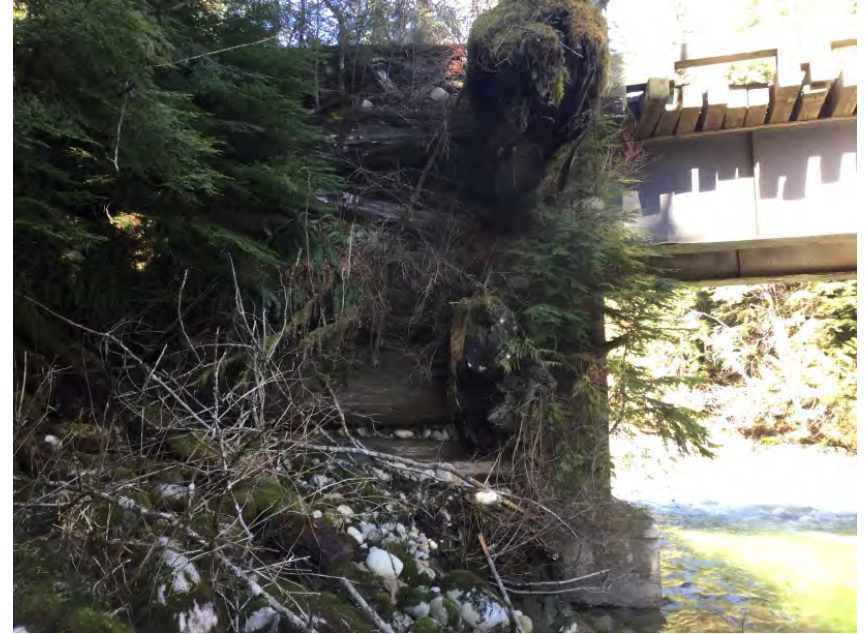
Downstream right bank condition

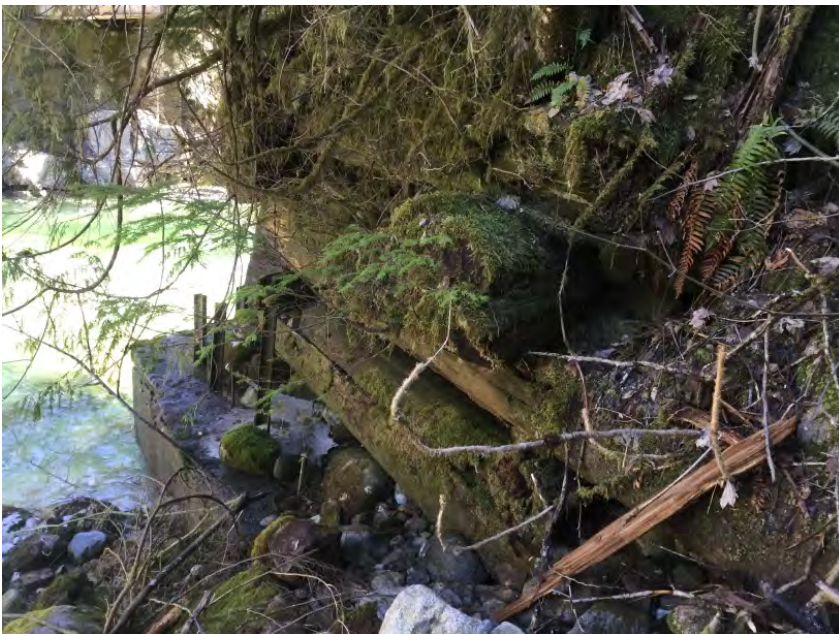
Upstream right bank wingwall condition

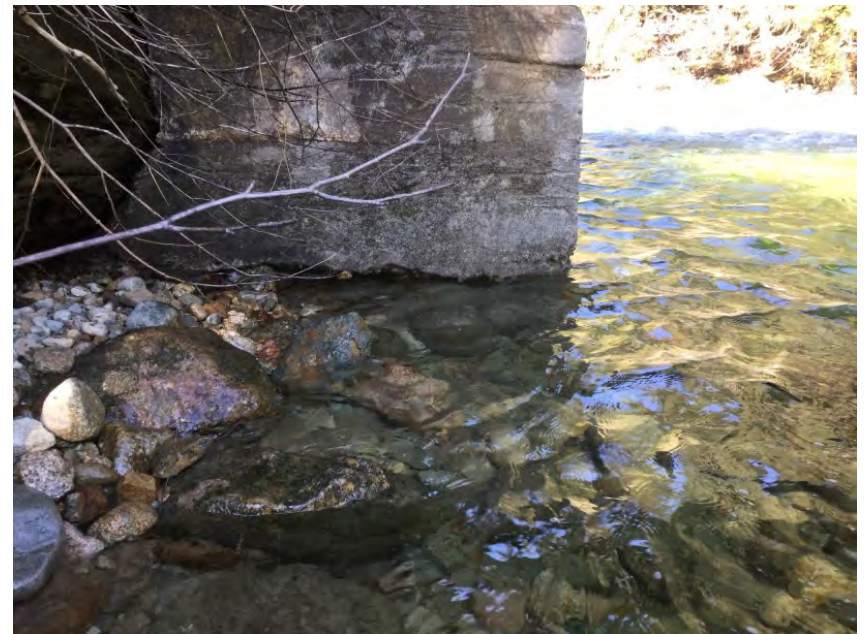
Scour under downstream right bank CIP does not appear any worse
