CK-2035

STATLU 7300 0.1km

2019 Inspection

| Crossing Name | Statlu River |

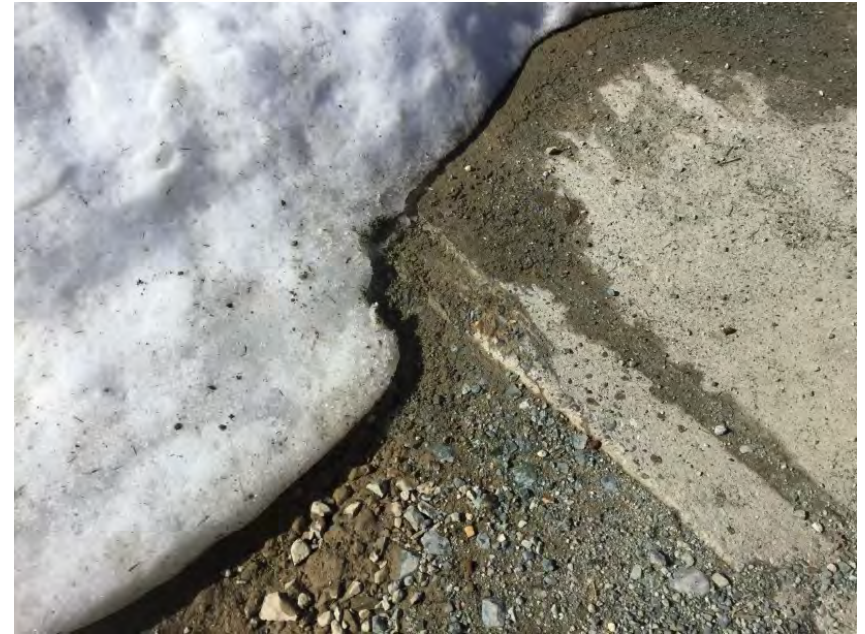
Ballast Wall Good Minor damage noted to top at left bank

Minor damage noted to top of ballast wall at left bank

| Repair Item | Priority | Repair Description |
|---|---|---|
| 3 | Low | Repair damage to top of ballast wall at left bank |

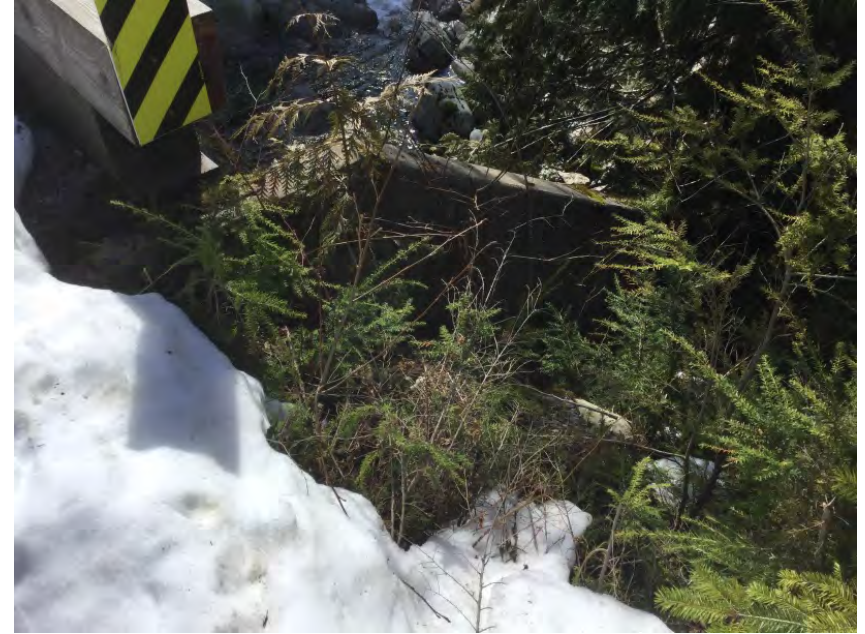
Fill Fair Poor downstream right bank

Fill eroding at downstream right bank

| Repair Item | Priority | Repair Description |
|---|---|---|
| 2 | Medium | Replace eroded fill at downstream right bank |

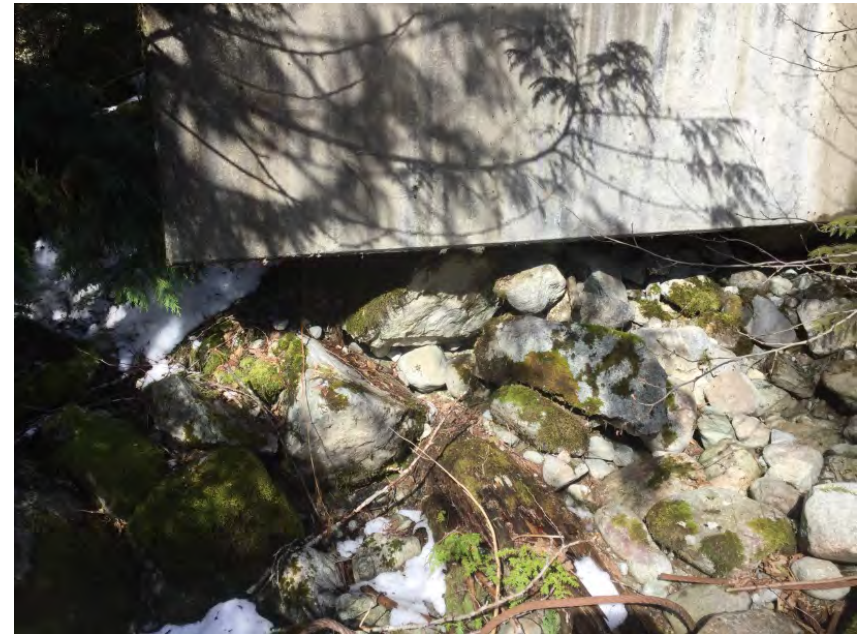
Fill eroding at downstream right bank

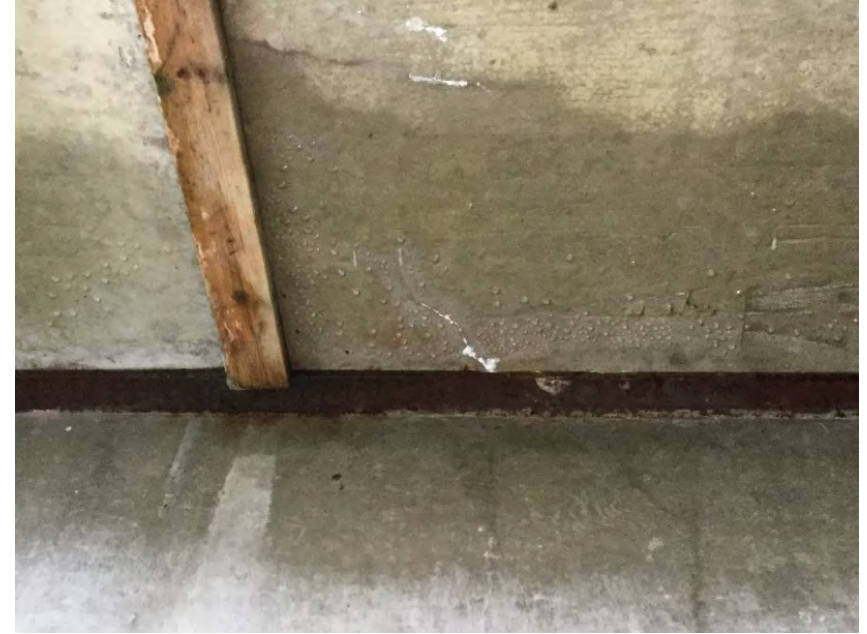
Minor cracking and efflorescence noted on panel 1 right bank

| Item | Monitor Description | Frequency |
|---|---|---|
| 1 | Deck panel condition | Routine Inspection |

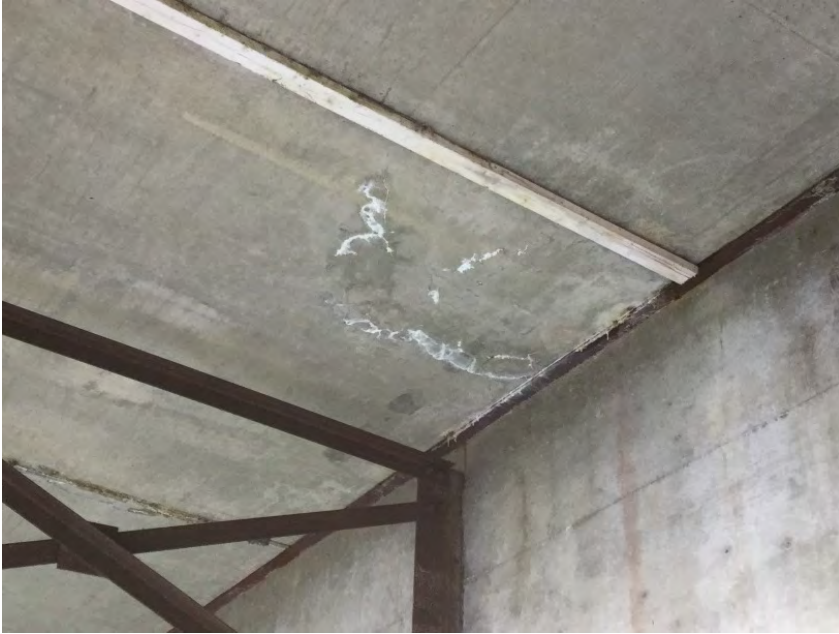
Minor cracking and efflorescence on Center panel

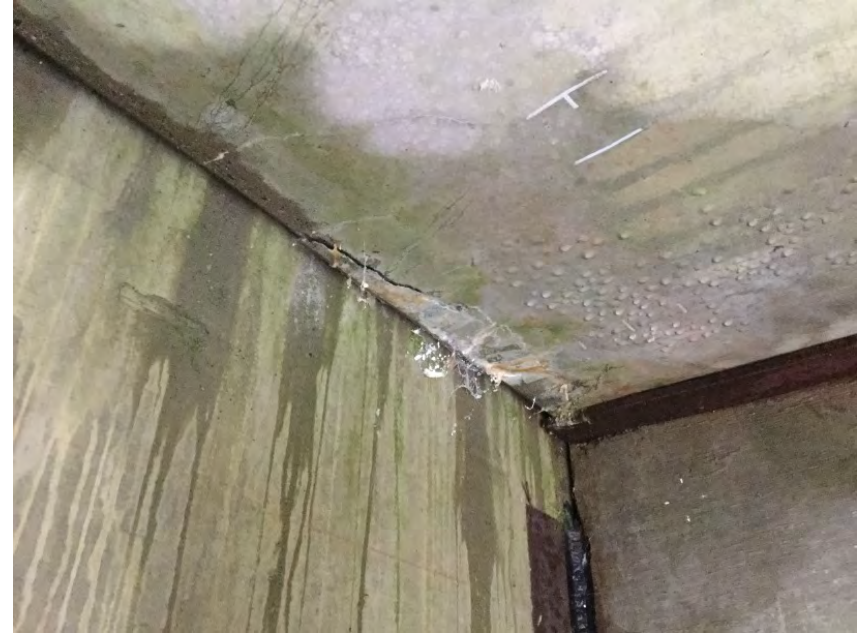
Minor damage noted to panel 1 at left bank

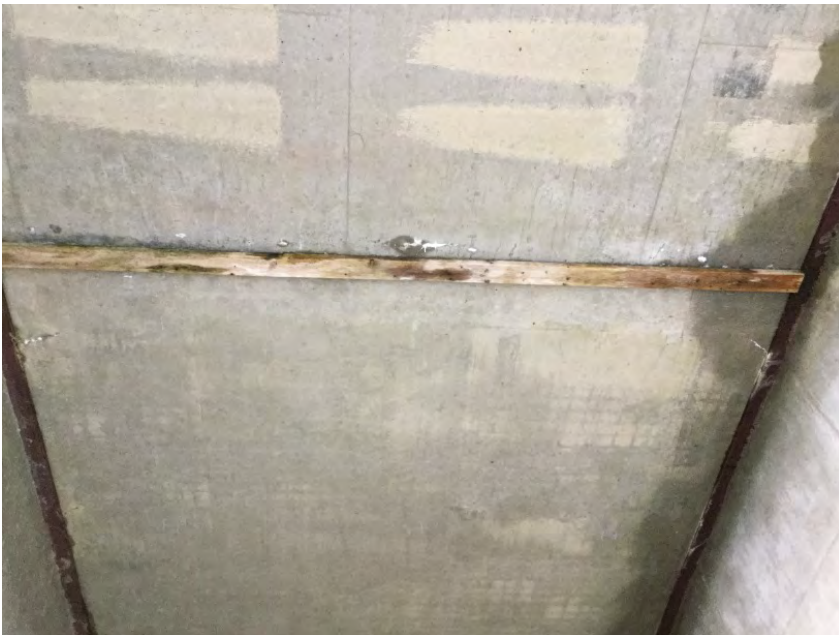
Minor cracking and efflorescence on panel 1 and 2 at left bank
