CK-2036

STATLU 7300 0.2km

2019 Inspection

| Crossing Name | Statlu Creek |

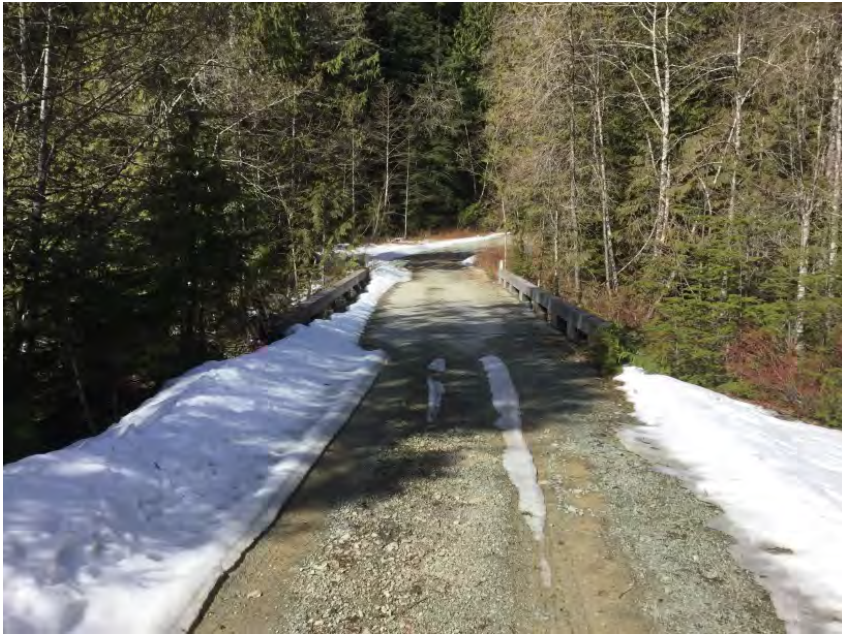
Approach from Left Bank when facing downstream

Brushing Required Y

Fender Condition Poor None

| 2 | Low | Brush and grade approaches and install fenders at both approaches |

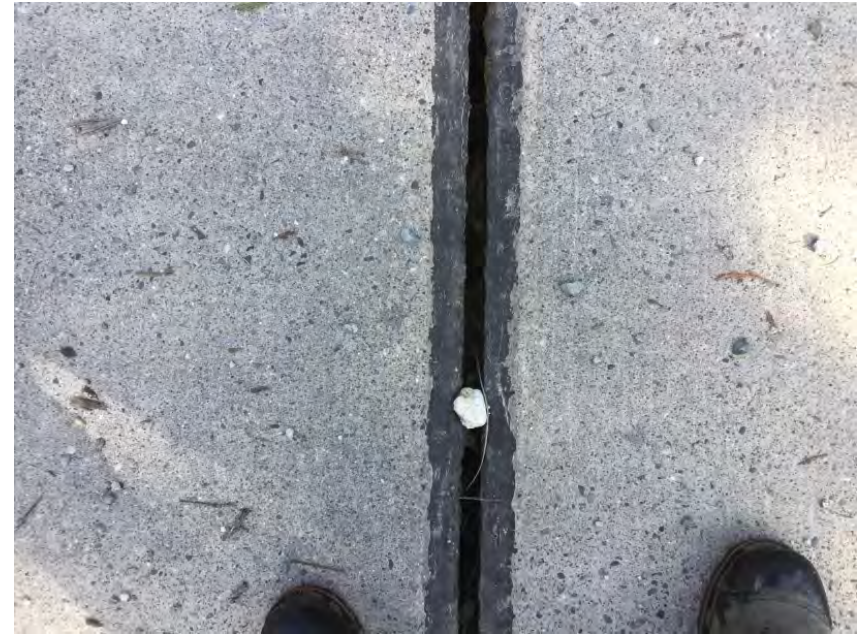
Deck Joints      Poor      All deck joint seals rotten/or gone

Deck joint seals missing

| 1 | Medium | Replace all deck joint seals |

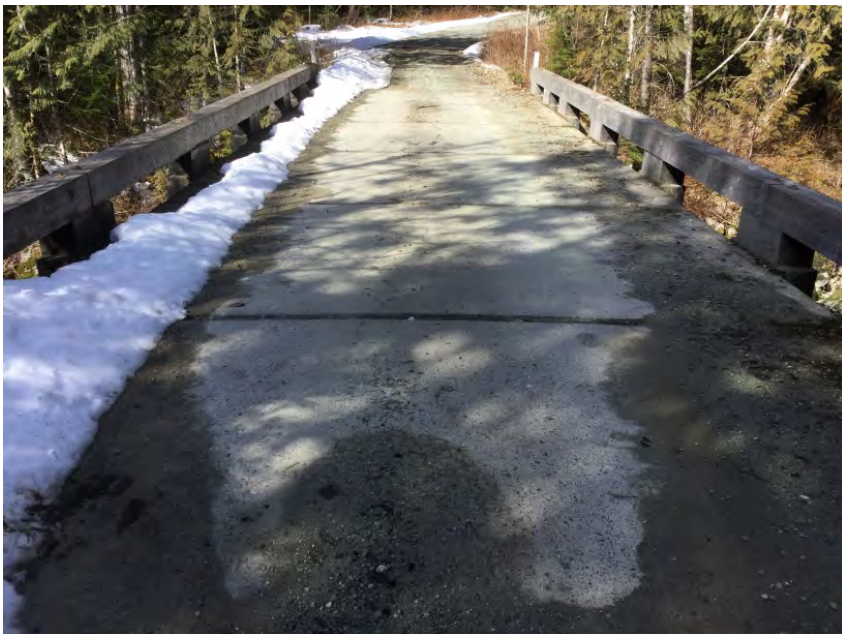
Overall Deck Condition      Fair

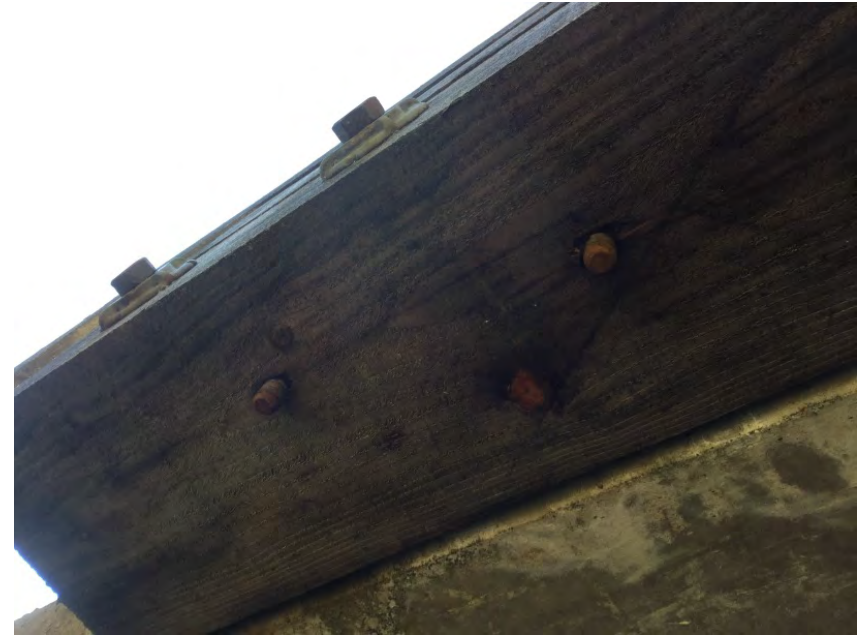
Hardware      Fair      Missing some guardrail hardware

Guardrail missing some hardware

| 3 | Low | Replace missing guardrail hardware |

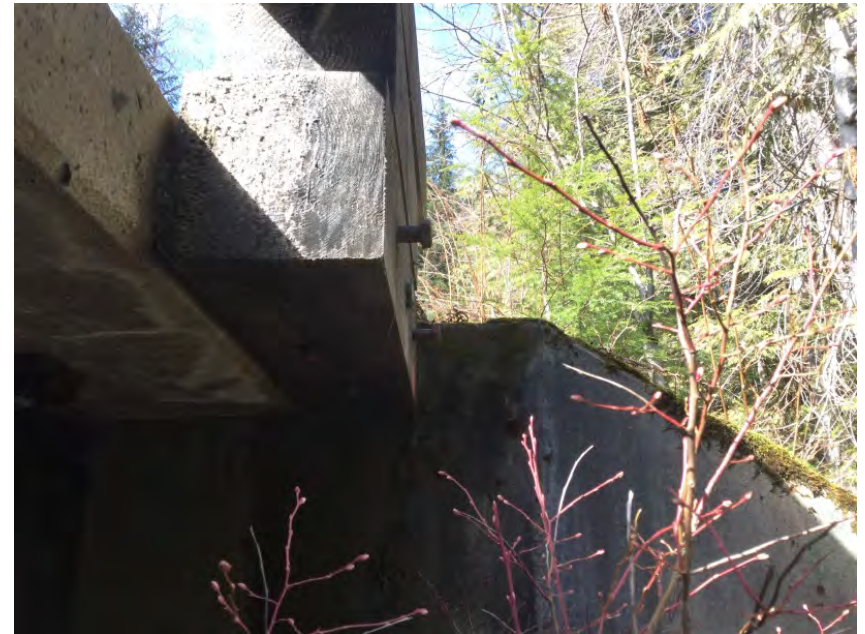
Loose sideblock bolts

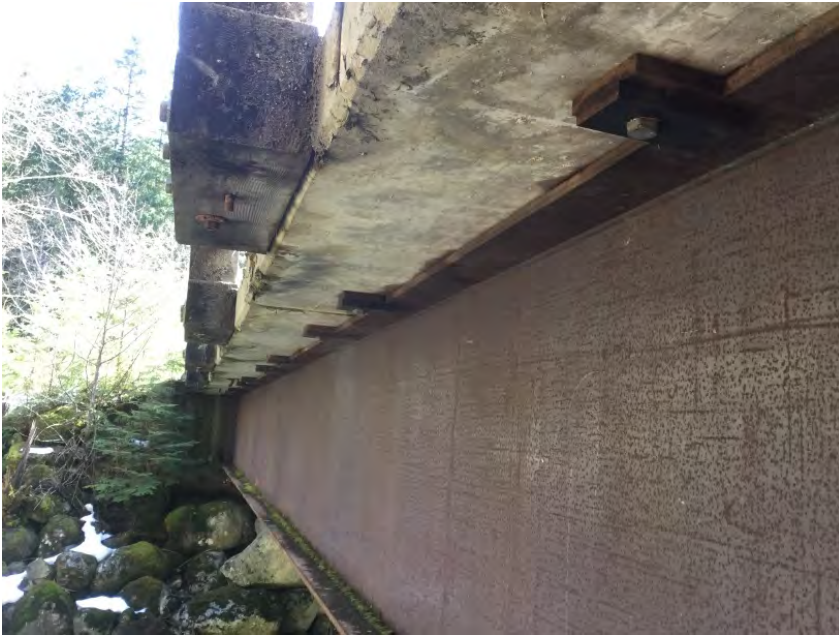
Deck to Girder Bolts      Good      Deck clips installed and functional

Deck clips

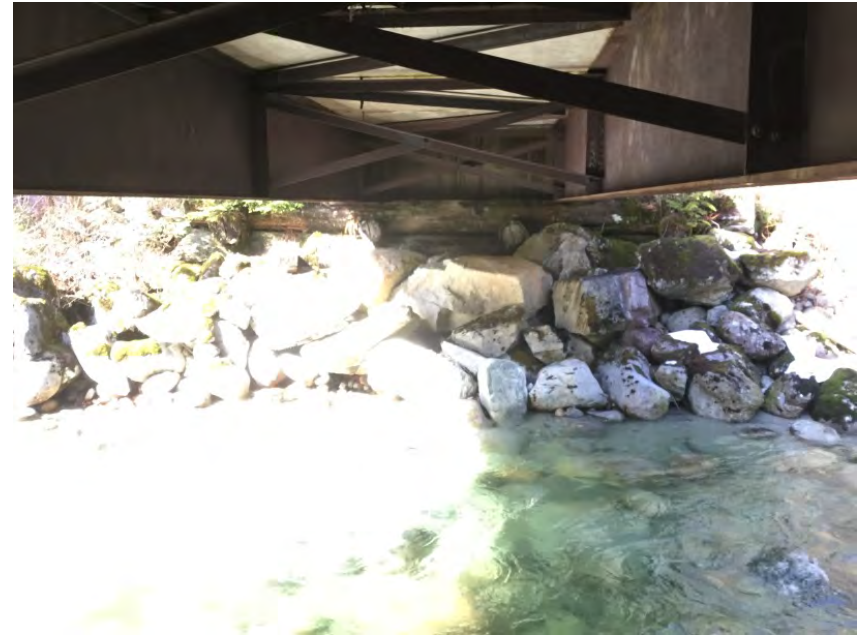
Right Bank Abutment when facing downstream

Log/Timber Cribs Fair 3x closed face logs with up 30mm sap rot

| 1 | Crib condition | Routine Inspection |

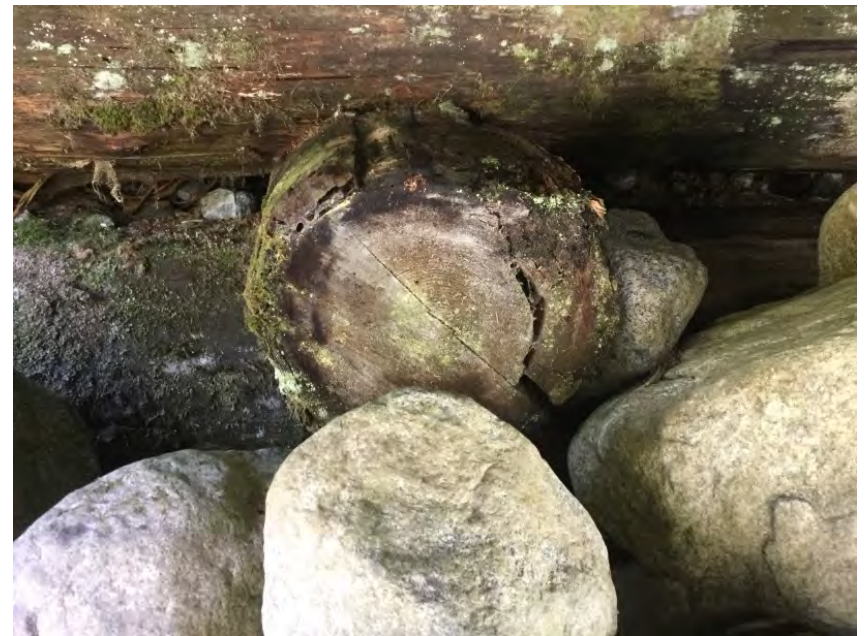
The log crib is showing its age with the noted sap rot depth and tieback condition. Monitor the crib condition, especially when using the bridge. Replace all deck panel joints; replace missing guardrail hardware; install fenders at both approaches; brush and grade approaches. The current load rating of L150 or 136 tonnes to continue.

Tie Backs Fair 4x with end splitting and 40mm sap rot

Tieback condition, typical
