CK-2052

CHILLIWACK LAKE 11.1km

2019 Inspection

| Crossing Name | Depot Creek | | |

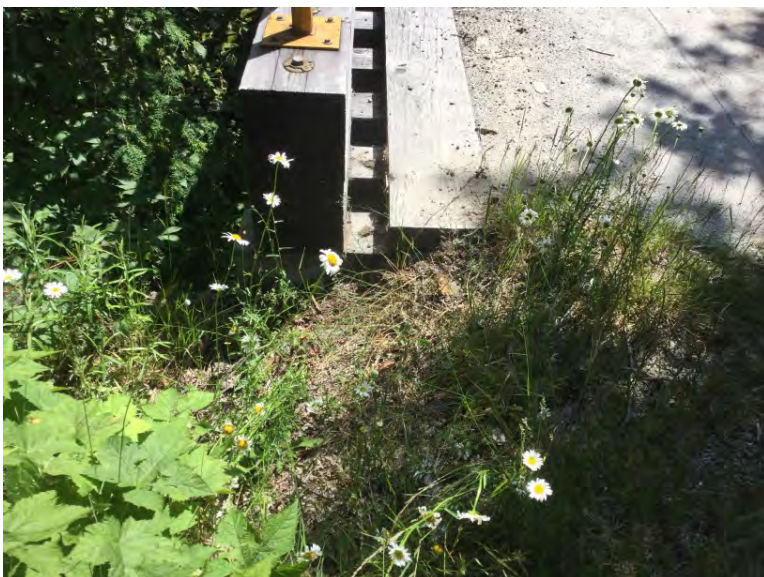
Loosing fill at both approaches

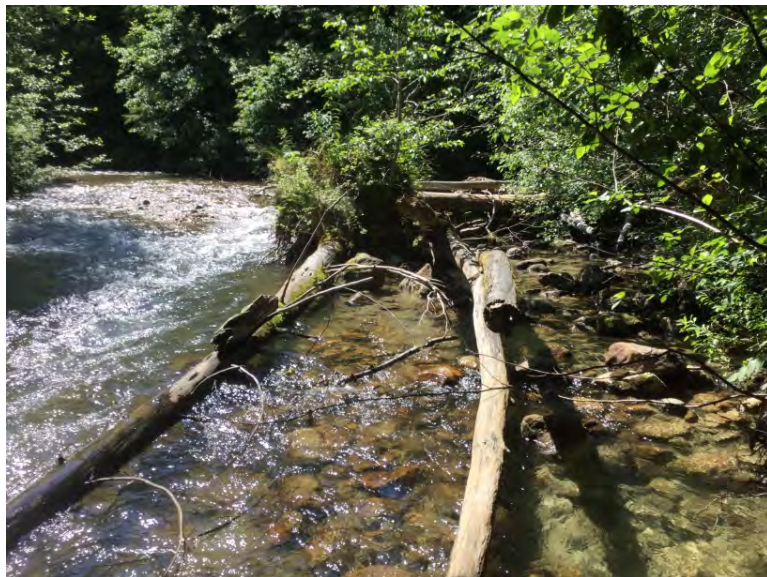
| Estimated Present Water Level Depth (m) | 0.4 | High Water | <input type="checkbox"/> | Debris | <input checked="" type="checkbox"/> |

Debris accumulations immediately upstream of crossing

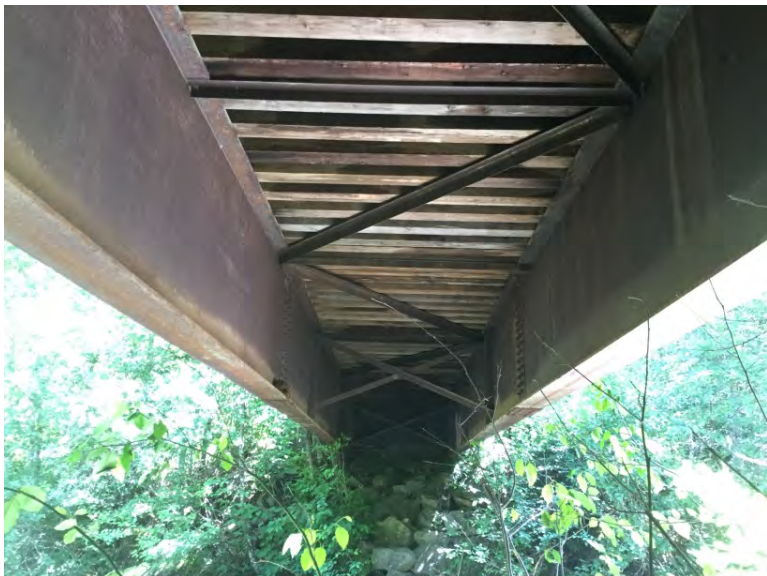
Superstructure

Girders Fair Light corrosion

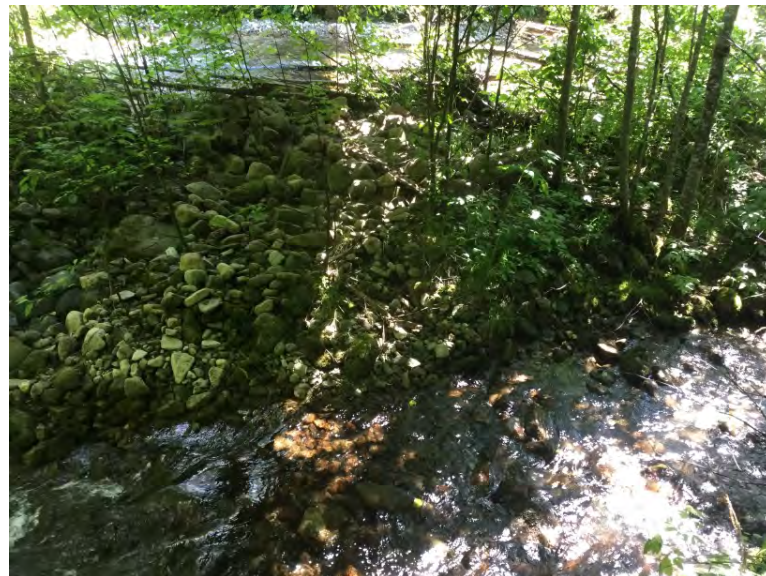
Comments 2 stream channels under bridge separated by aggraded material with 10-15 year old Alder

2 stream channels under bridge

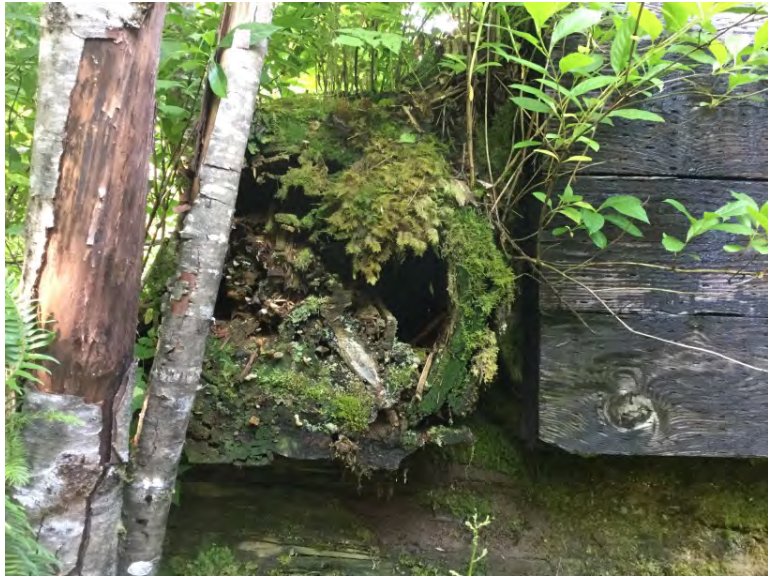
Logs retaining fill in road are rotten

Rotten fill retainment logs

Rotten fill retainment logs at all corners

Replace the fill retainment logs; brush approaches; replace delineators, and post bridge ahead signs prior to industrial activity. The current load rating of L45 or 41 tonnes.

| Item | Priority | Repair Description |
|---|---|---|
| 1 | High | Replace fill retainment logs prior to industrial traffic |
