CK-2053

LIUMCHEN 0.2km

2019 Inspection

Crossing Name Tamihi Creek

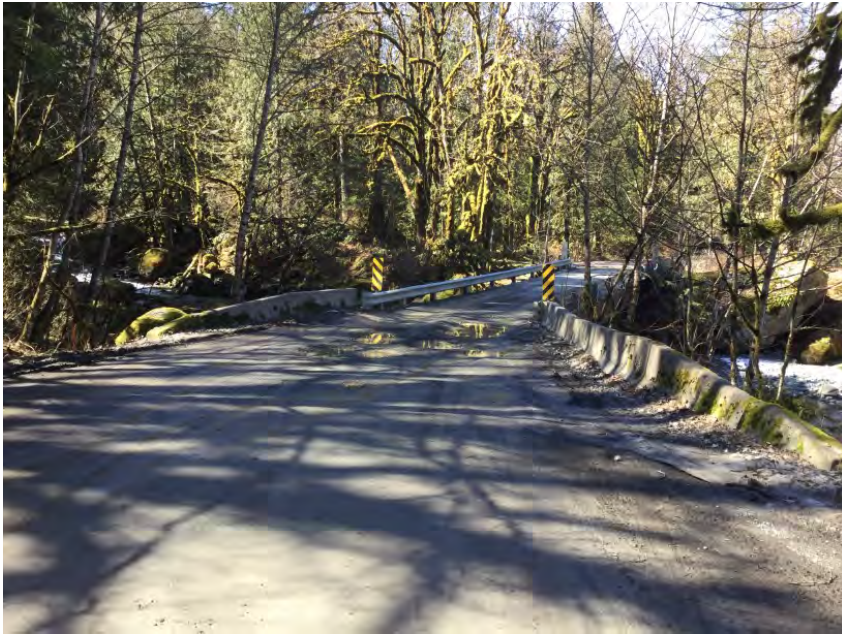
Approach from Right Bank when facing downstream

Potholes at approaches

| Repair Item | Priority | Repair Description |
|---|---|---|
| 1 | Low | Grade approaches |

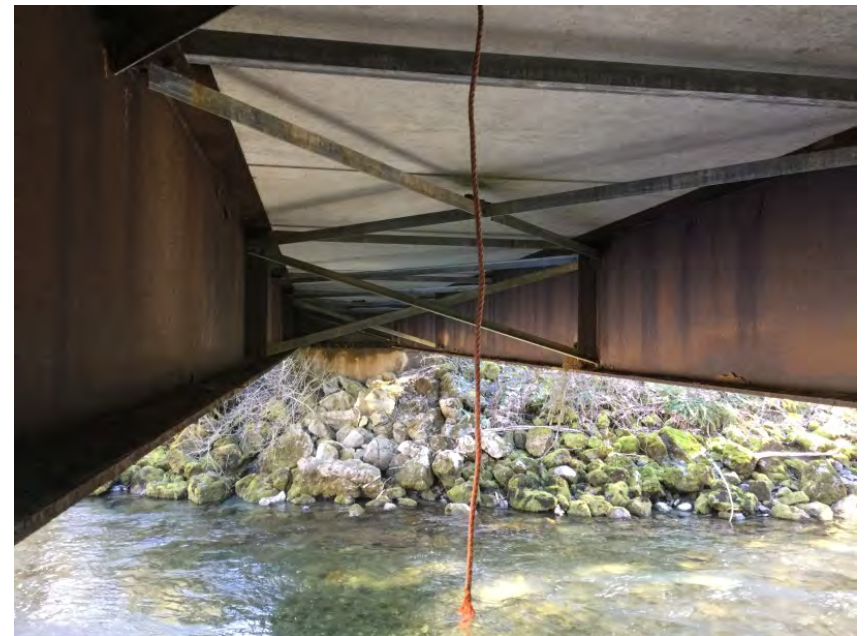
Superstructure

Girders Fair corrosion

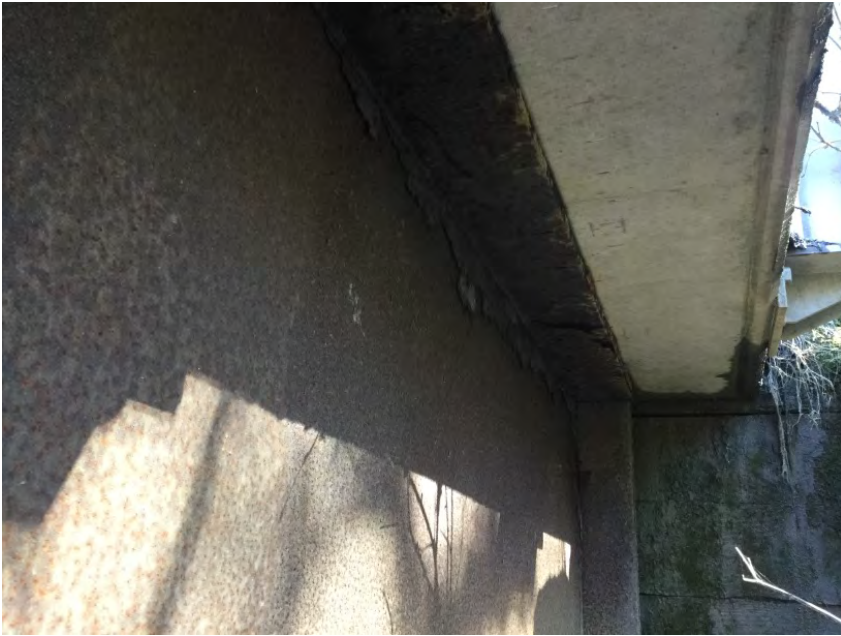
Steel delamination noted on girders

Grade approaches and continue to monitor the steel girder condition. The current load rating of BCL-625 or 63 tonnes to continue.

| Item | Monitor Description | Frequency |
|---|---|---|
| 1 | delaminating steel | Routine Inspection |

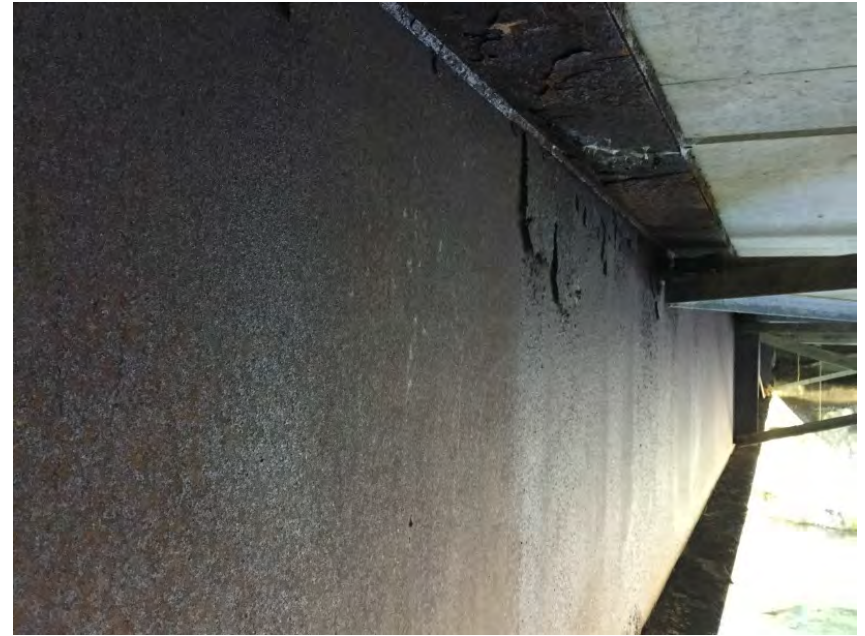
Steel delamination

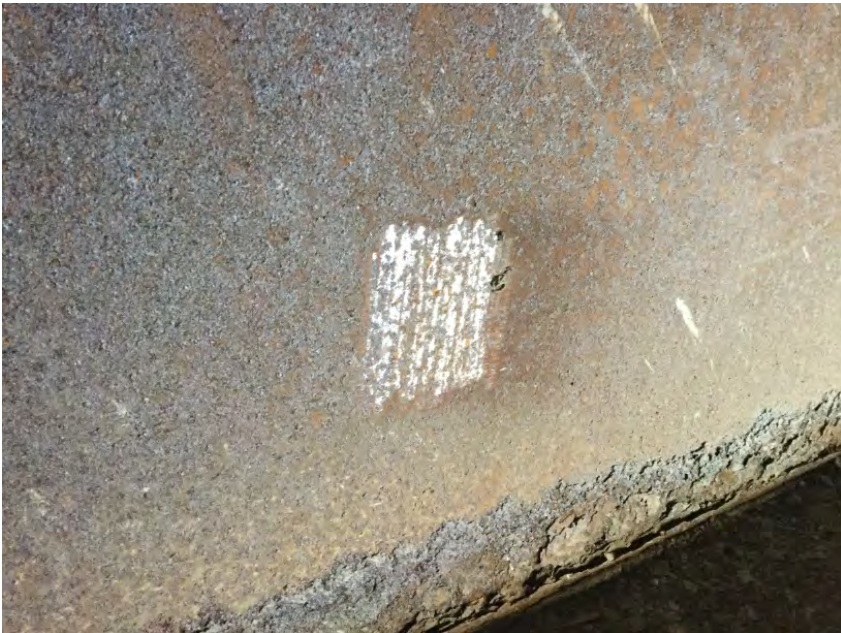
Location of previous web measurements - no further delamination
