CK-2054

LIUMCHEN 0.9km

2019 Inspection

| Crossing Name | Little Tamihi Creek |

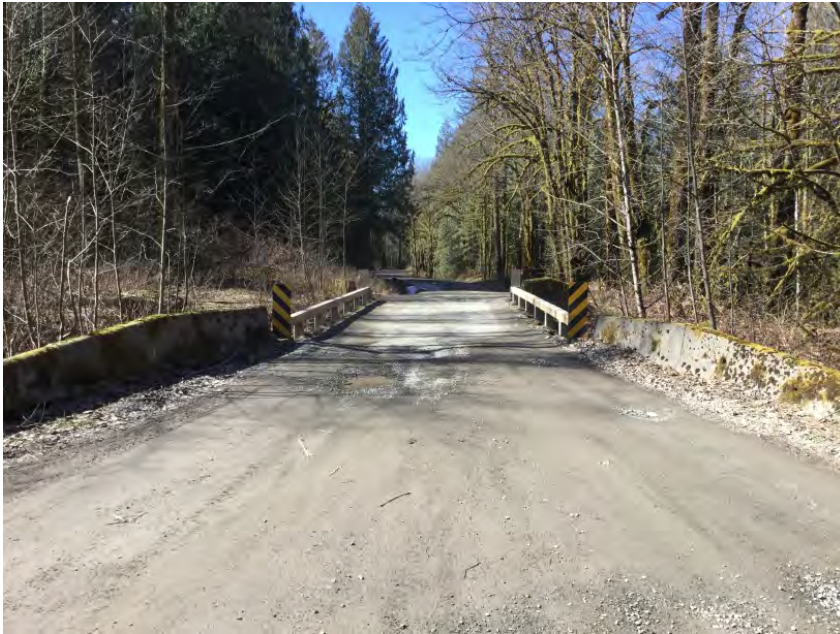
Approach from Right Bank when facing downstream

Road Surface Fair Potholes

| 1 | Medium | Grade approaches |

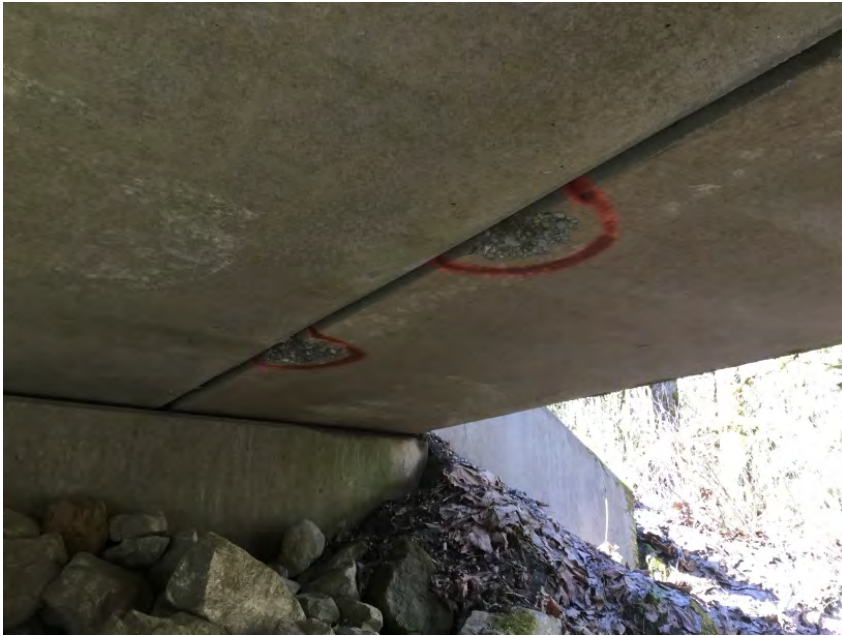
Damage to underside of slabs
